Aspect Weekly Update

Seven Acres Development (Former LDM Site - ECSI #887)

QUARTERLY UPDATE: JANUARY 1 - MARCH 31, 2023

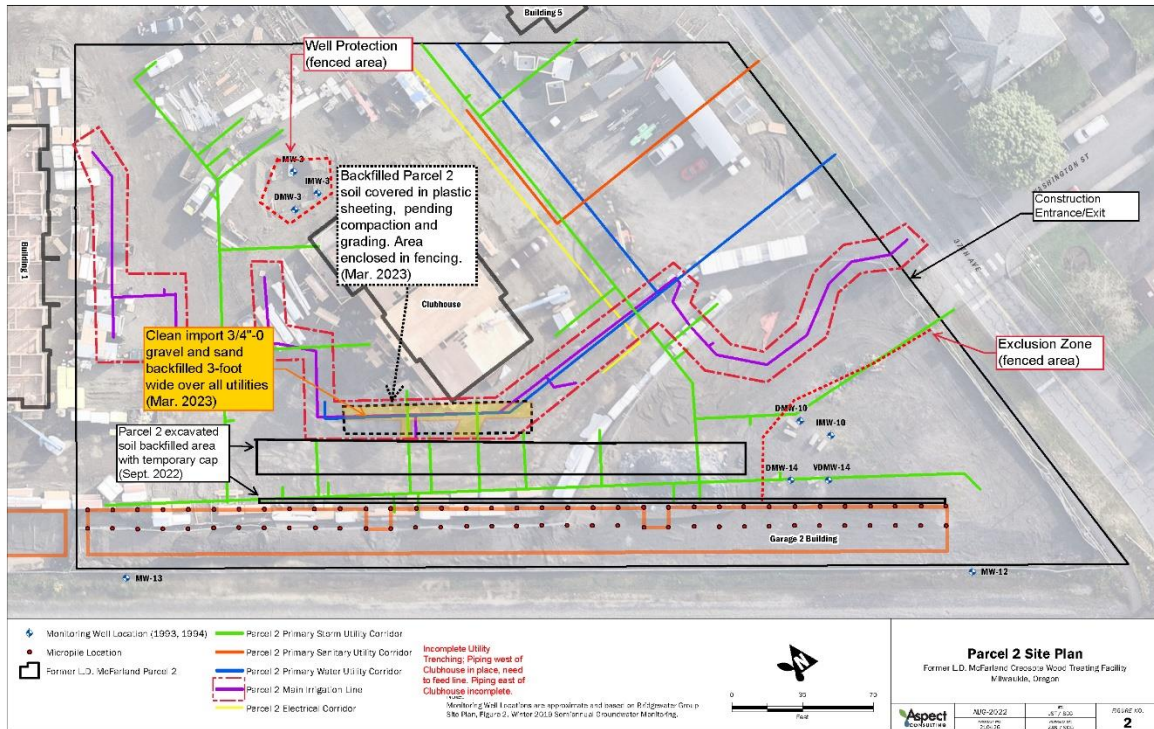
PLAN VIEW PROGRESS

Parcel 2 construction work focused on Phase I pavement completion, Phase II pavement preparation, Clubhouse construction, Garage 2 construction, tree well excavations, soil management, and final well adjustments.

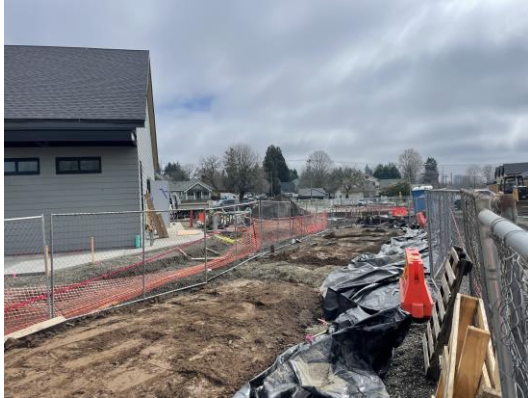
3/29/23 Parcel 2 utility and tree well excavated soil placed in parking stall footprint south of Clubhouse, outside clean backfilled utility trenches. Area is enclosed in fencing, covered in plastic sheeting, and pending compaction and subgrade preparation for final cap.

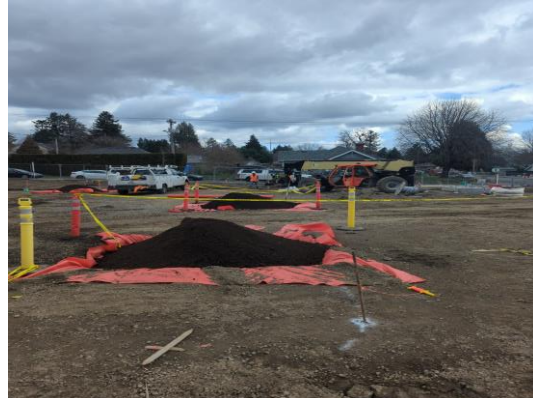
3/15/23 Parcel 2 tree wells excavated and backfilled with clean import landscape soil over orange landscape marker fabric.
