## Aspect Quarterly Update

Seven Acres Development (Former LDM Site - ECSI #887)  
QUARTERLY UPDATE: OCTOBER 17 - DECEMBER 30, 2022

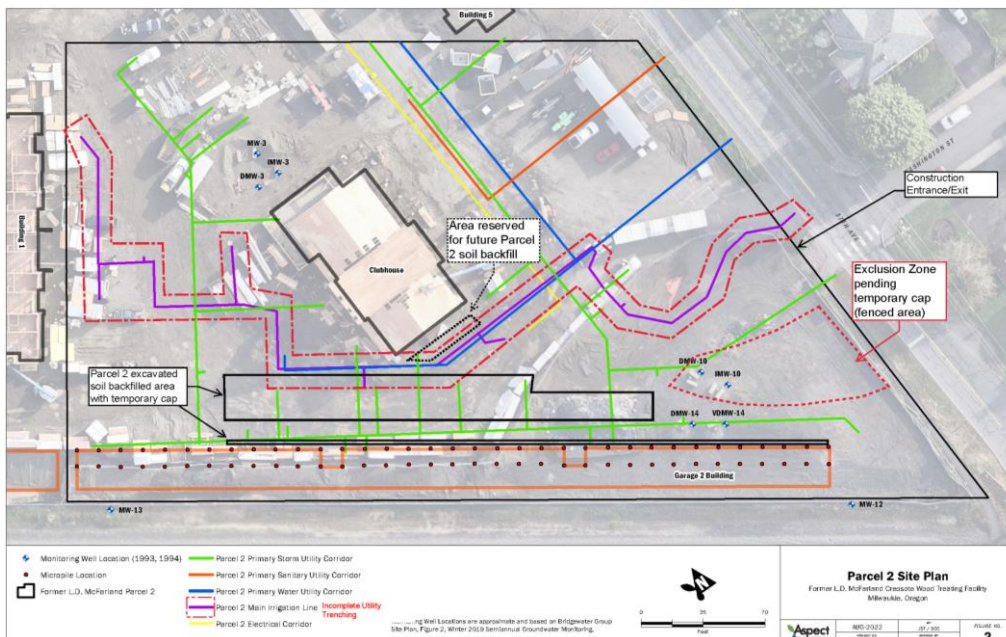
## PLAN VIEW PROGRESS

Parcel 2 construction work focused on Phase I pavement preparation, Clubhouse construction, Clubhouse slab and vapor barrier repairs, Garage 2 vapor barrier installation and construction, tree well excavations, soil management, and hazardous waste debris disposal.

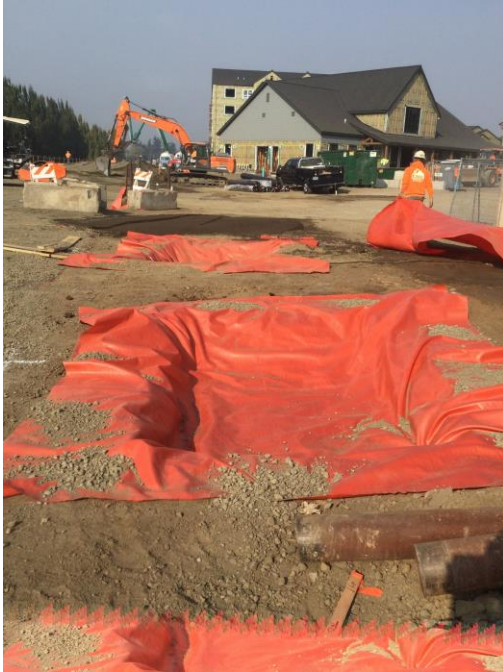
10/18/22 Parcel 2 tree well excavations with liner, viewing northwest.

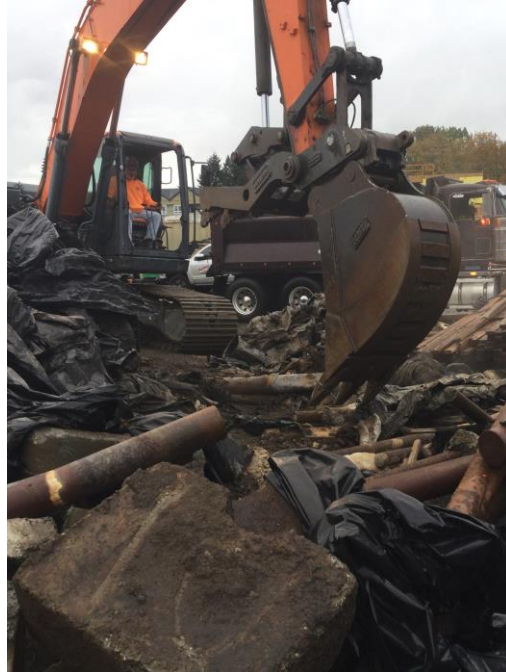
11/1/22 Parcel 2 hazardous debris haul, viewing north.

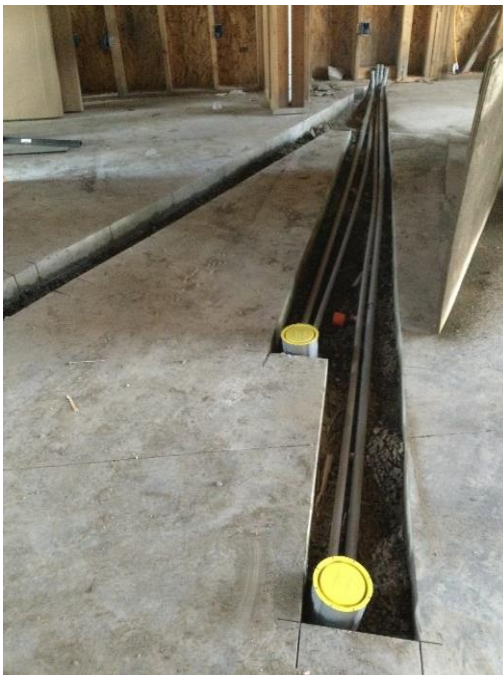
12/1/22 Parcel 2 Clubhouse slab and vapor barrier breach before repair.

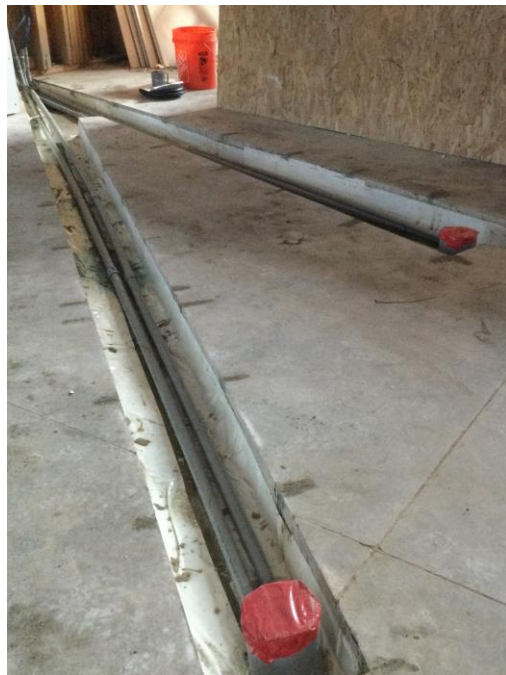
12/27/22 Parcel 2 Clubhouse completed vapor barrier repair before concrete slab pour.
