## Aspect Weekly Update

### Monroe Street Apartments Development (Former LDM Site - ECSI #887)

WEEK 24: MARCH 28 - APRIL 1, 2022

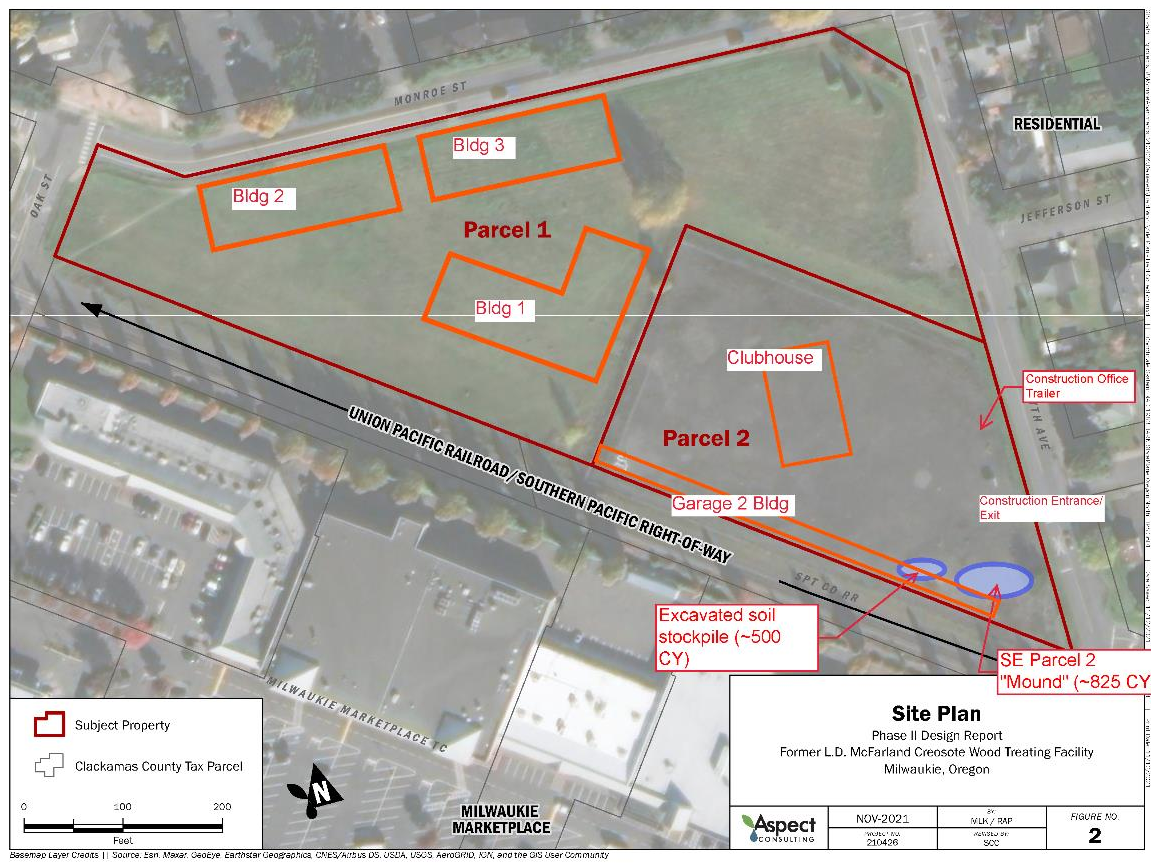
## PLAN VIEW PROGRESS

Construction work focused on Buildings 1, 2, and 3 on Parcel 1, and on the Clubhouse on Parcel 2.

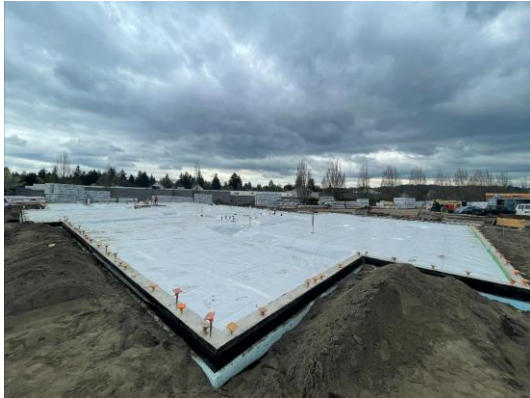
3/28/22 Clubhouse vapor barrier, looking southwest.

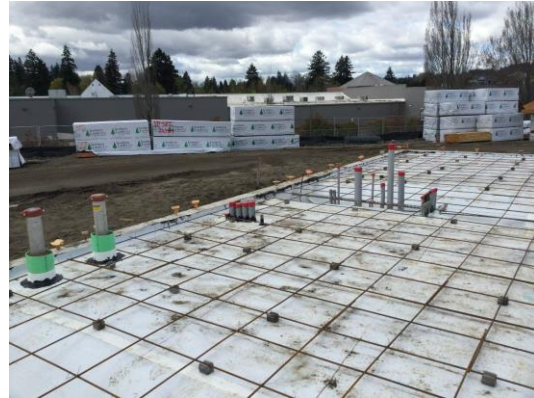
3/31/22 Clubhouse after rebar placement, looking south. Vapor barrier below rebar.
