## Aspect Weekly Update

Seven Acres Development (Former LDM Site - ECSI #887)

WEEK 43: AUGUST 8 - AUGUST 12, 2022

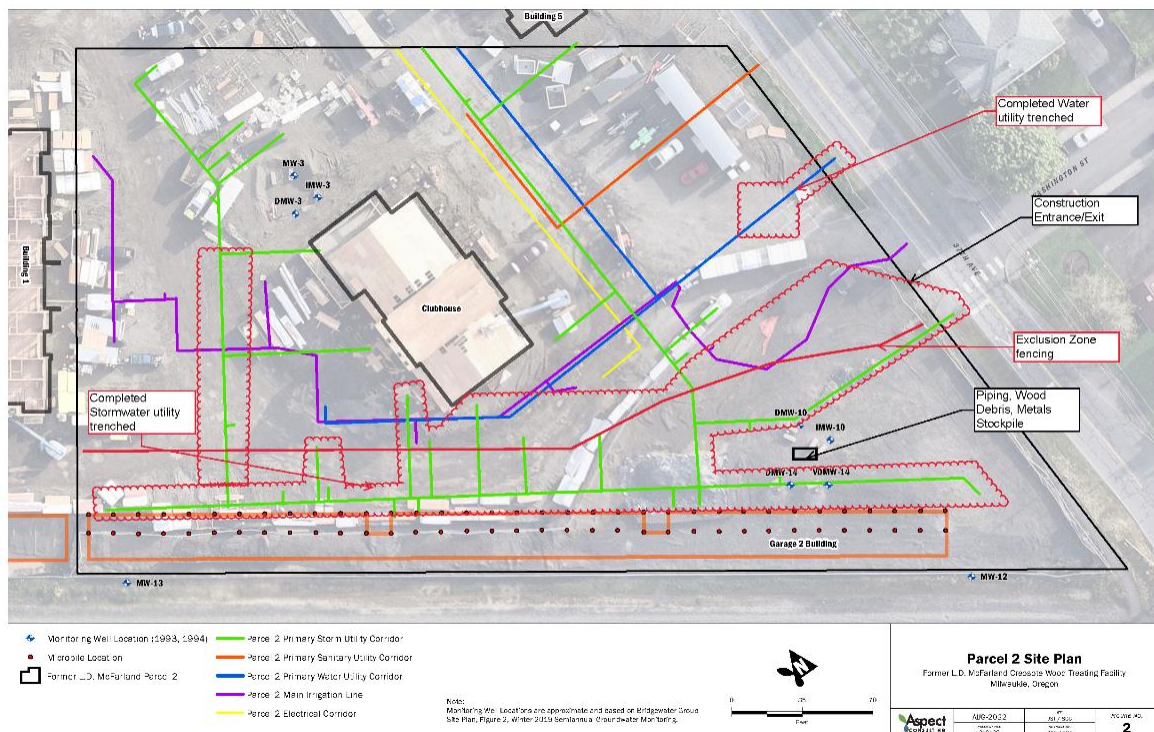
Parcel 2 construction work focused on utility trenching and Garage 2 backfill.

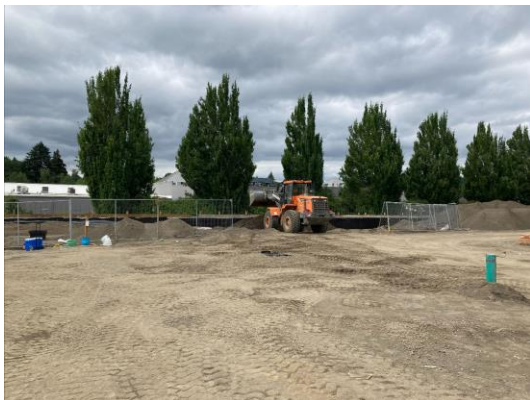
8/10/22 Backfilling Garage 2 footprint in Parcel 2, looking south.

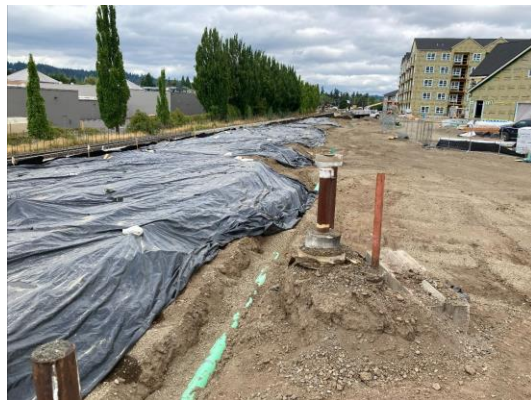
8/10/22 Garage 2 area on left, looking west, and protected monitoring wells next to storm utility line (Parcel 2). Clubhouse on right and Building 1 beyond.
