Aspect Weekly Update

Monroe Street Apartments Development (Former LDM
Site - ECSI #887)

WEEK 4: NOVEMBER 8 - NOVEMBER 12, 2021

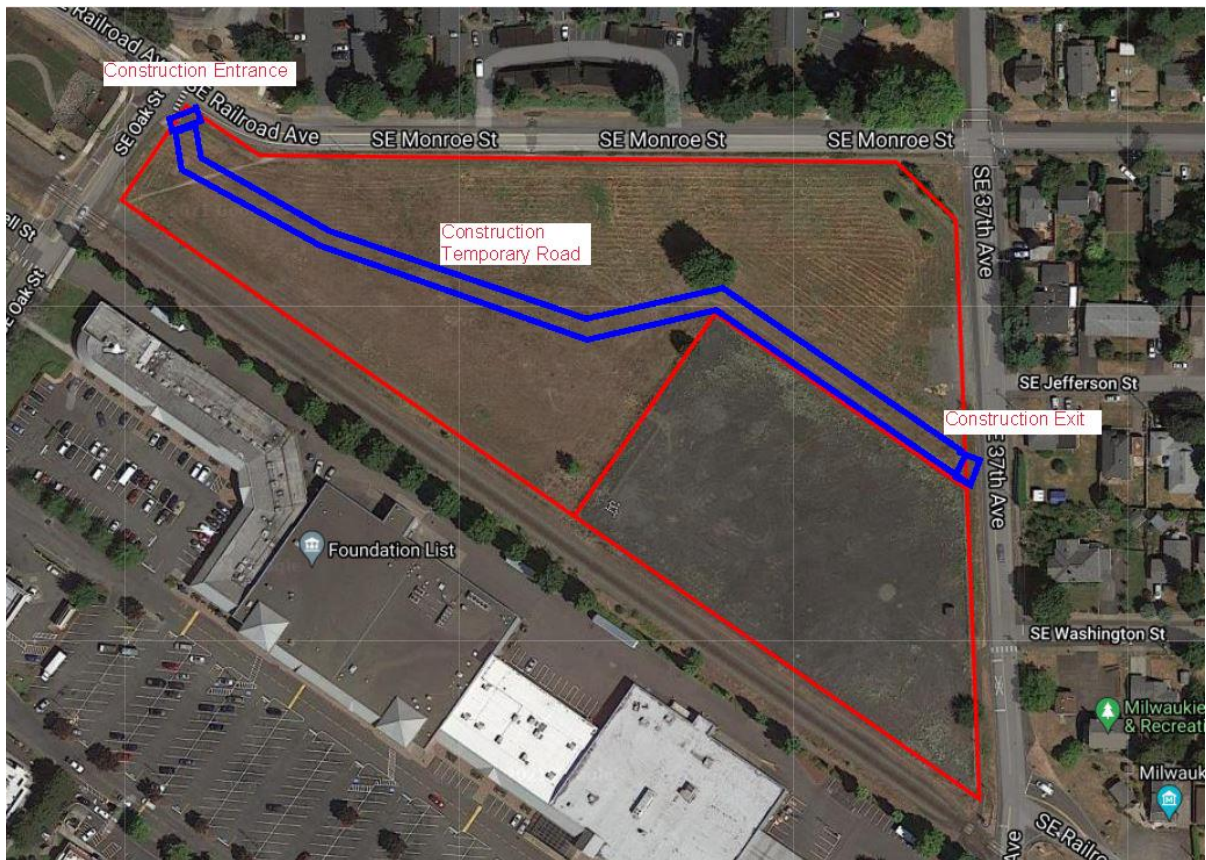
Temporary construction road on Parcel 1.

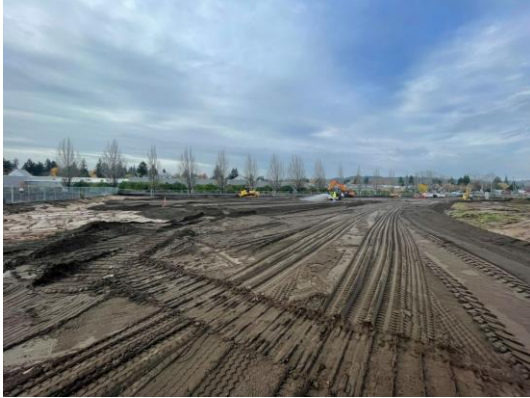
11/10/21 Parcel 1 fill placement. View to southwest from the center of Parcel 1.

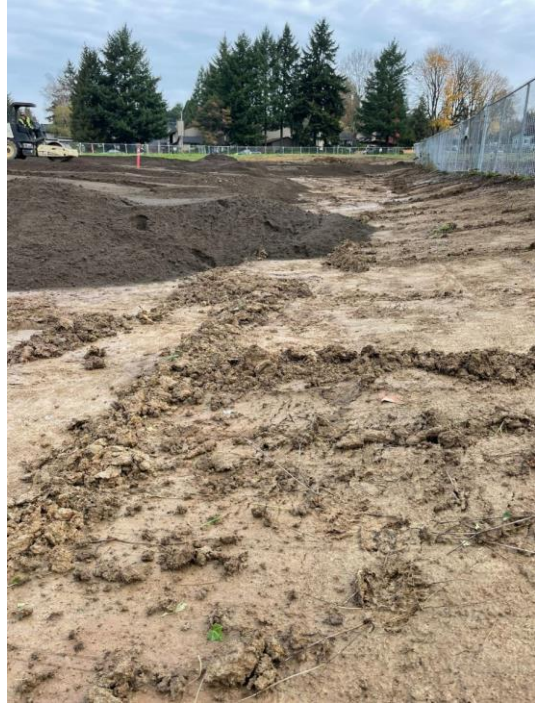
11/10/21 Parcel 1 fill nearing Parcel 2's fence, northward view from southern portion of Parcel 1. Cone in background marks sewer manhole.
