Underwater Investigation

KELLOGG CREEK BRIDGE

22142

2/10/2016

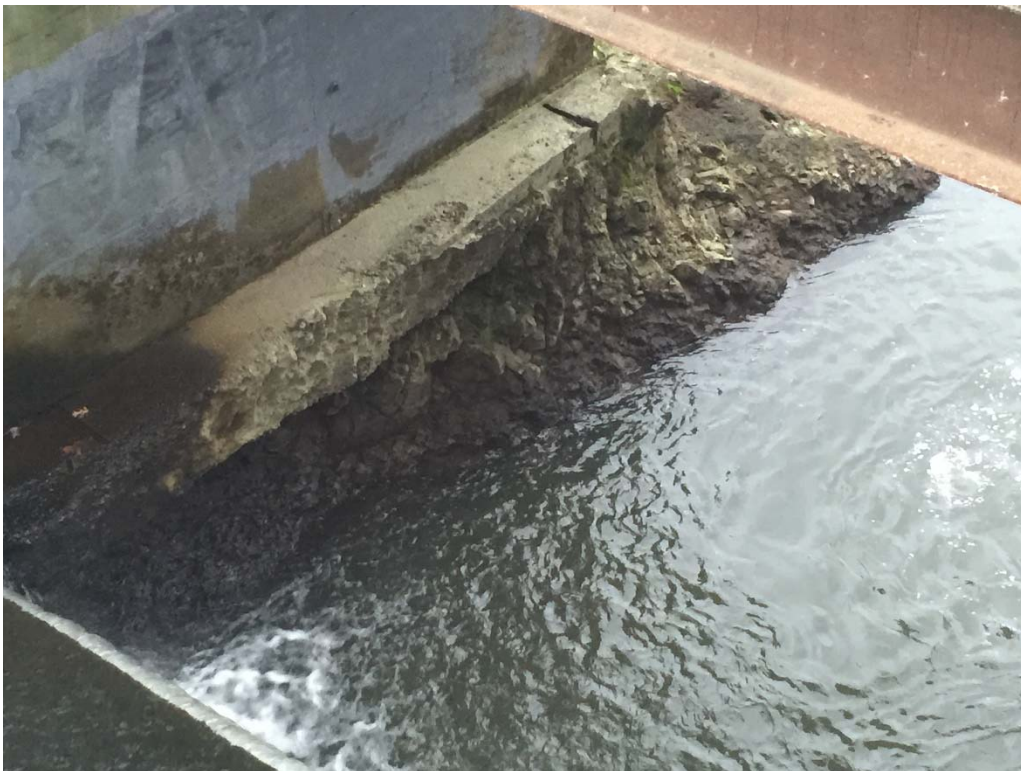
The diver did not find any scour or undermining of the structure under the water's surface. All the scouring and undermining was visible above the water and is pictured in the following pictures. The diver noted approximately 8 inches of undermining on the South abutment (pictured below). The north abutment was undermined approximately 42 x 36 inches in the Southwest corner near the boulder.

South Concrete Footing – Poured on Rock
Undermined Maximum 8 inches (No Foundation Piles Visible)

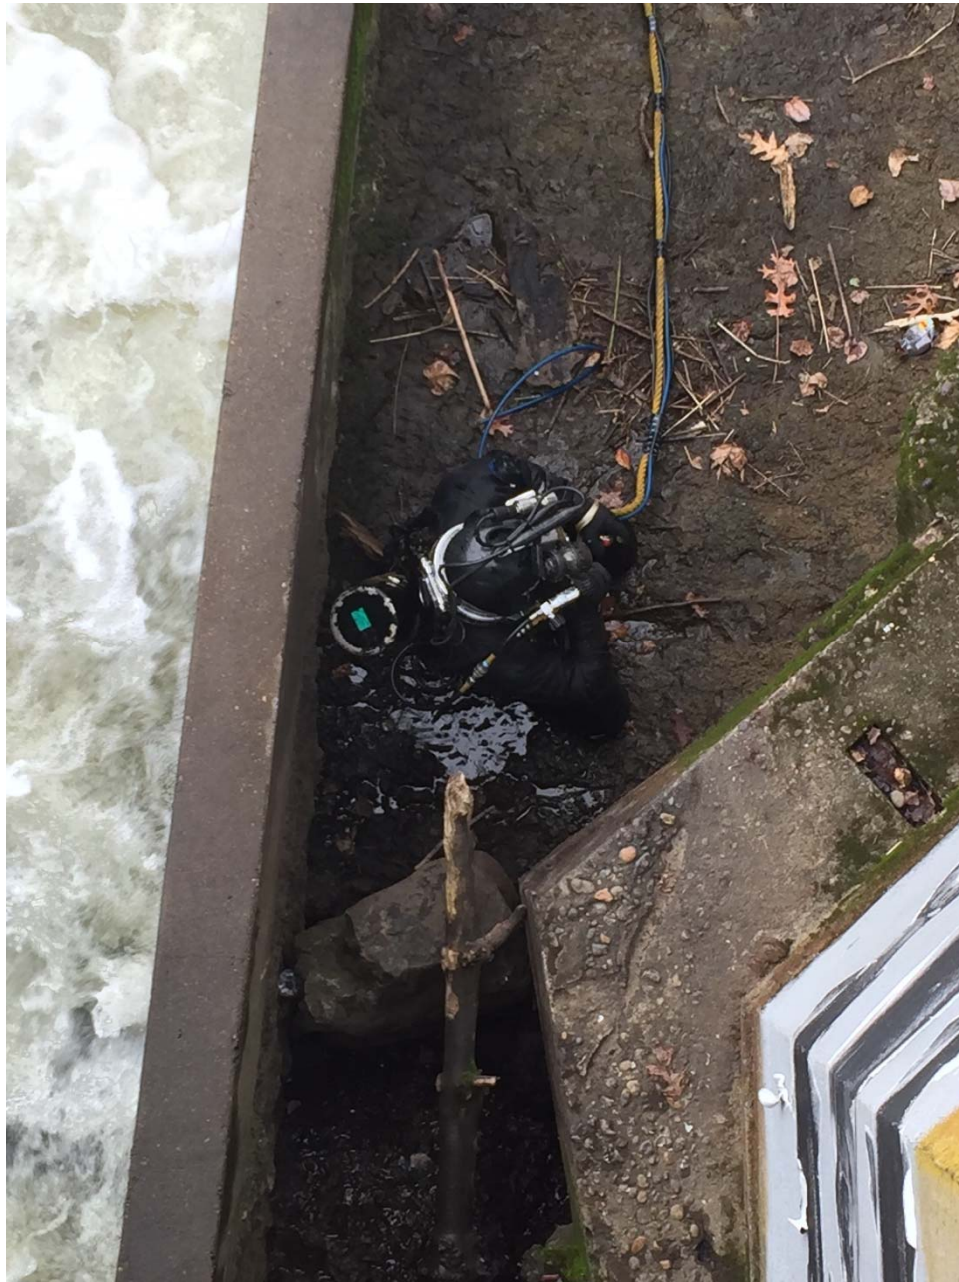
Looking at North Abutment SW Corner

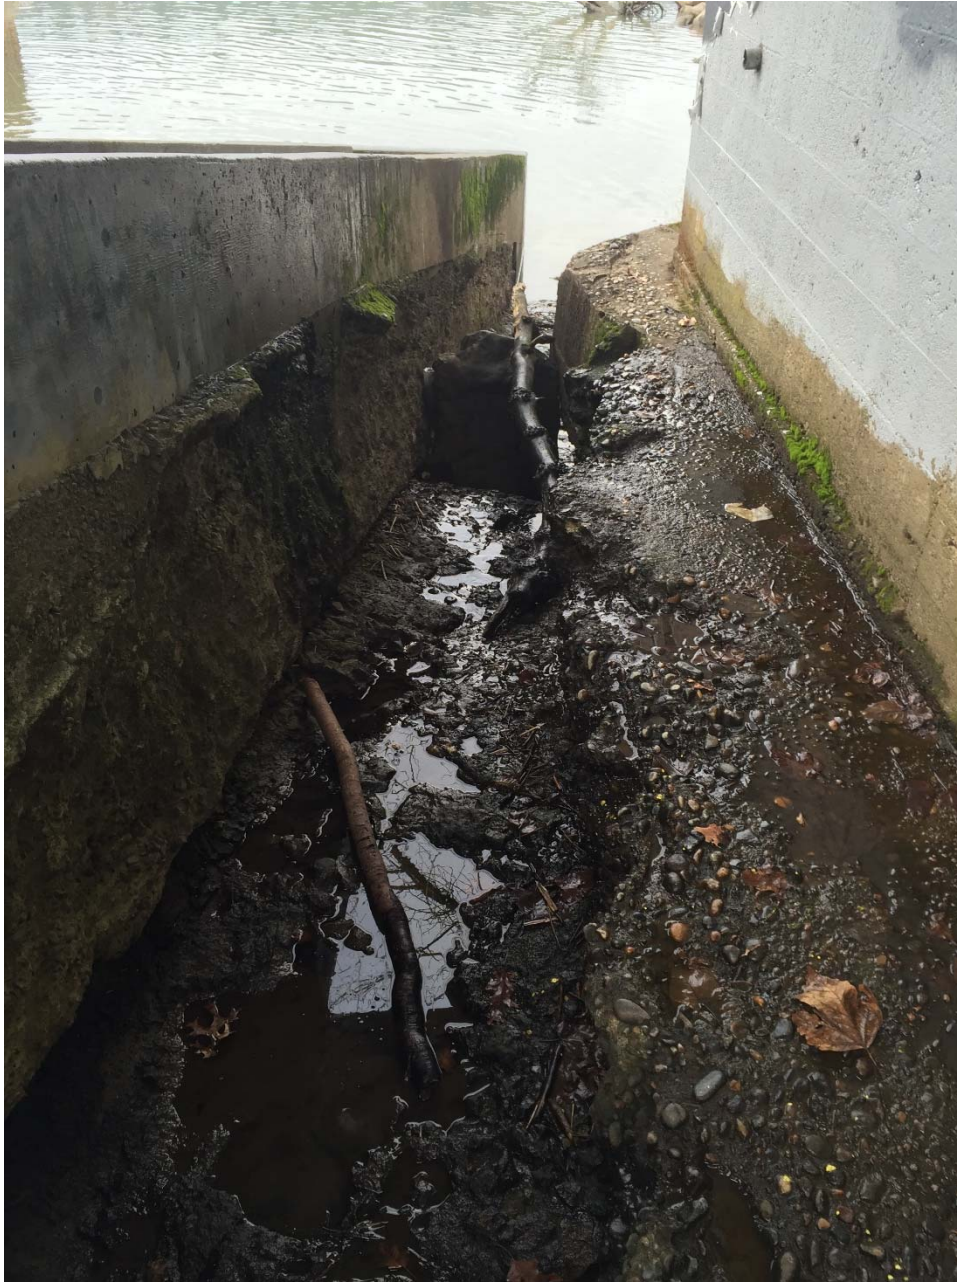
North Footing between Fish Ladder and Footing
This area is 237 inches long

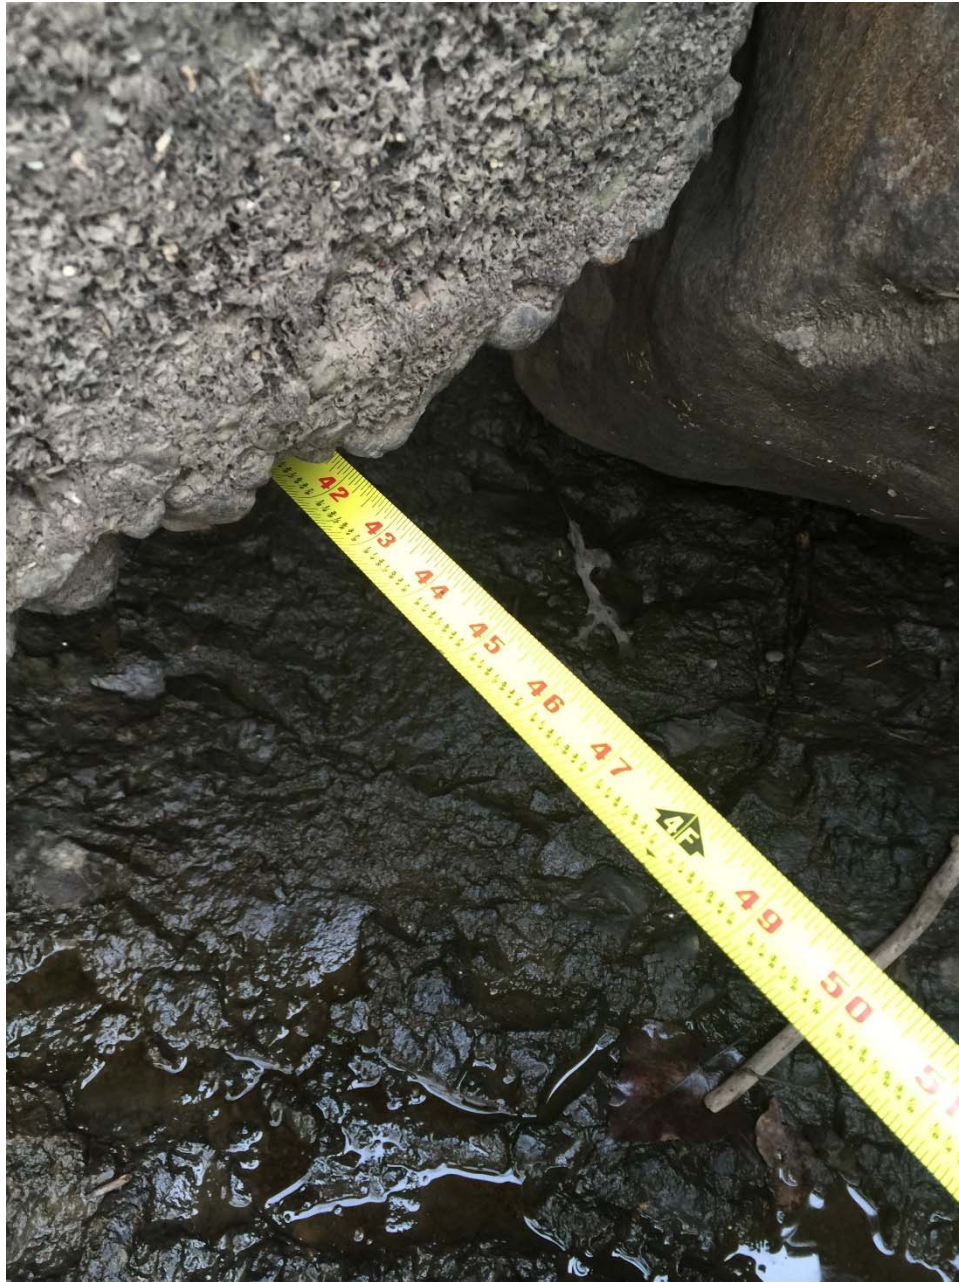
North Footing – SW Corner (by lodged boulder)
Scour depth 42 inches x 36 inches wide

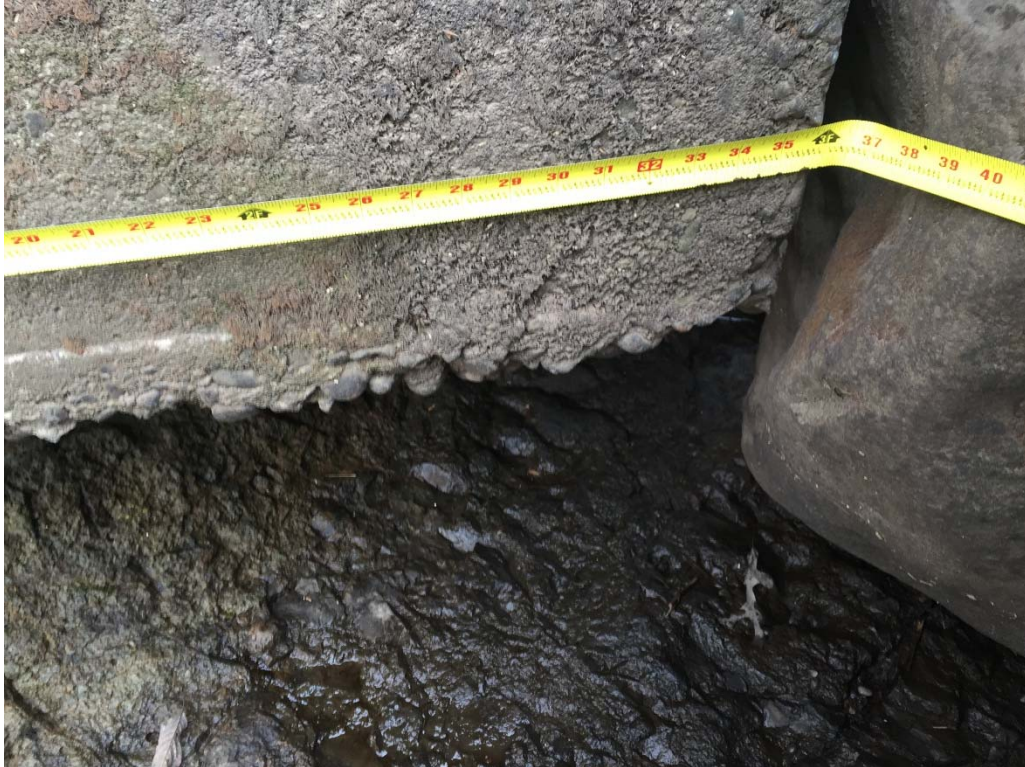
North Footing SW Corner (by boulder) – Scour Width

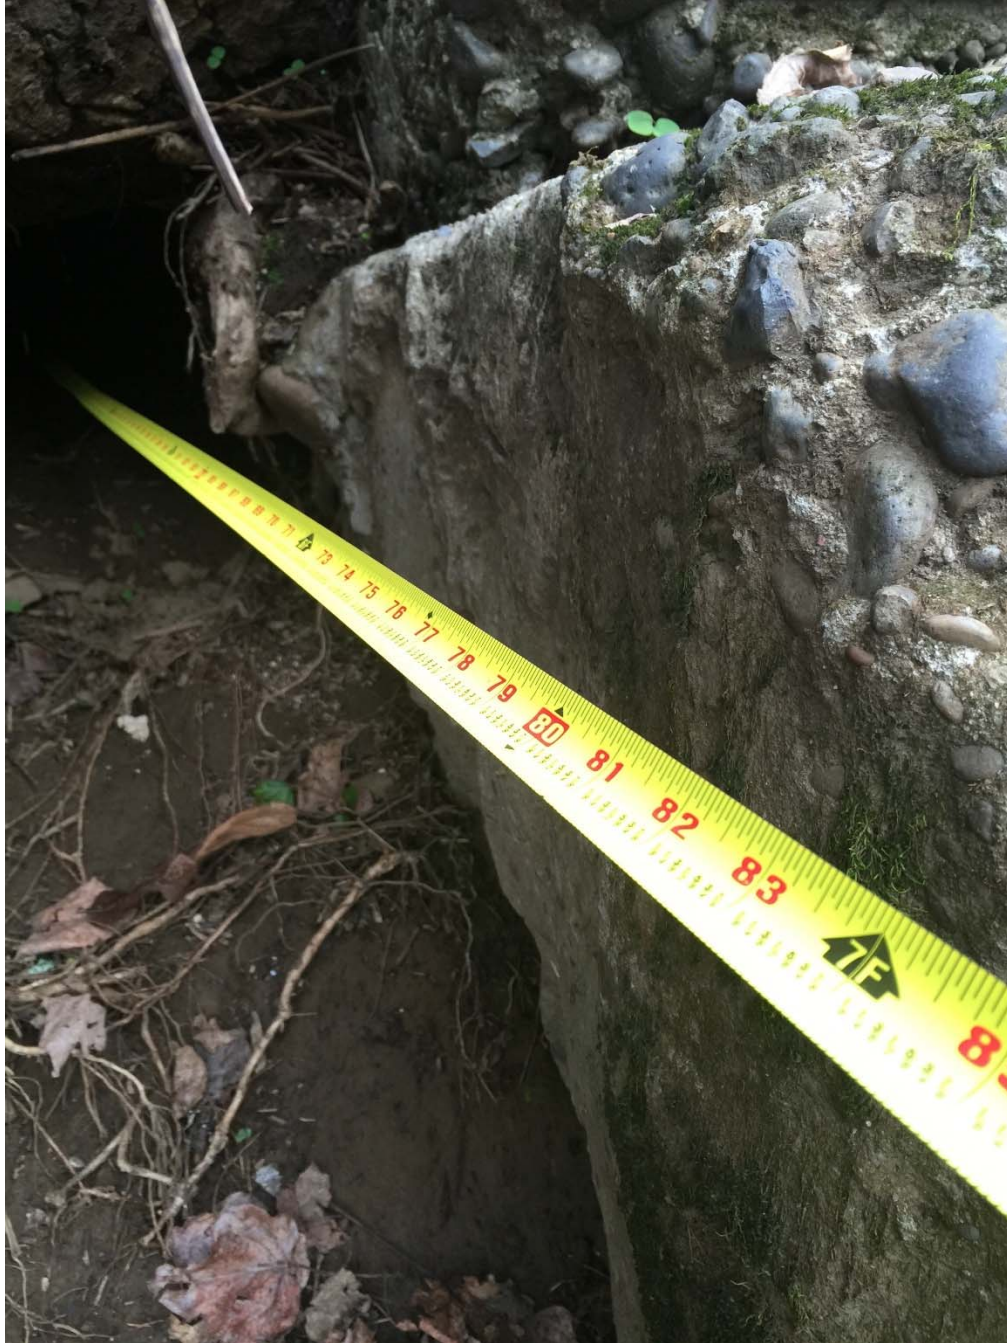
Possible Animal Hole – North Abutment West Corner
Hole is 72 Inches Deep
One of Two Holes

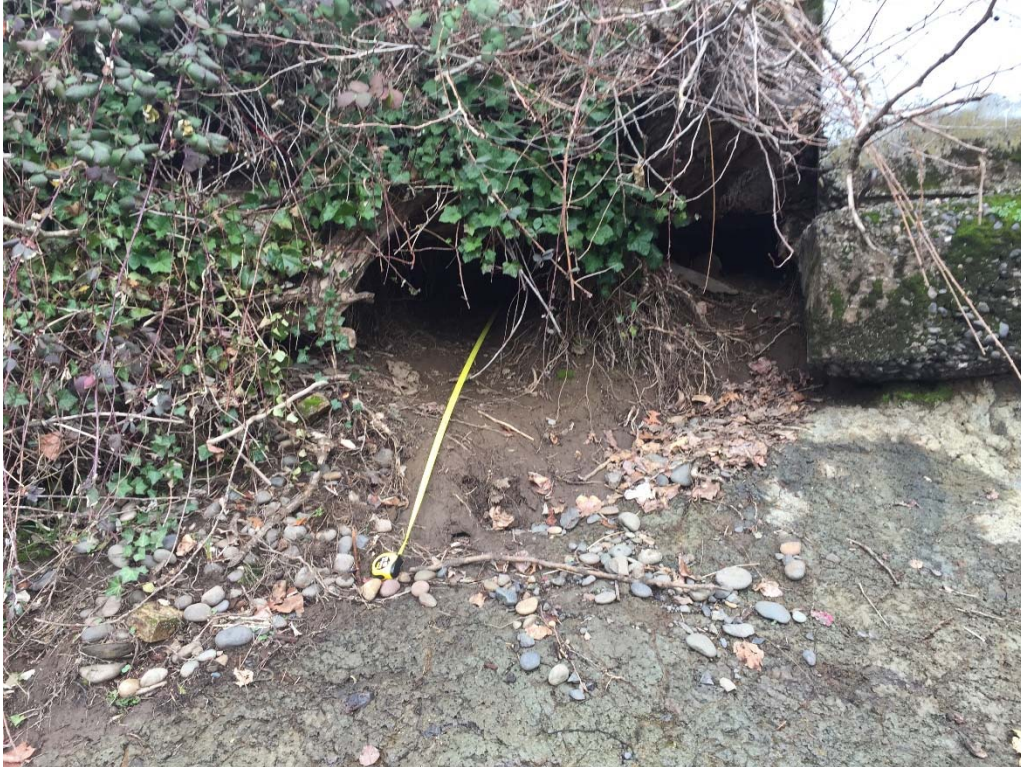
Animal Holes – North Abutment, West Side

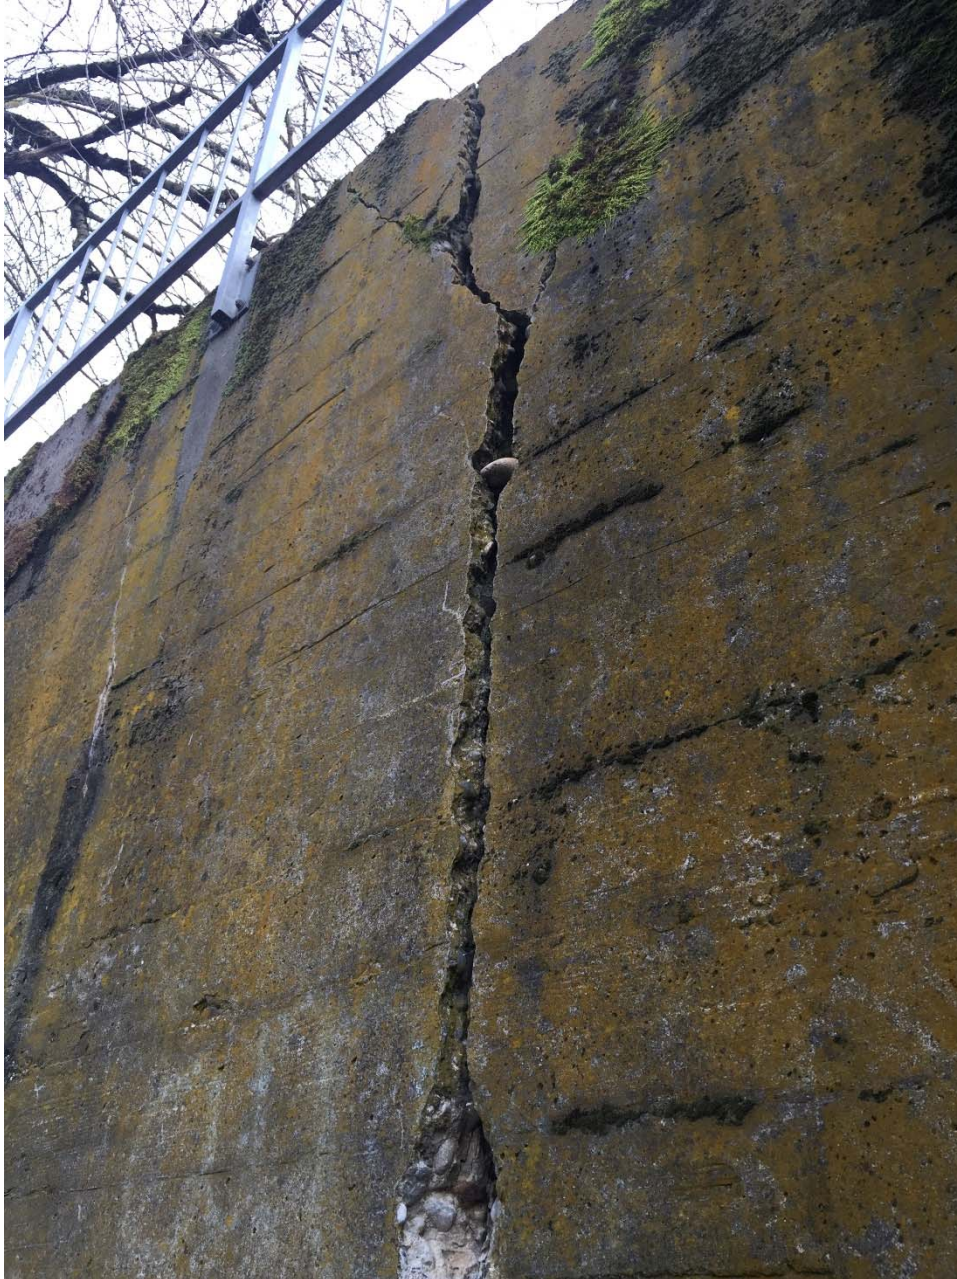
North side of bridge, West retaining wall. Crack fill height of wall approximately 17 feet in length. Handrail on top of retaining wall has begun to warp.

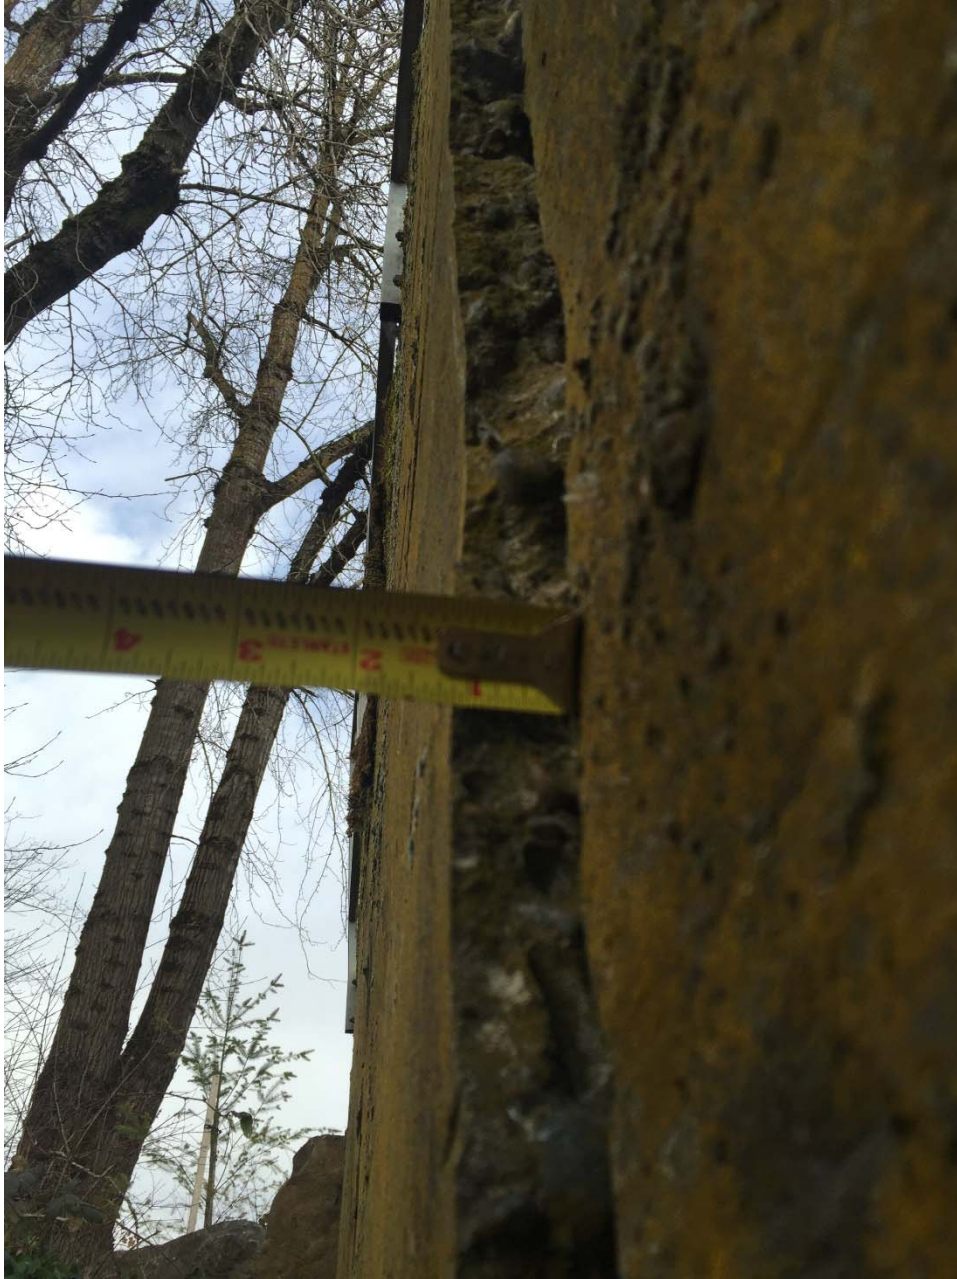
Wall Pushed Out (West) 1 to 1.5 inches

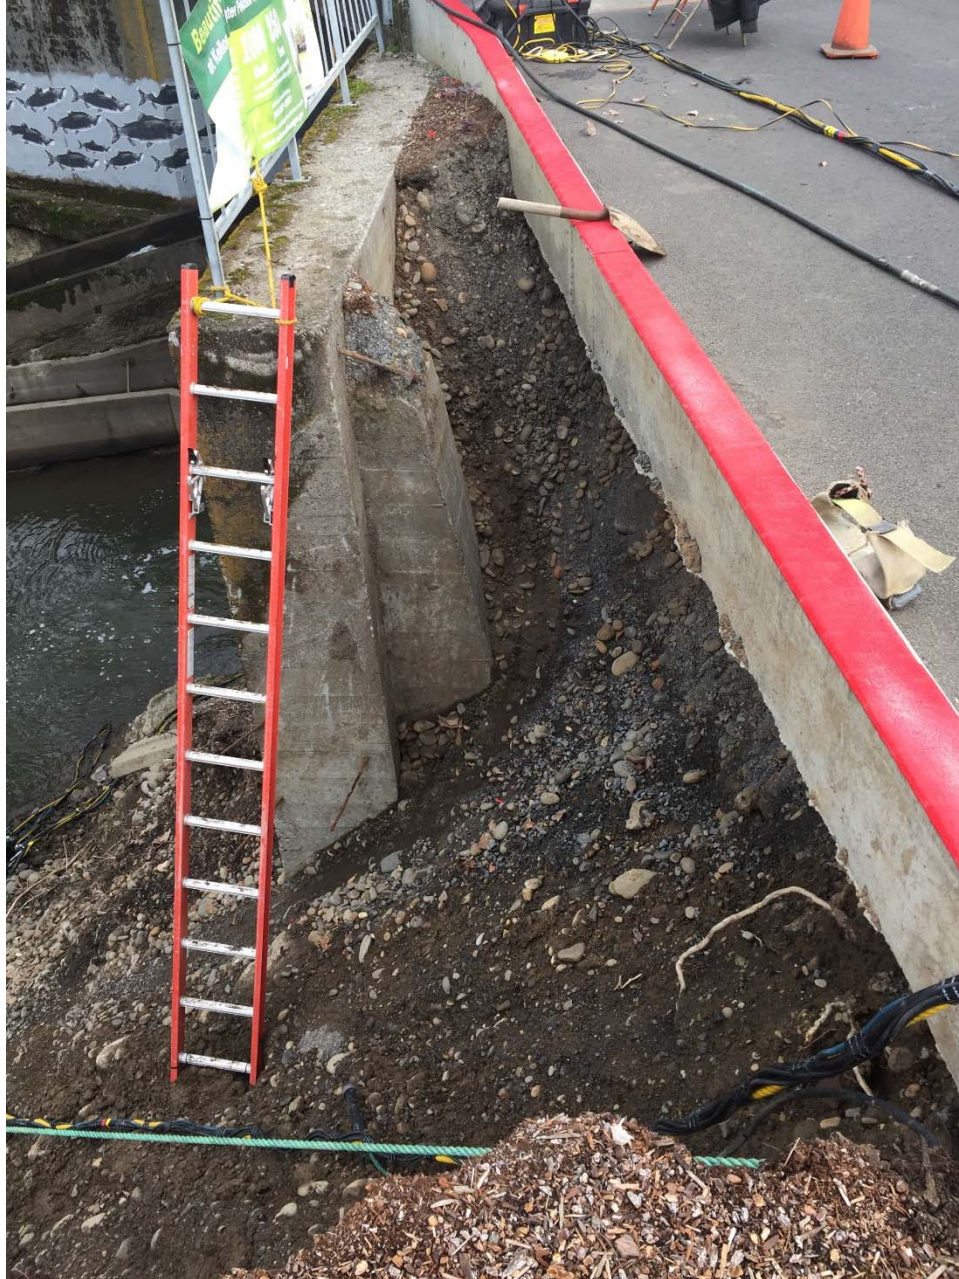
Undermining – South Abutment (Approach)
West Wingwall in Foreground

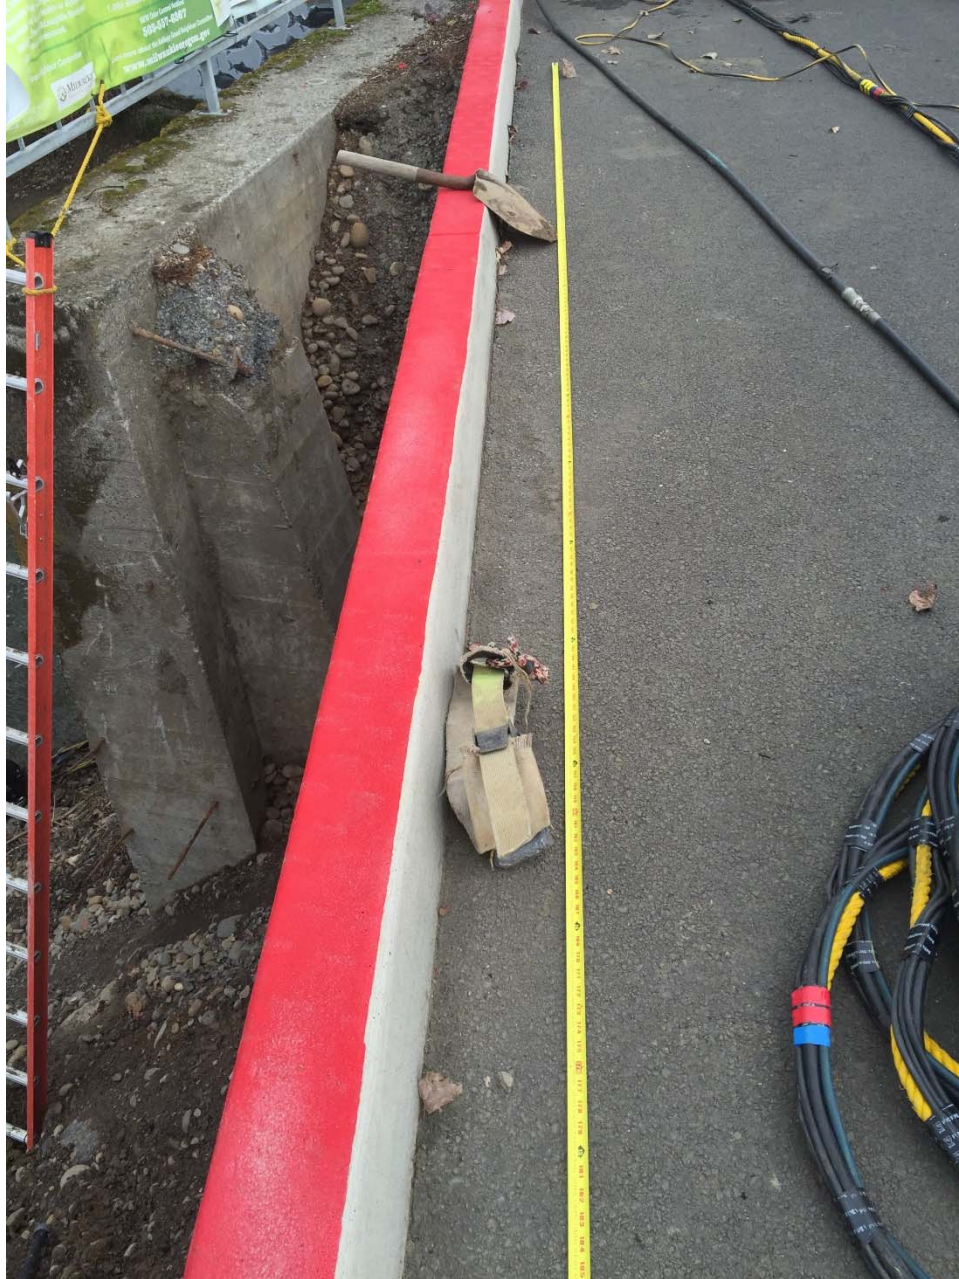
Length of Undermining (18 feet in length)

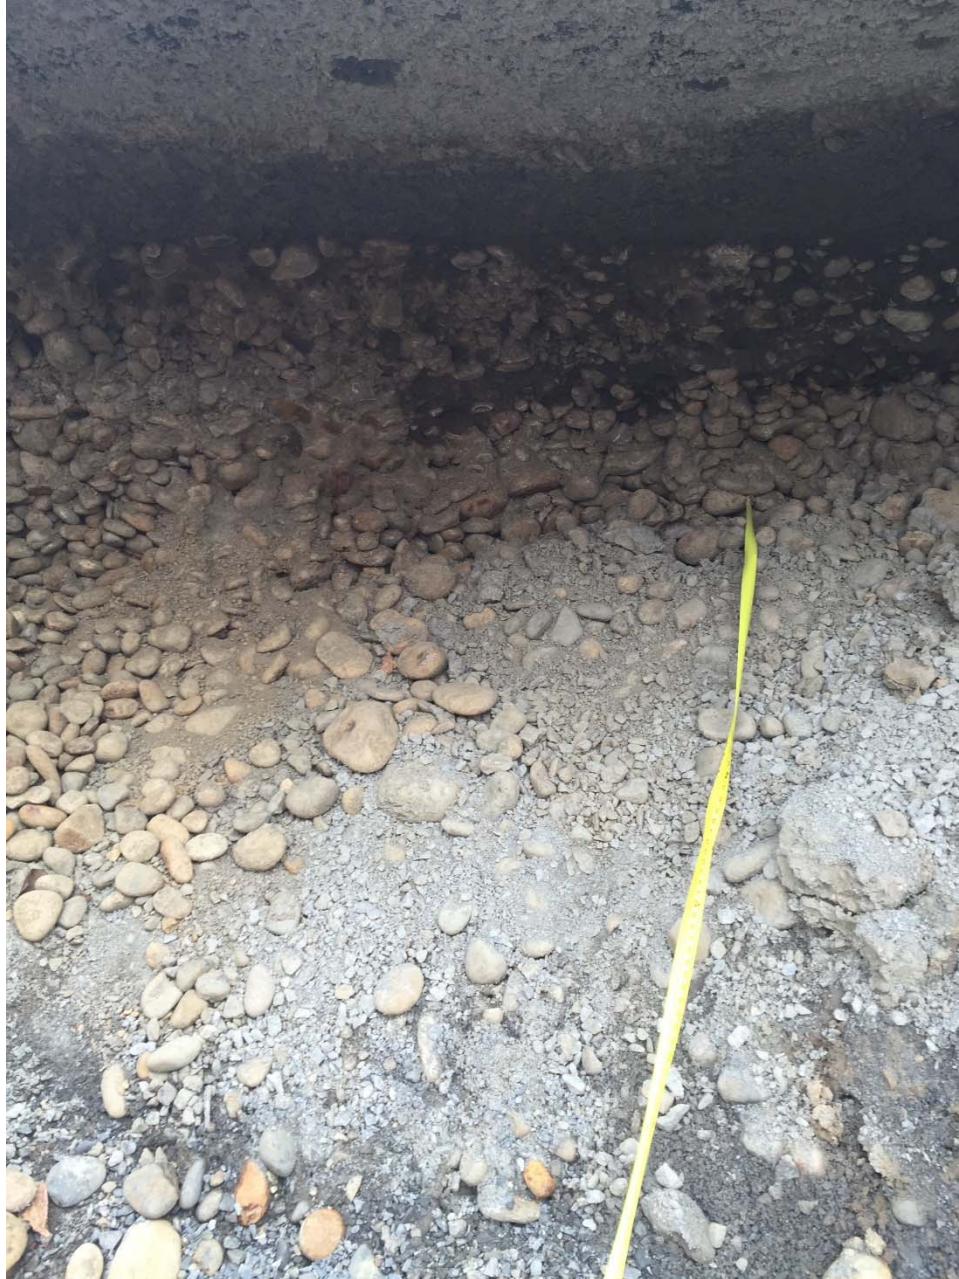
Looking at Undermining South Approach

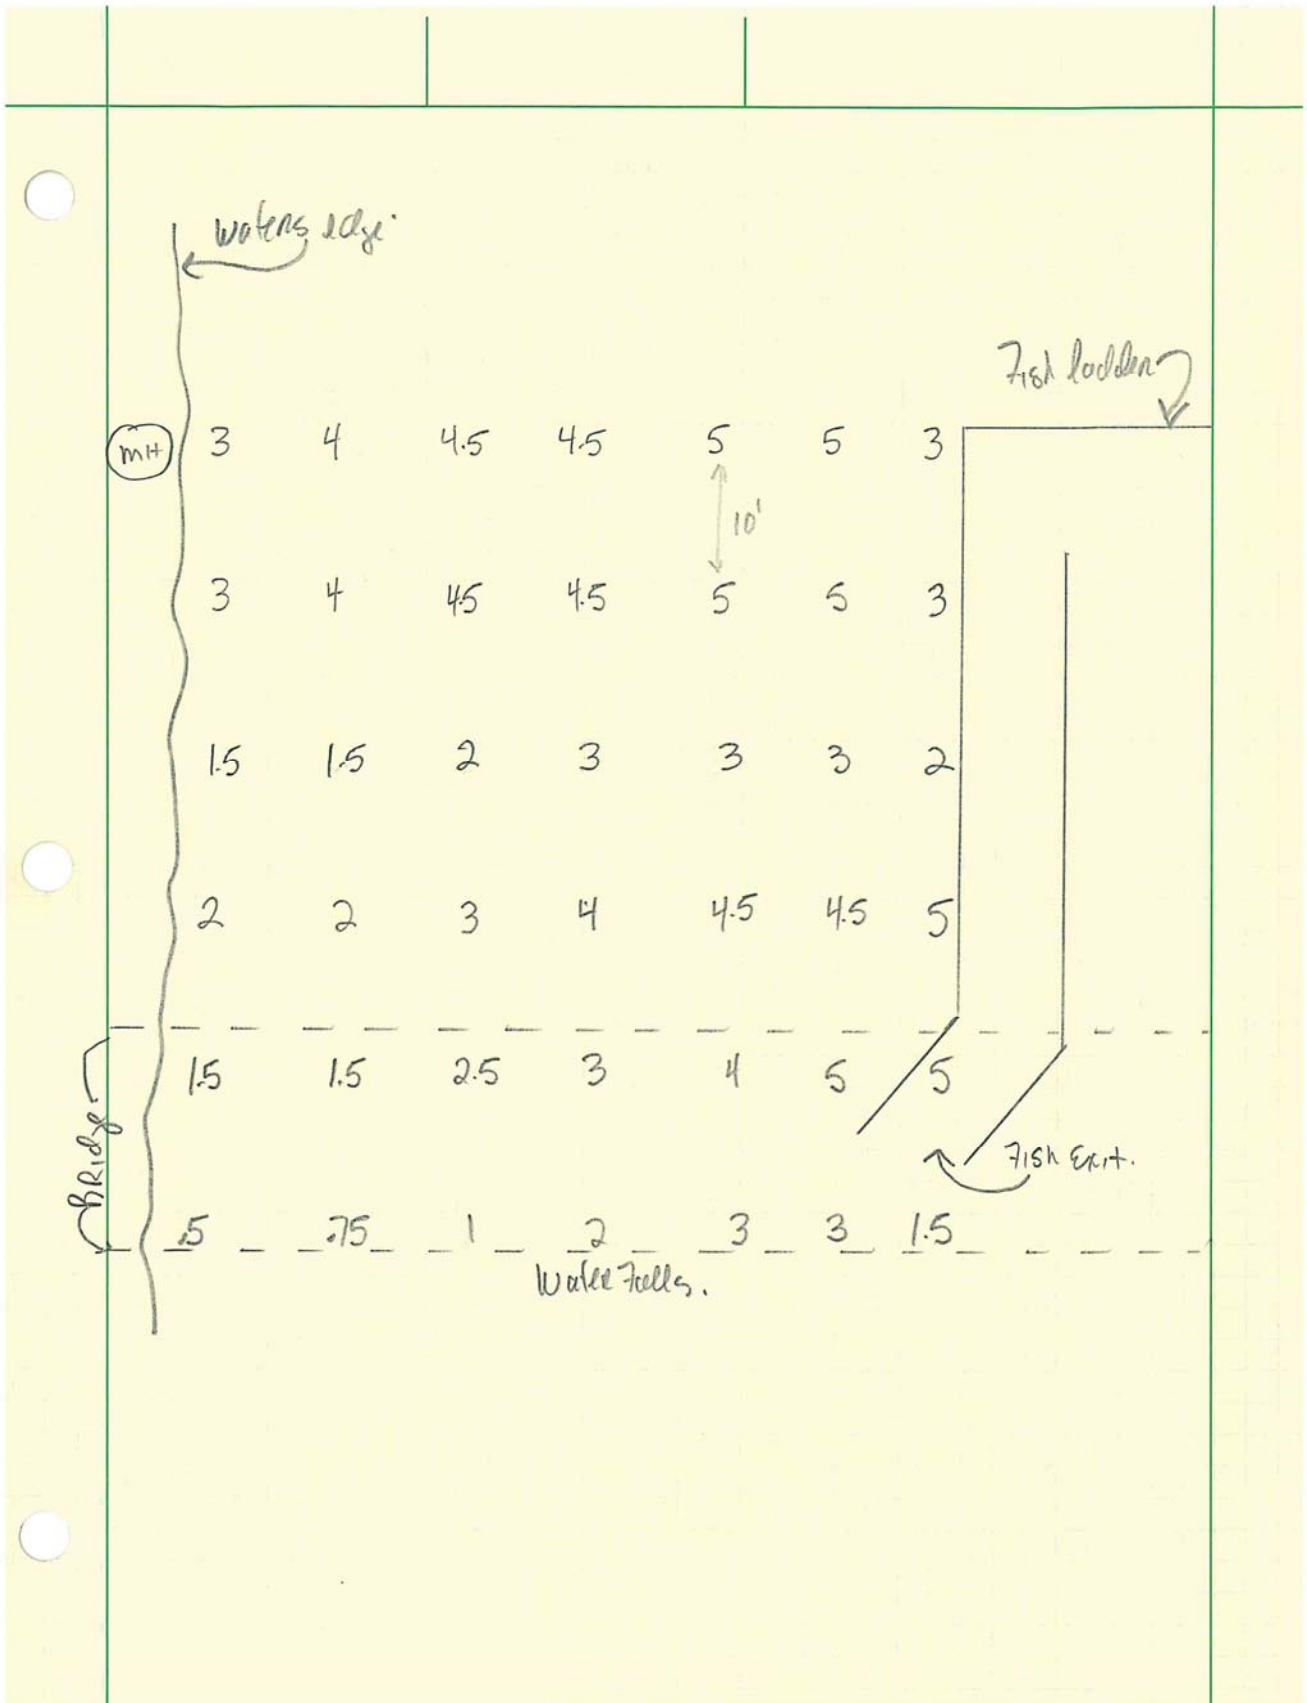
Bathymetric Soundings Across Channel

The diver then crossed the channel, six times, taking measurements and inspecting the channel bottom looking for scour holes. A bathymetric drawing showing the water depths was generated by using the diver's pneumofathometer which is accurate to 1% of water depth. No overly large scour holes were found in the channel bottom during the dive. Maximum depth reached was approximately five feet near the opening of the fish exit.
