Oregon White Oak (*Quercus garryana*)
Evaluation of Tree
Tree Protection Plan
Kronberg Park
February 21, 2012

Wendy Hemmen, PE
City of Milwaukie
6101 SE Johnson Creek Blvd.
Milwaukie, OR 97206

Terrence P. Flanagan
Teragan & Associates, Inc.
3145 Westview Circle
Lake Oswego, OR 97034

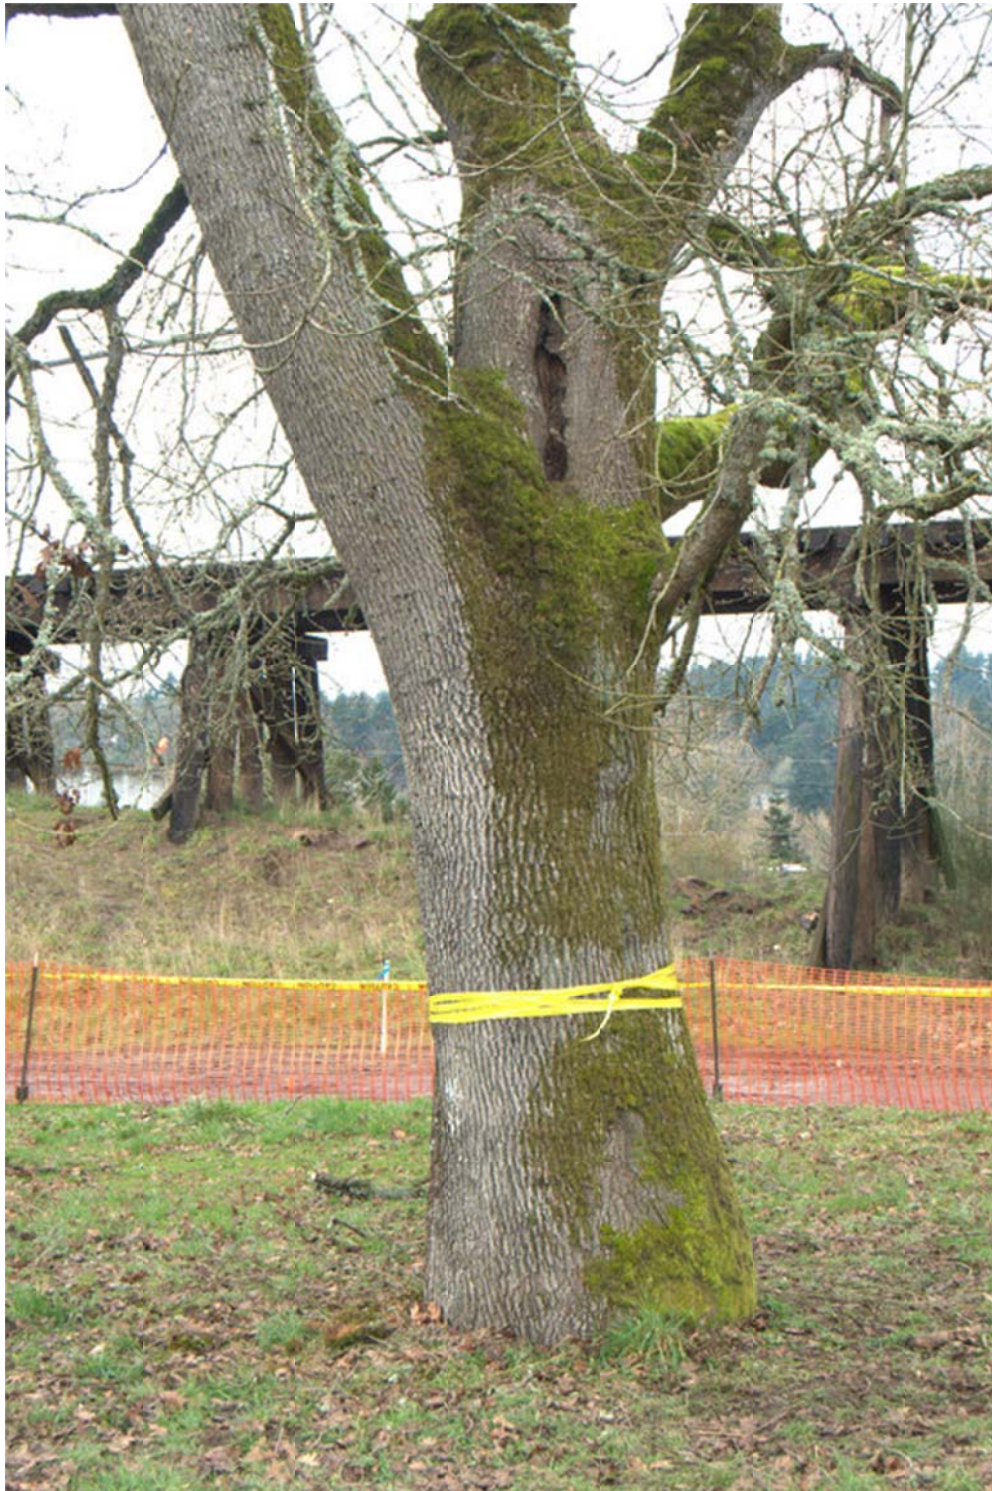
- A cavity in one of the main leaders in the tree's northeast sector approximately 10 feet above ground level.
- An unusual configuration for a large branch that was growing almost straight down from its point of attachment on the tree's NE side approximately 30 feet above ground level.
- A broken branch, approximately 3 inches in diameter in the upper crown on the tree's SE side approximately 30 feet above ground level. .
- A branch that has grafted to one of the larger leaders on the tree's SE side approximately 25 feet above ground level.
- Broken, hanging branches in the crown of the tree.

Photo taken from the east showing cavity in northeast leader.

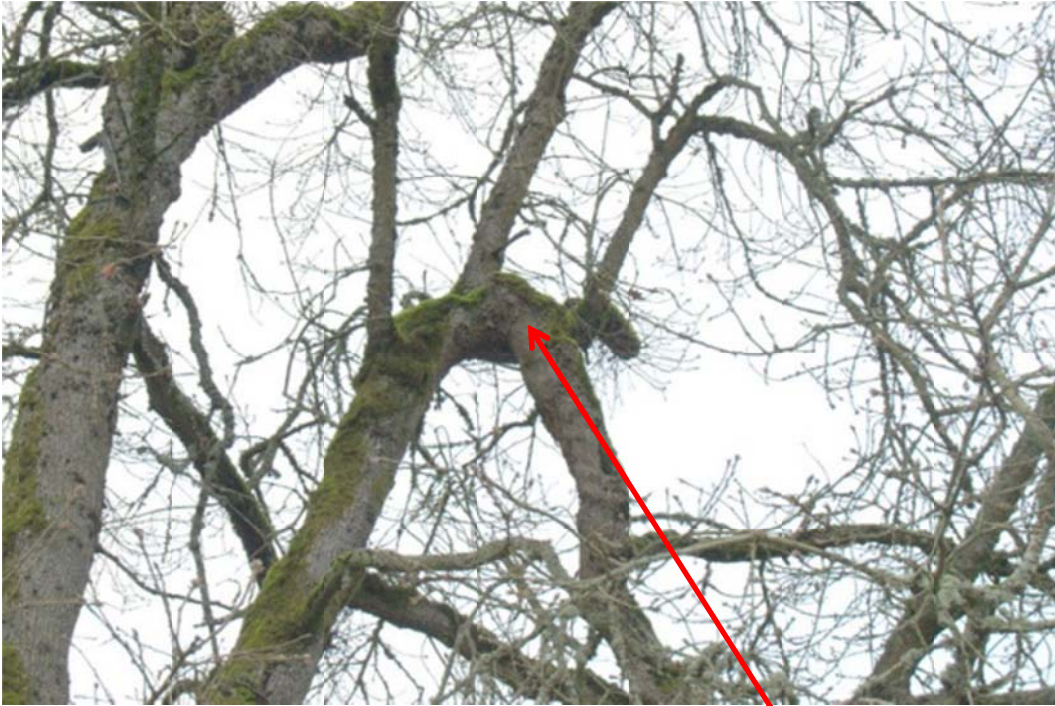
The aerial inspection of the crown did not reveal any concerns. The inspection of the unusual positioned branch revealed that it was strongly attached with no weakness apparent. The inspection of the graft of the branch to the leader also revealed a strong attachment with no concerns.

Odd branch attachment angle

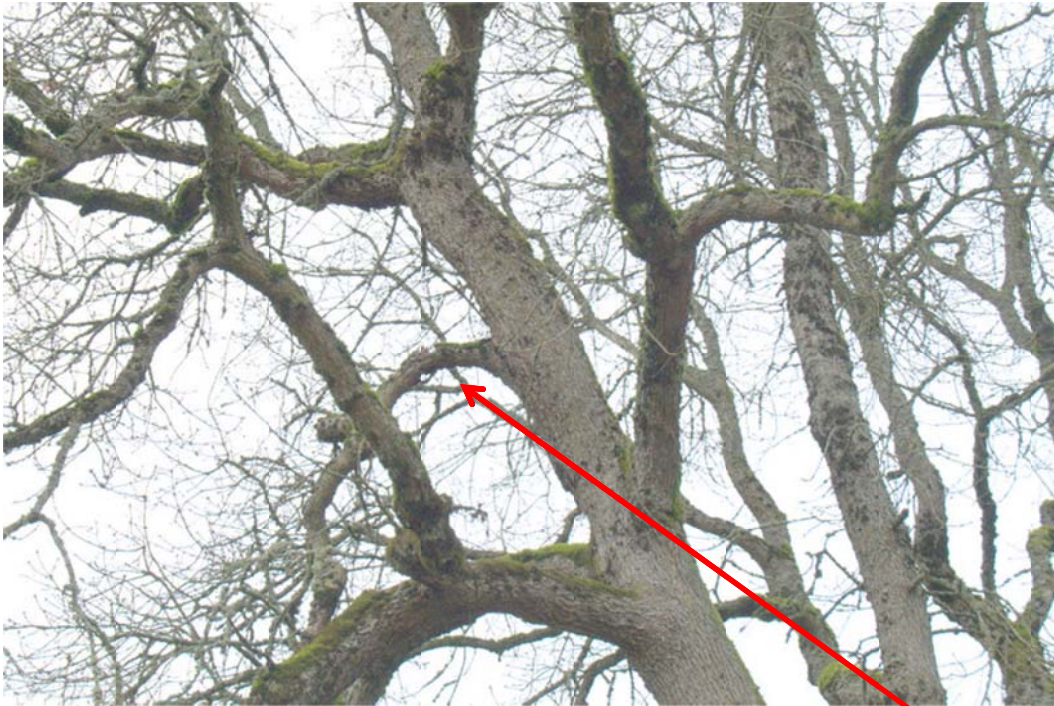
Broken branch in upper crown of tree

The first step to complete in the tree protection plan is to crown clean the tree to remove all dead branches, branches conflicting with each other and branches that are damaged. In addition, in order for the light rail bridge to be built, the west side of the tree will have to prune to a point 10 feet east of the east edge of the light rail platform to allow construction access and clearance from the rail. The west side pruning will entail removing the lowest leader that grows to the west side of the tree and a few other smaller branches on the lower half of the tree's crown to provide the necessary clearance. Any branches that encroach into the 10 foot setback that arise from the leaders/branches of the tree in the upper half of the tree's crown shall be tied back during the lifting of the long trusses to build the bridge. The project arborist shall oversee the pruning to ensure it is done properly and not done to excess.

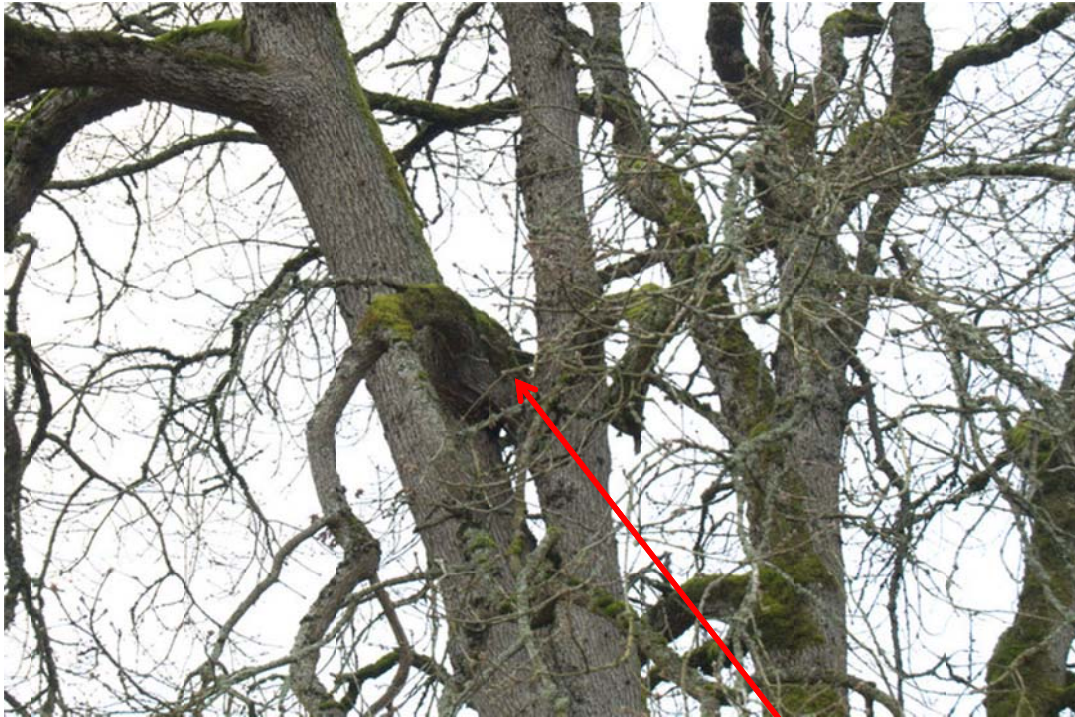
Grafted branch to main leader

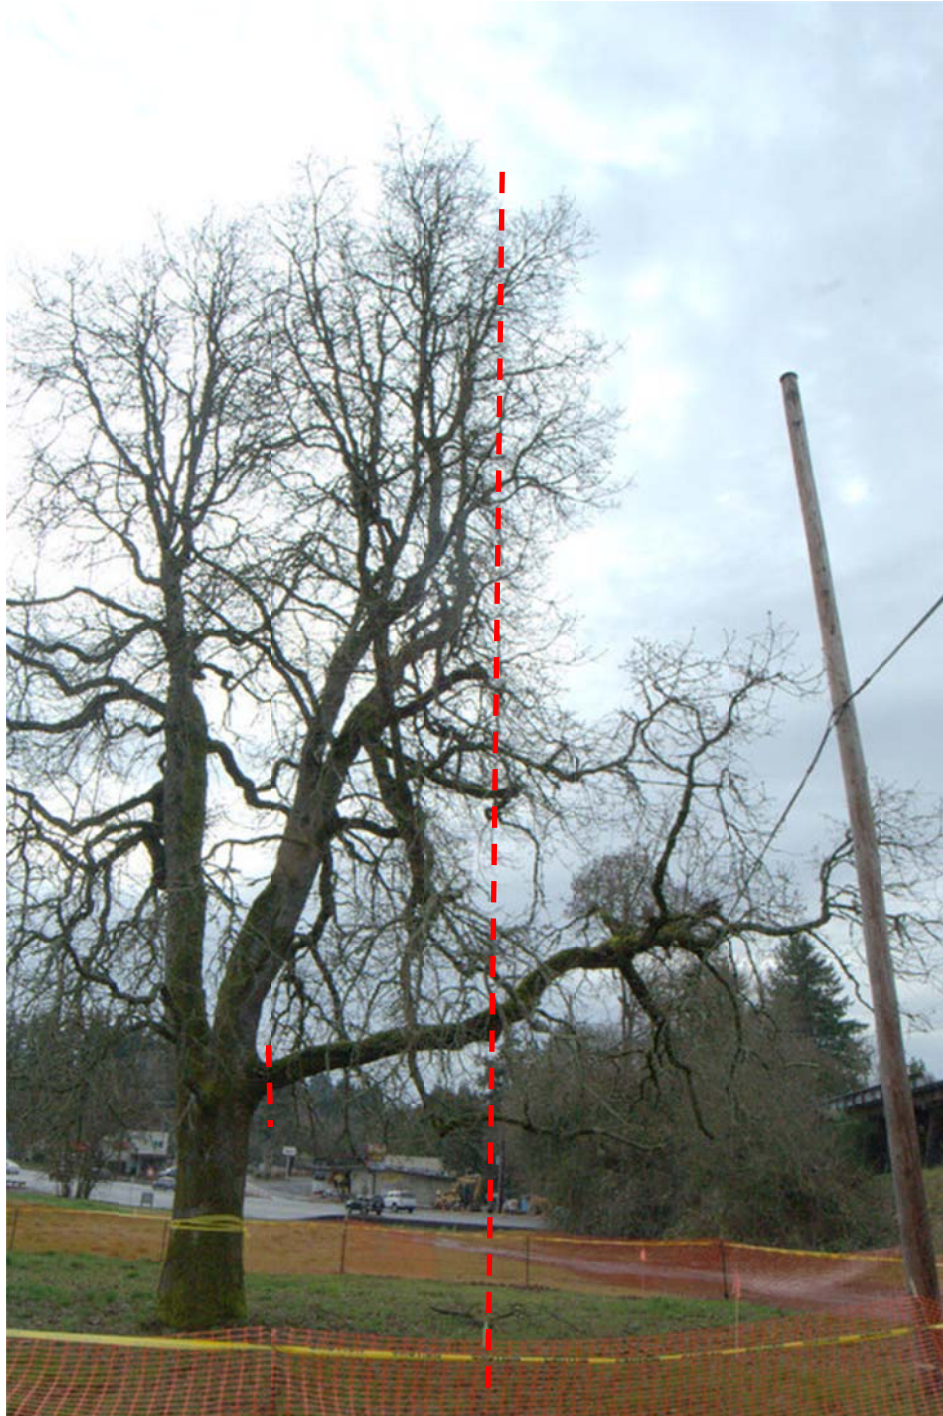
Approximate location of cut line that the tree will need to be pruned back to clear the east side of the bridge deck and 10 foot construction access deck. Lowest leader will be cut back to the trunk of the tree, other branches to be pruned back to appropriate location as defined by ANSI A300 pruning standards.

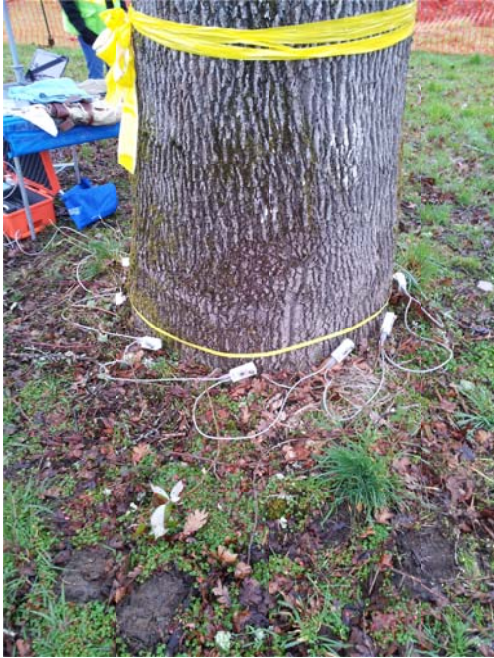
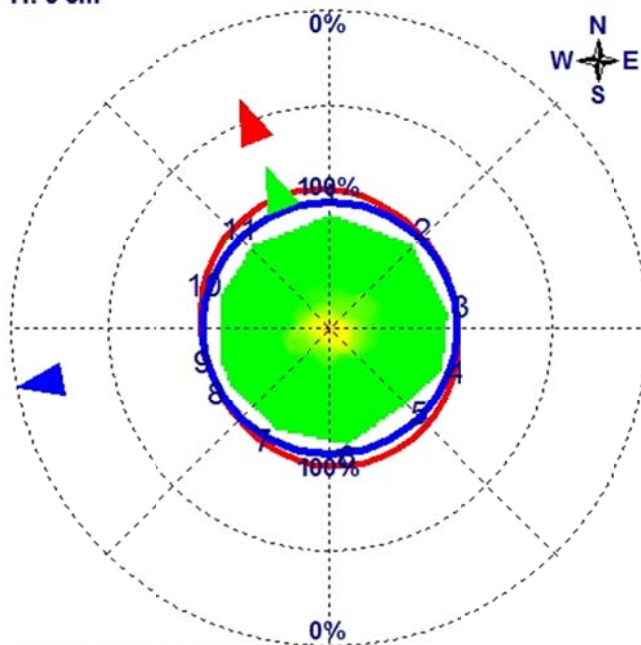
5 cm Level Sonic Tomography Measurements

- Geometric (92% - 100%)
- Weighted (92% - 100%)
- Ratio weighted/geometric (100% - 100%)

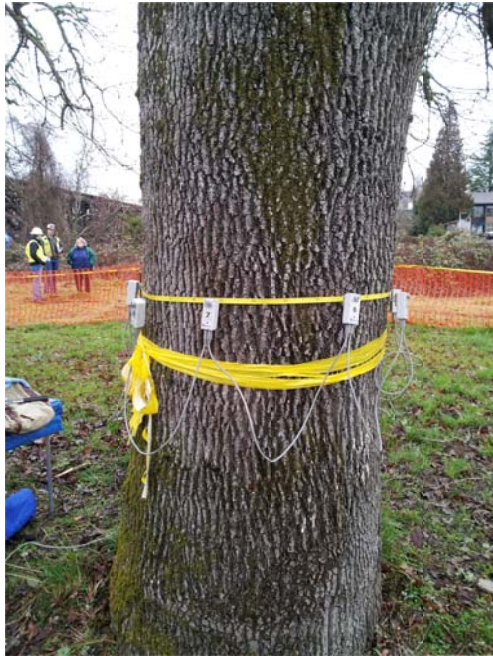
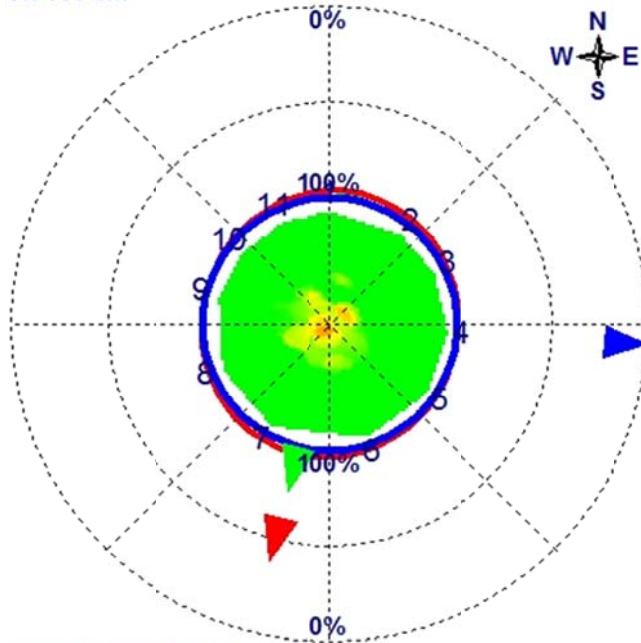
130 cm Level Sonic Tomography Measurements

- Geometric (96% - 100%)
- Weighted (96% - 100%)
- Ratio weighted/geometric (100% - 100%)

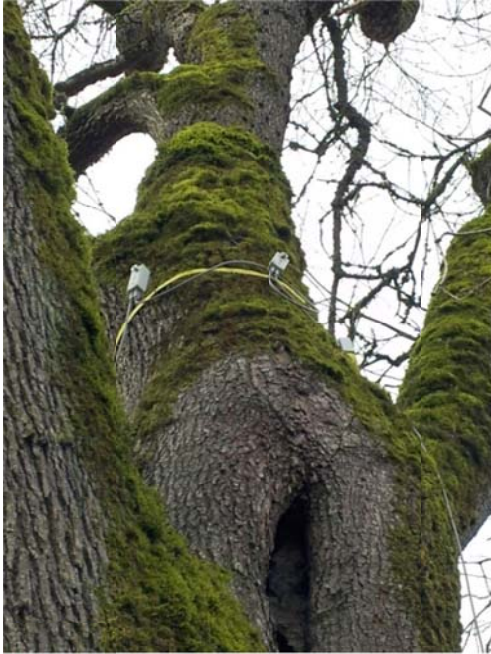
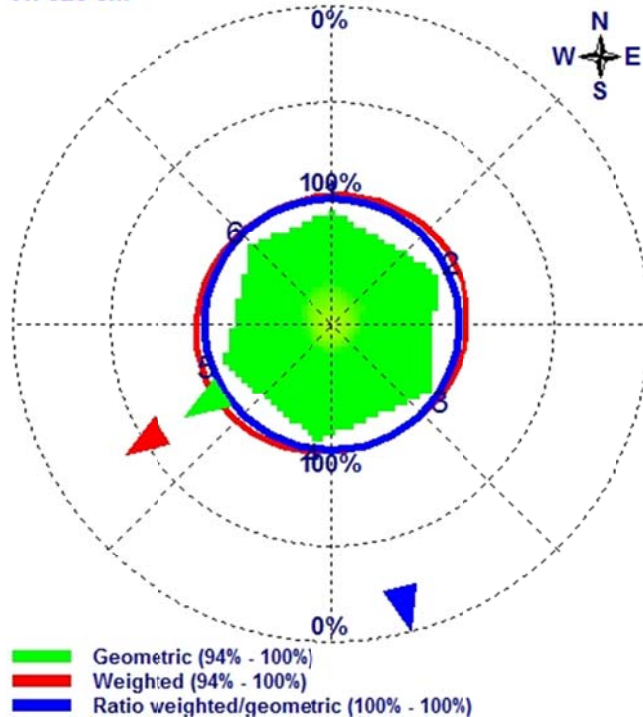
620 cm Level Sonic Tomography Measurement

620 cm	Measurement of leader above the decay cavity to determine if there was any decay in the leader above the cavity that would lead to strength loss.	No strength loss in the tree at this point in the trunk of the tree.
370 cm	This measurement was of the east leader that had to cavity to insure it was solid.	No indication of any decay. No strength loss indicated.
Combined View	Sonic tomography measurements of the three trunk readings were combined to give estimated 3-D view of any decay columns.	While this graphic does show some decay in the center of the tree as indicated by the color red, it is NOT a significant amount and has not led to any strength loss that would compromised the structural integrity of the tree.

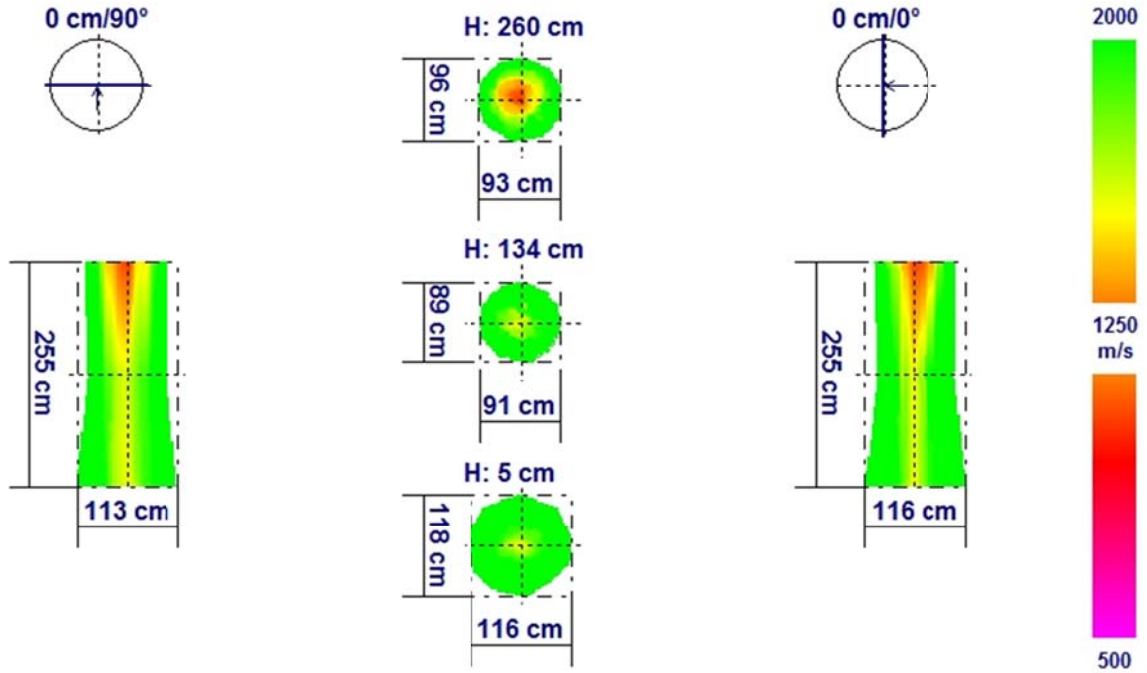
Appendix #2 - Combined Sonic Tomography Readings View of Trunk

The sonic tomography measurements showed that there was little decay in any of the measurements. Tomography measurements were made at the following locations on the tree;
