**AGENDA
GOOD NEIGHBOR COMMITTEE**

SCHEDULE OF TREES TO BE REMOVED

KELLOGG WATER TREATMENT CONTROL PLANT - MILWAUKIE, OR 8/4/2014
TREES PROPOSED FOR REMOVAL

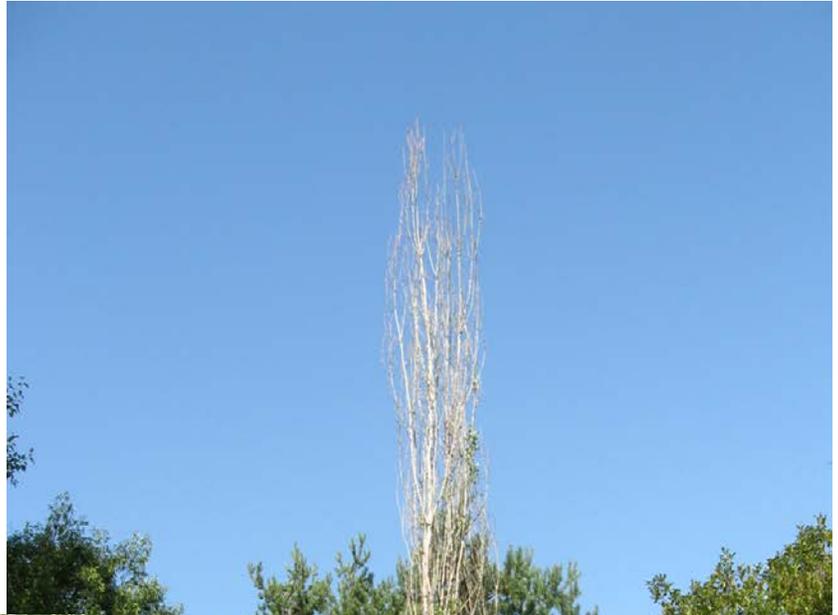
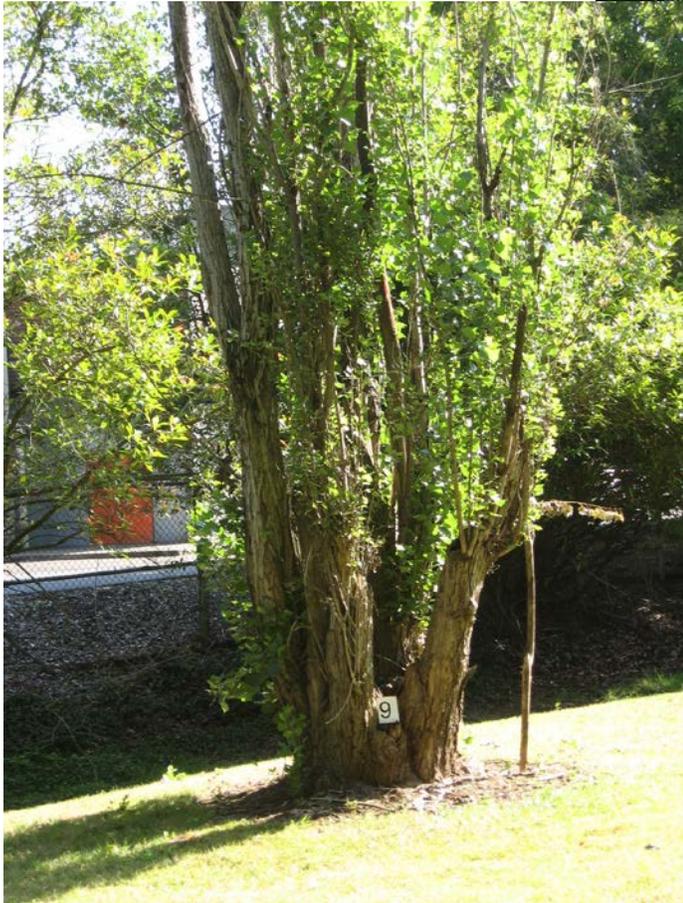
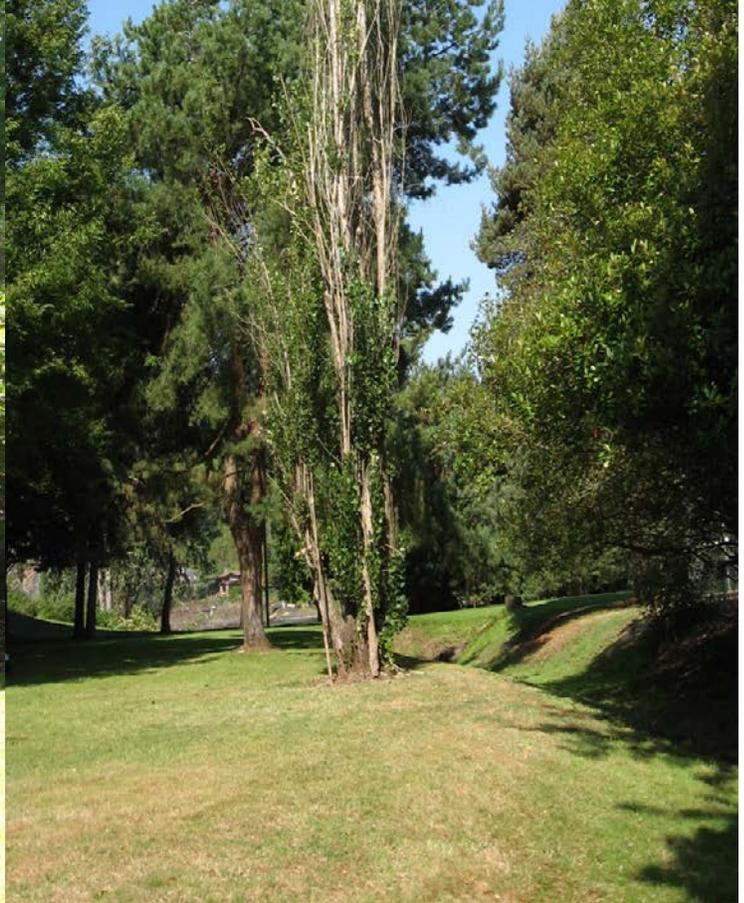
Tree #9- Showing extent of crown dieback (right) and multiple new stems surrounding decayed original stem (below)

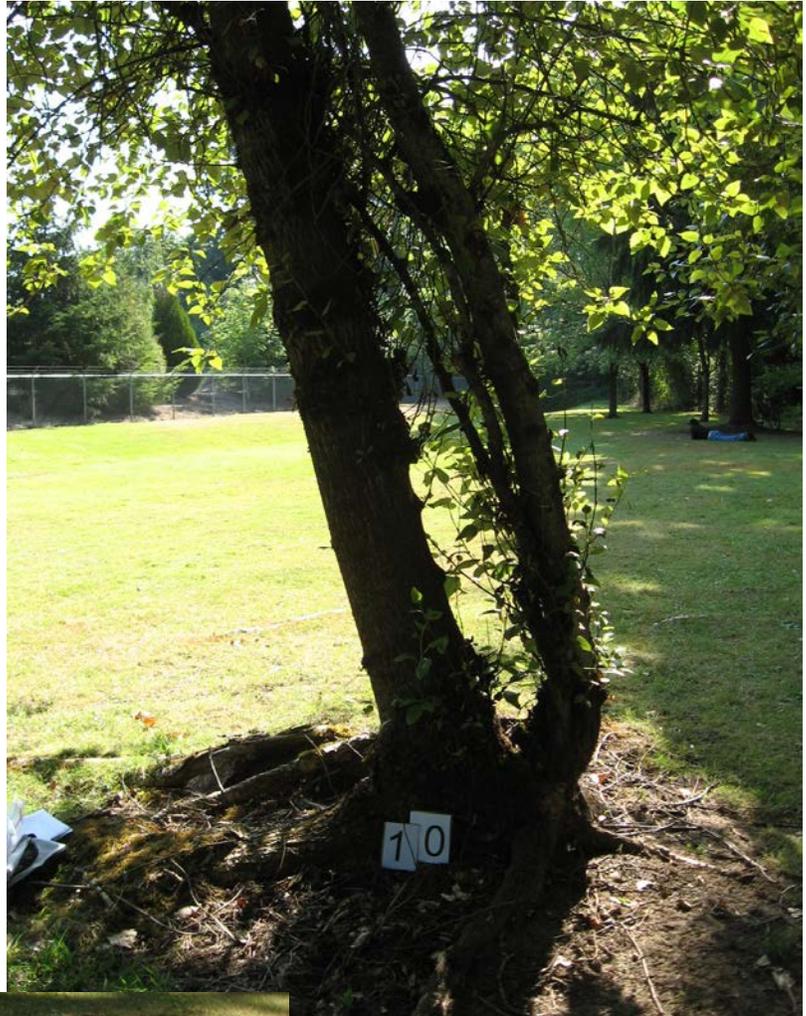
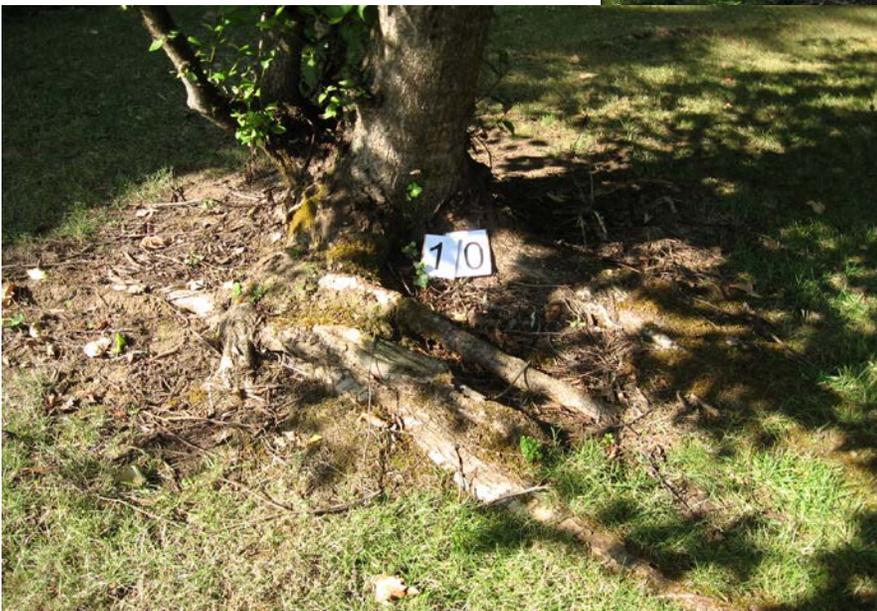
Tree #10 - Showing girdling
damaged roots and trunk lean.
Note secondary leader.

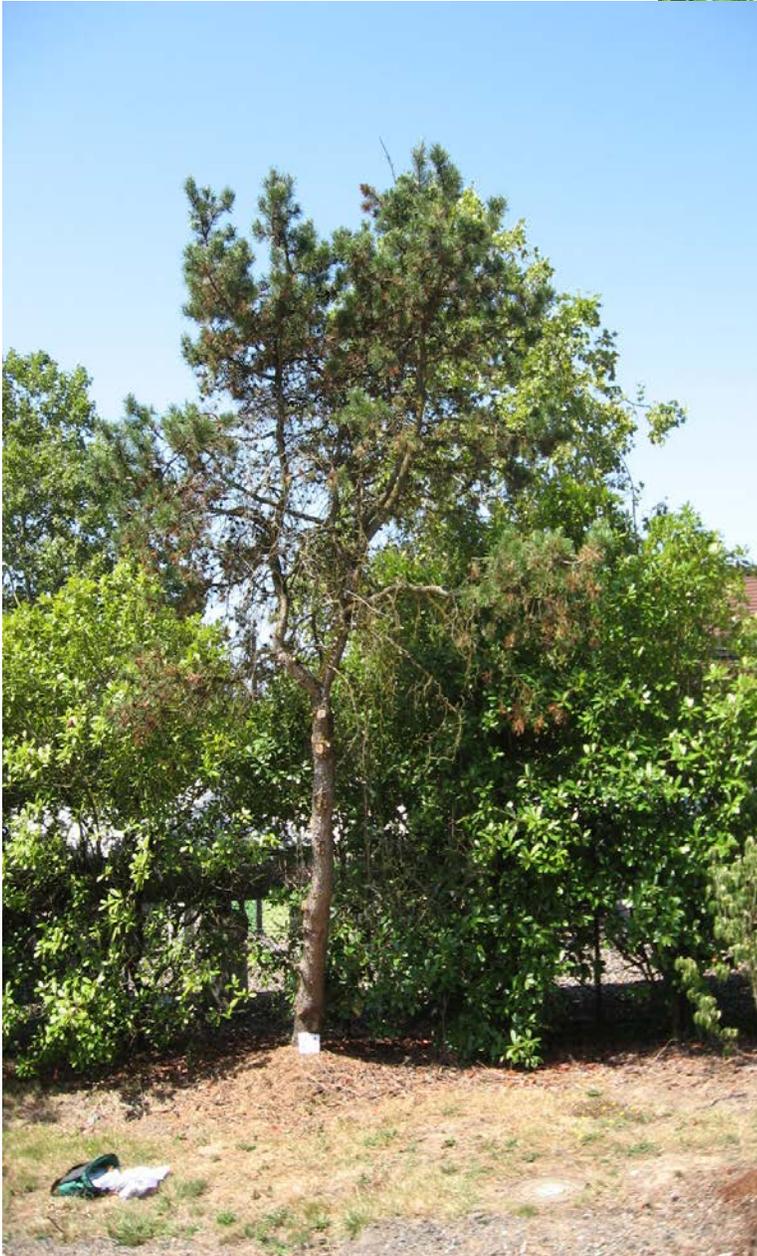
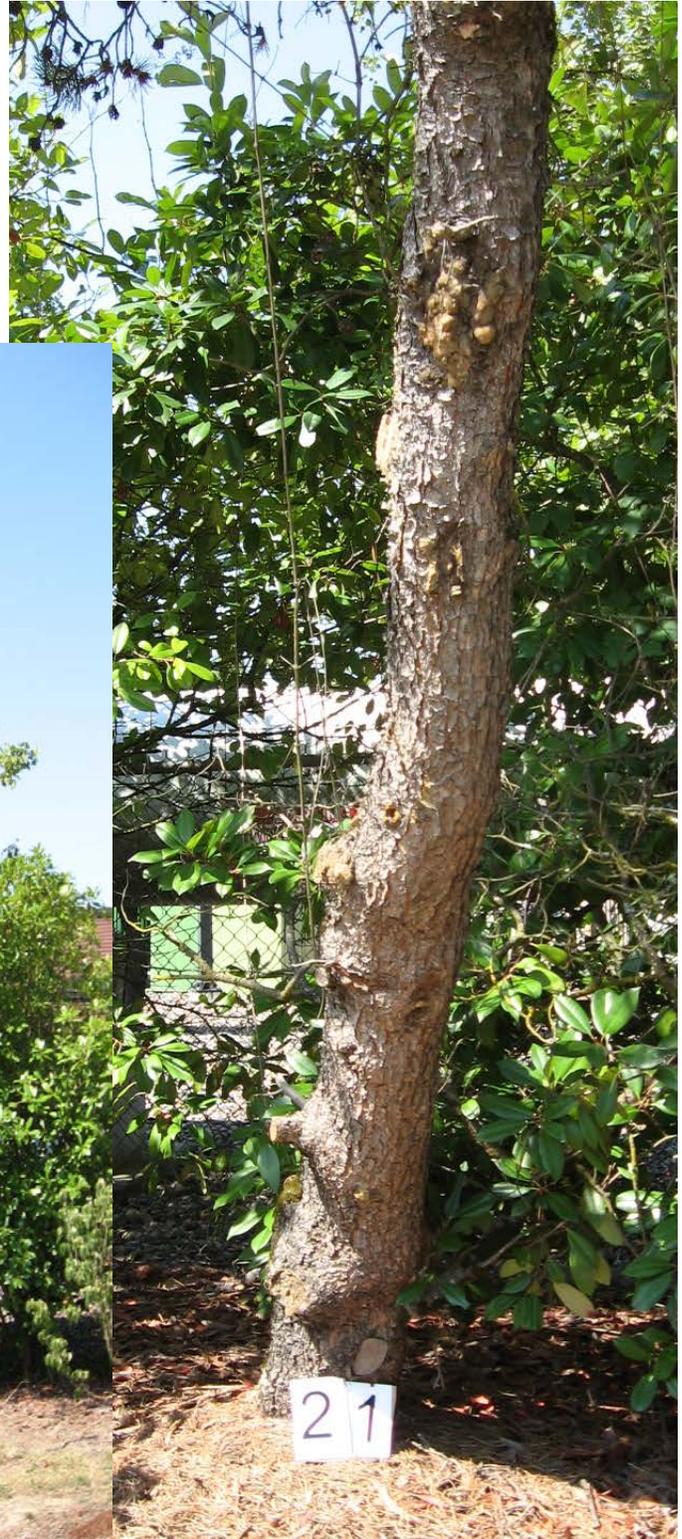
Tree #21 - Showing extensive
branch removals and crown
dieback.

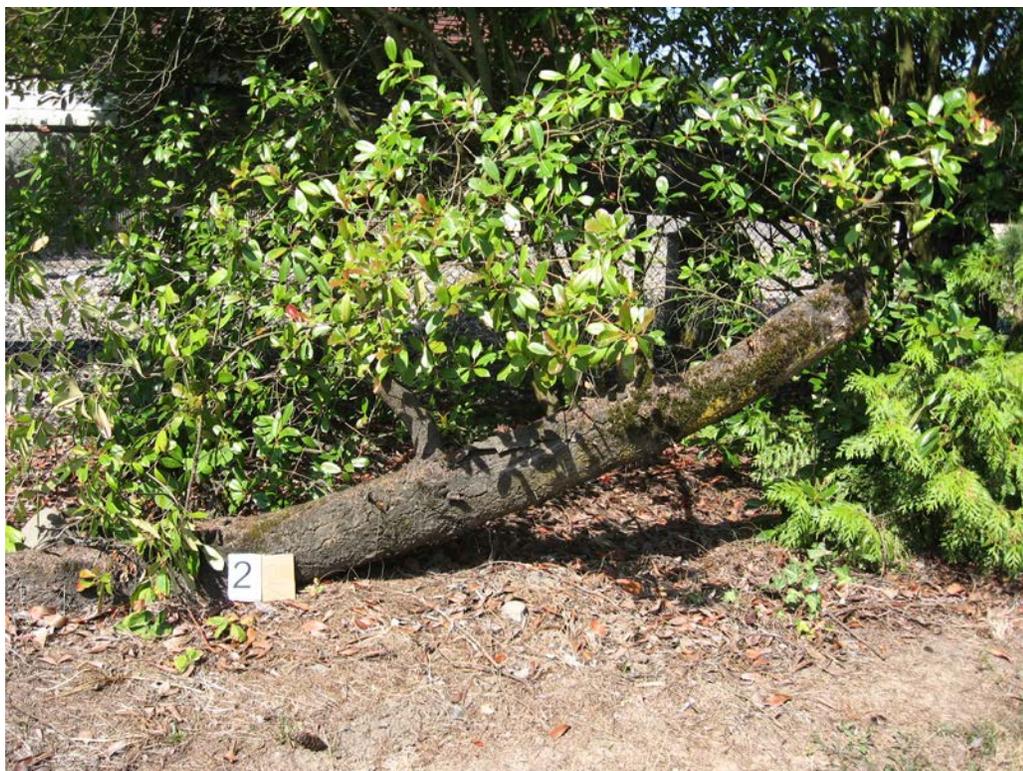
Tree #22- Showing remainder
of stem lying on ground (all
limbs removed)

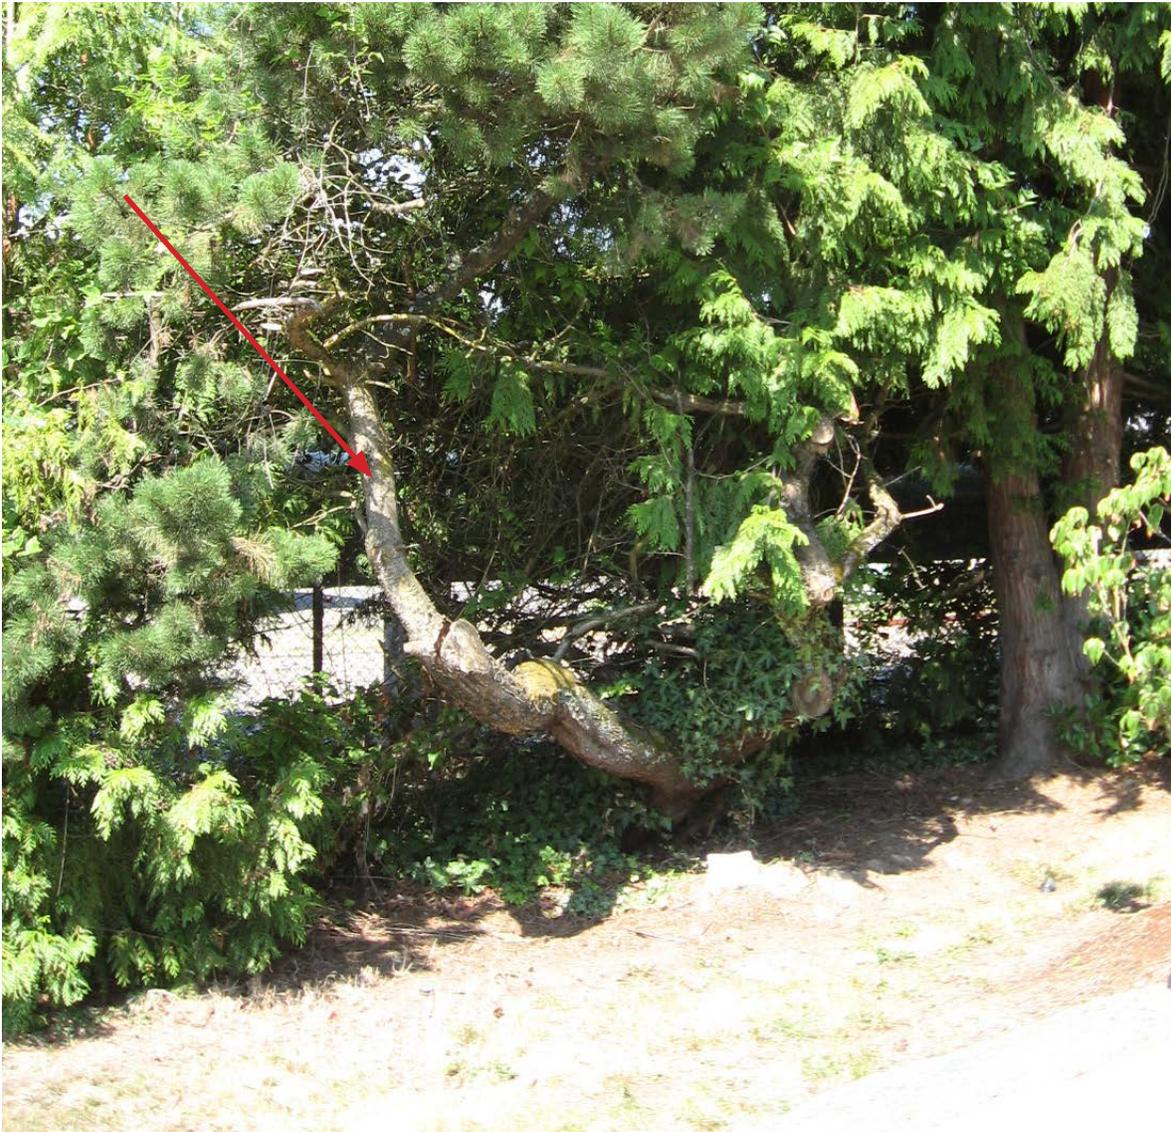
Tree #23- Showing remaining stem leaning on ground with new leader developed from former branch.

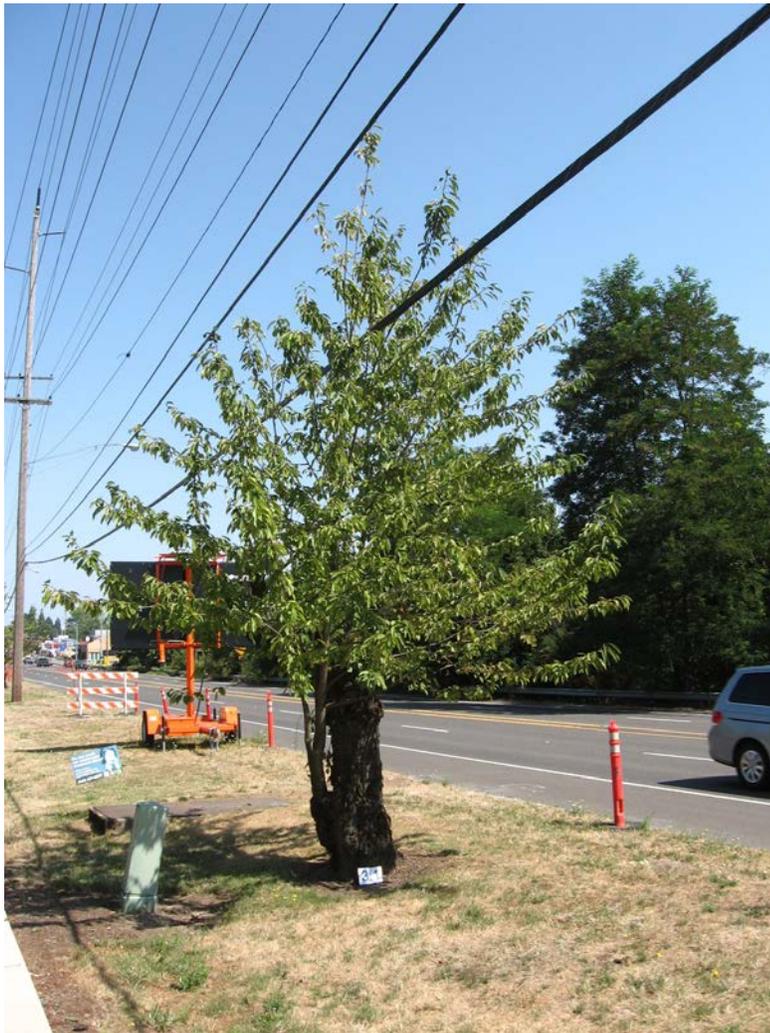
Tree #31- Past topping at 6' height has resulted in undersized canopy; tree severely stressed.

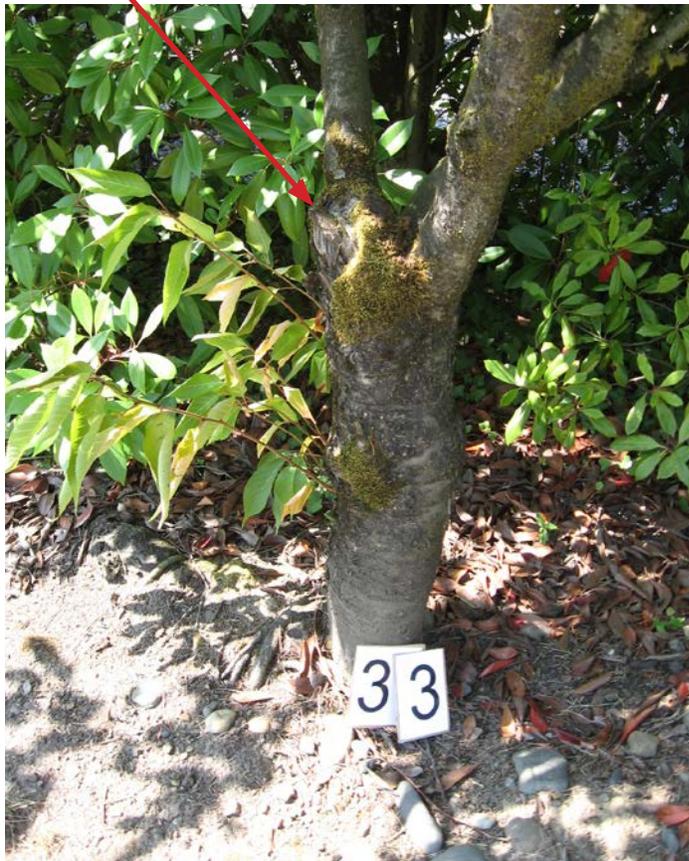
Tree #33- Showing unhealed
wound left by major branch
loss.

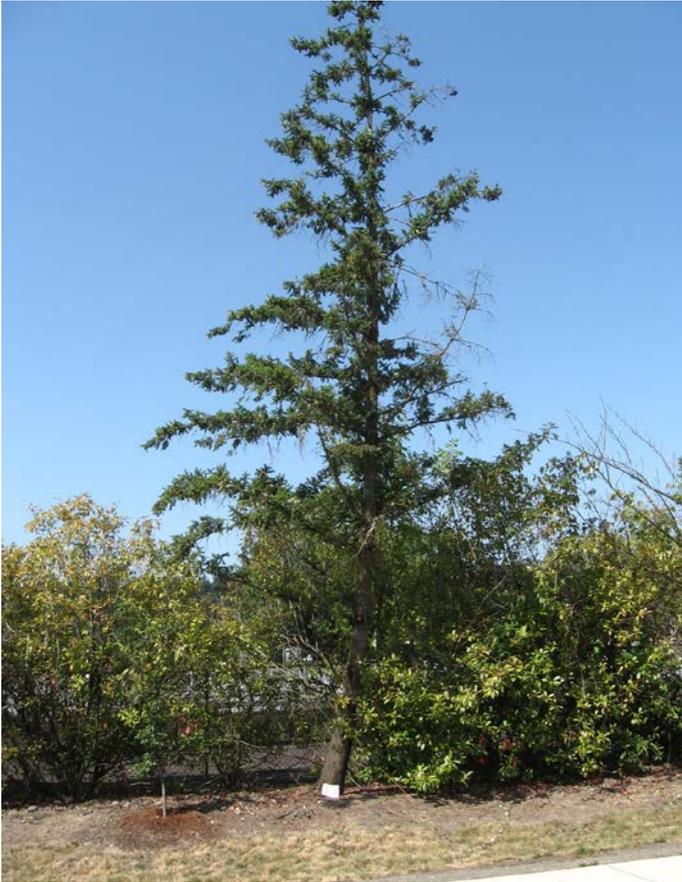
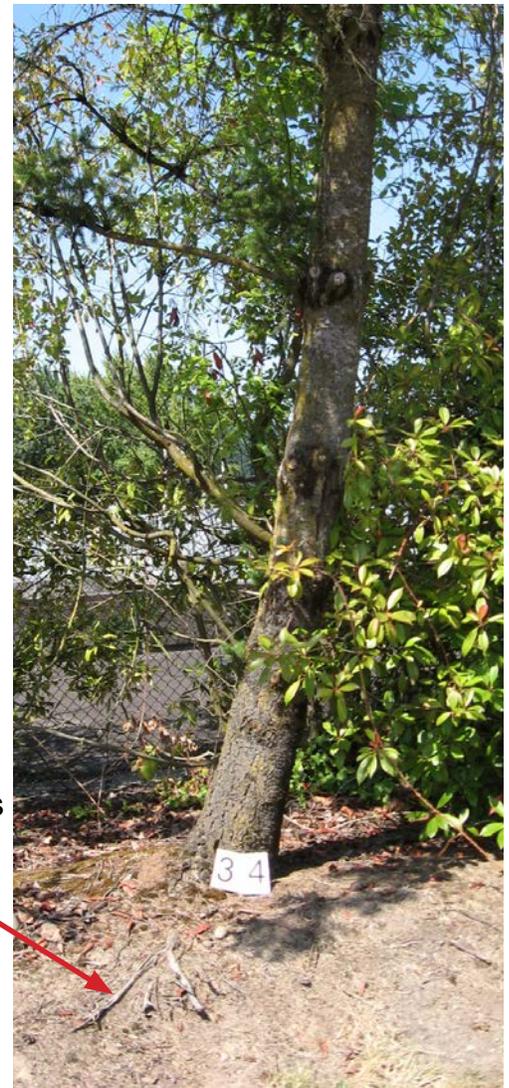
Tree #34- Sparse canopy, possibly due to root impacts from trail construction?

Damaged roots visible

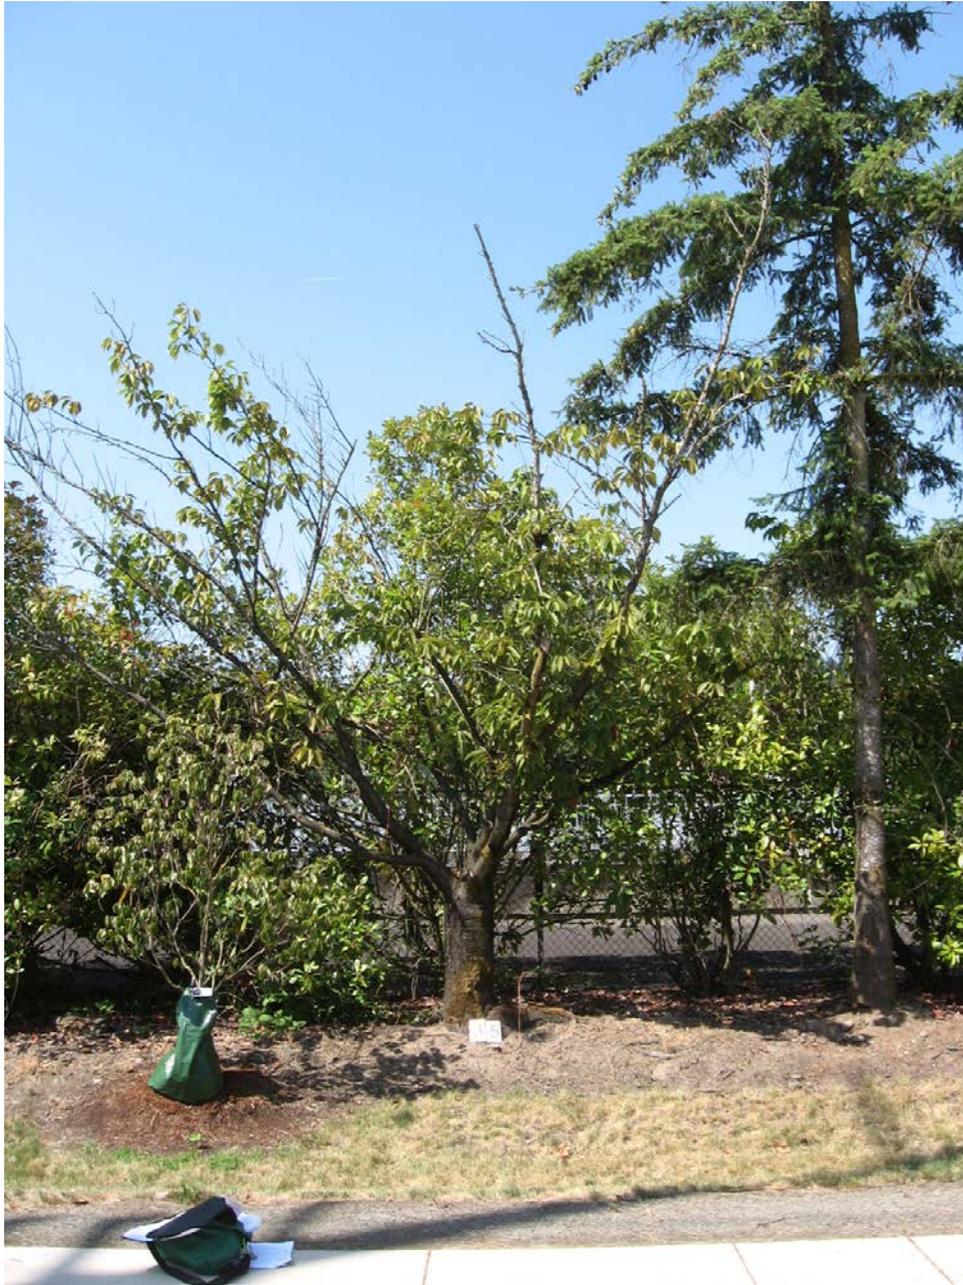
Tree #35- Sparse canopy; tree severely stressed.

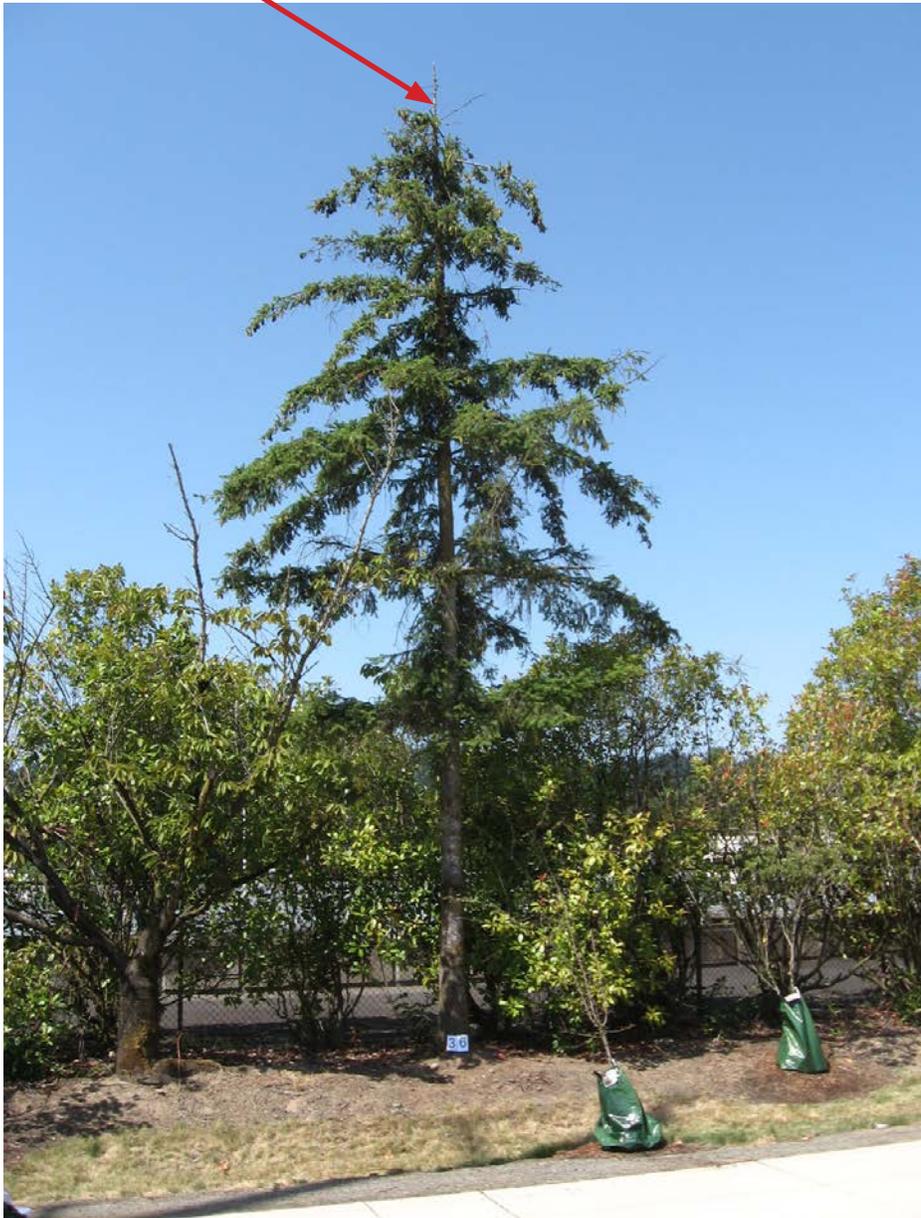
Tree #36- Sparse canopy, possibly due to root impacts from trail construction? Dead leader and sparse canopy may indicate root rot

Note dead leader

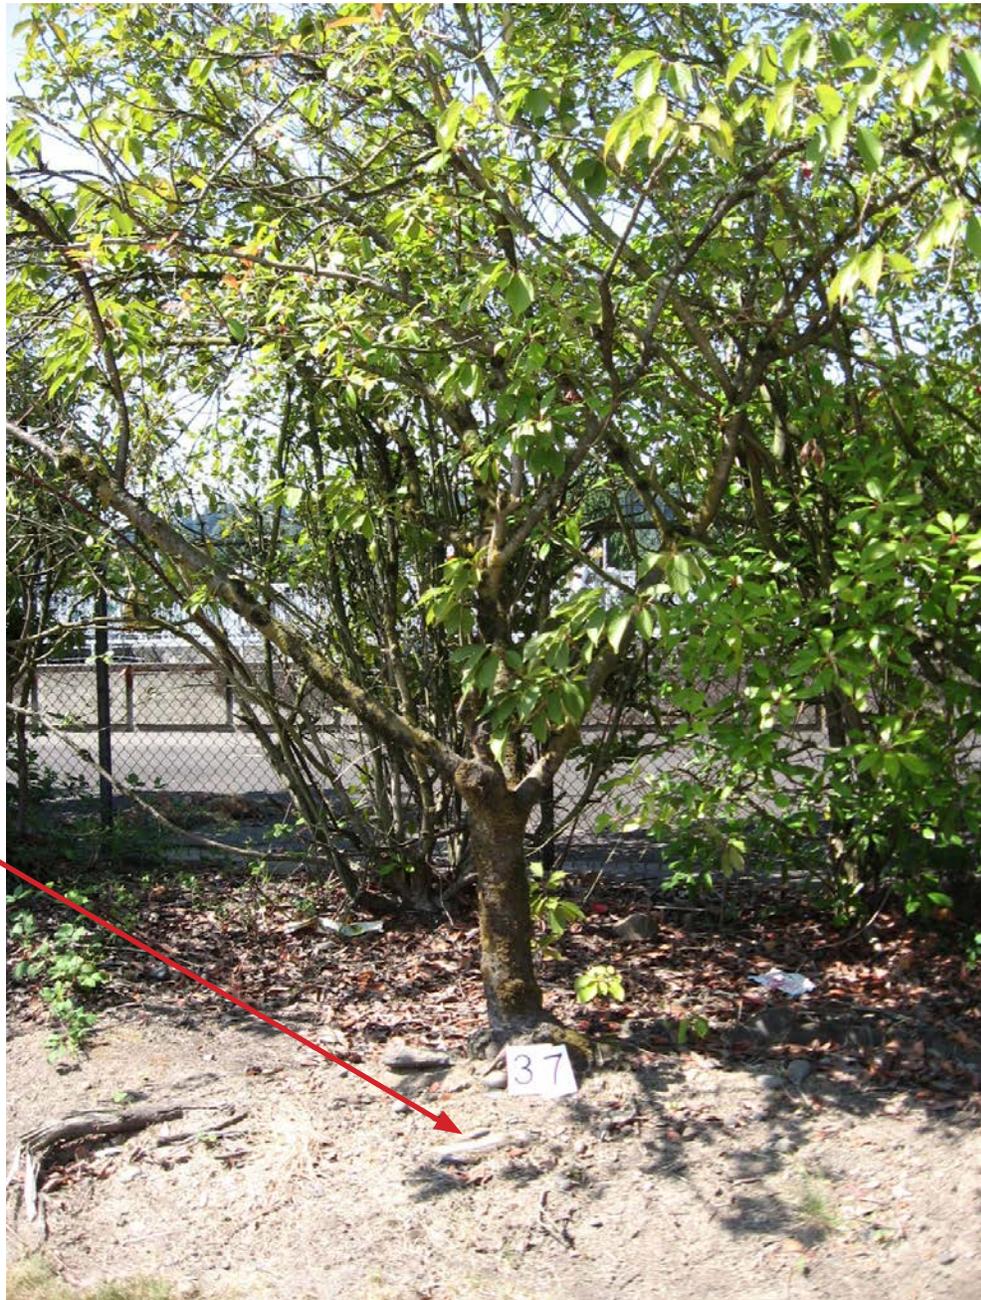
Tree #37 - Tree in decline, probably due to heavily damaged roots, which are still visible.

Note multiple
damaged roots
visible

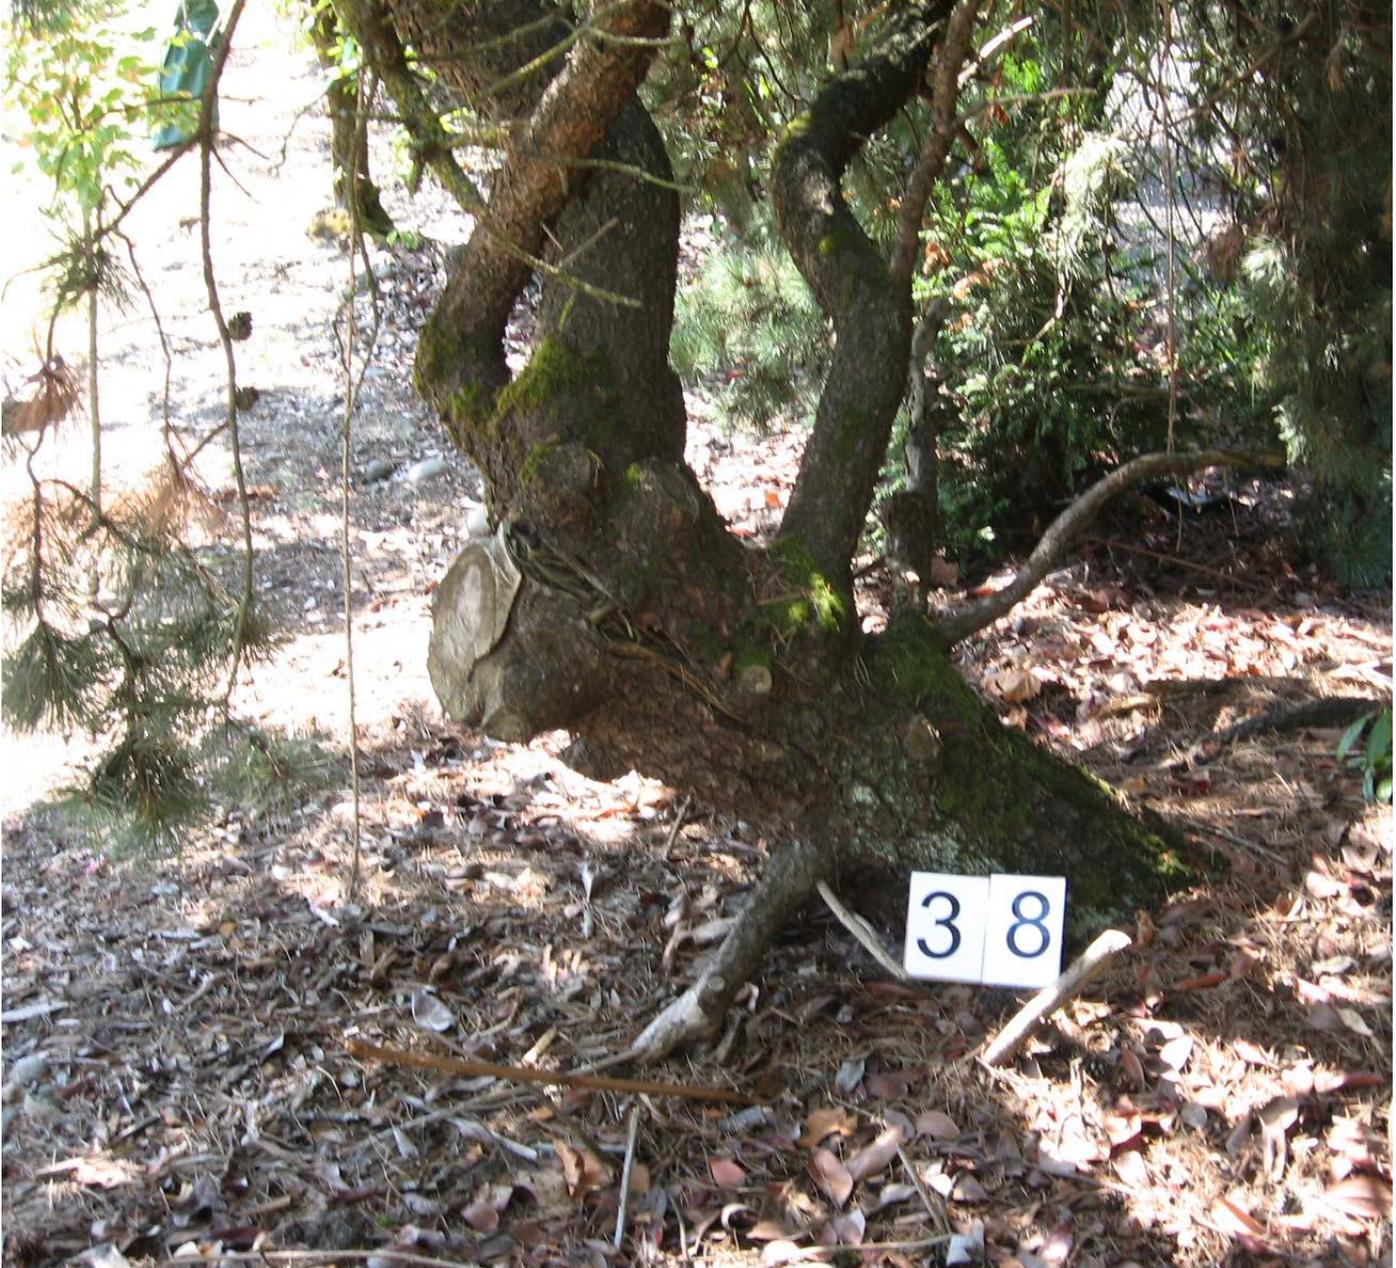
Tree #38 - Tree topped at some point and new leader has formed from existing branch. Extensive branch dieback present, indicating tree is in decline.

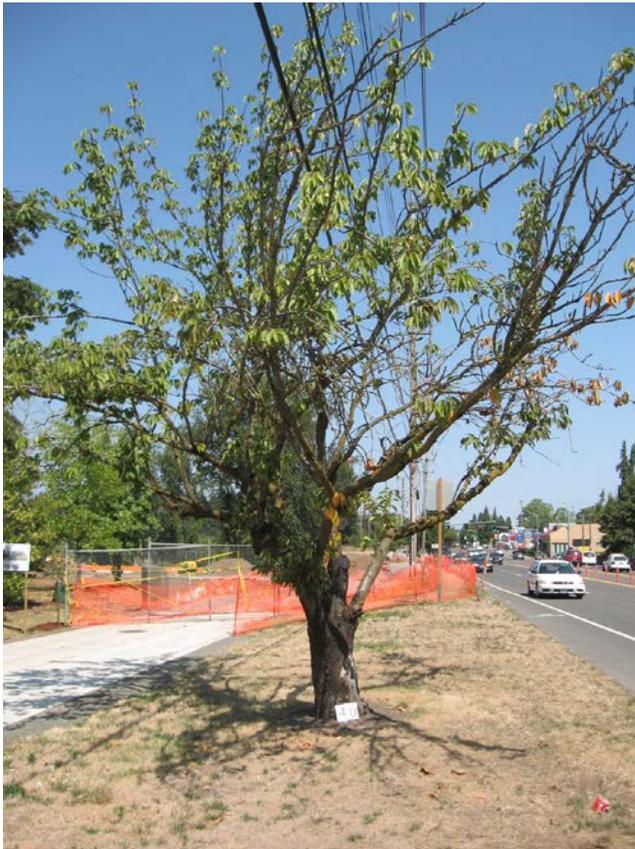
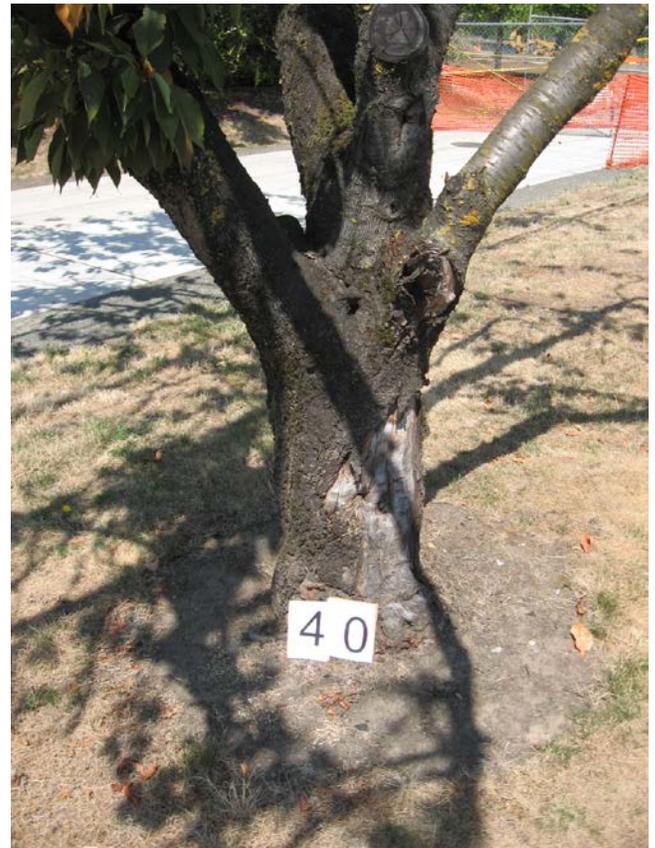
Tree #40 - Major unhealed wound on stem (right, below) and sparse canopy.

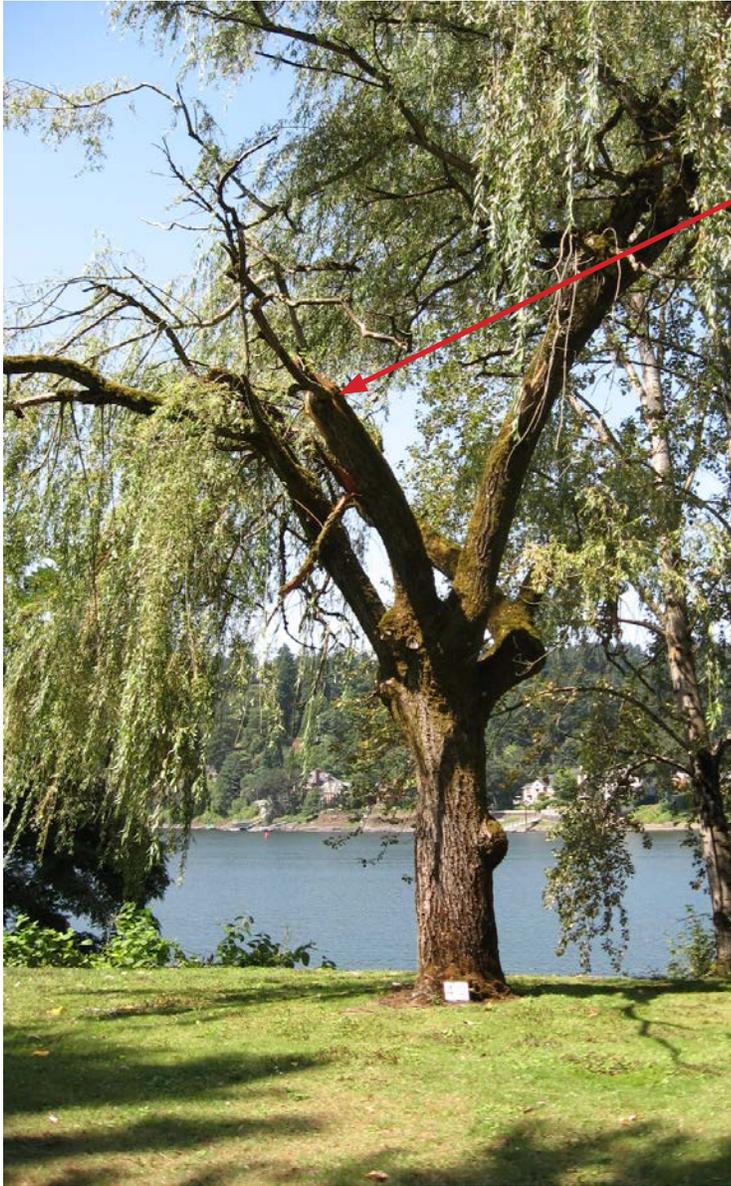
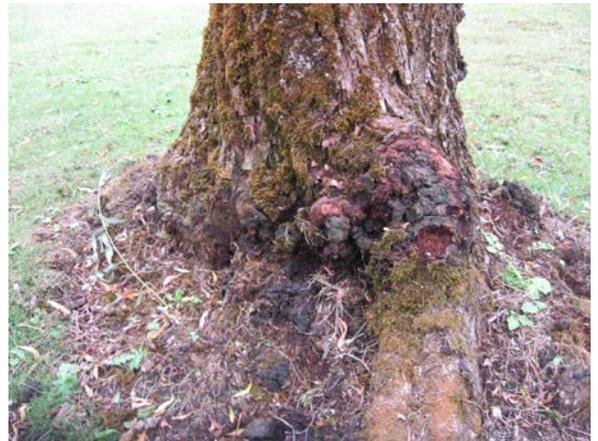
Tree #42- Willow with very recent large limb failure (at arrow in photo on right). Close-up of trunk base (below) showing evidence of probable butt and root rot.

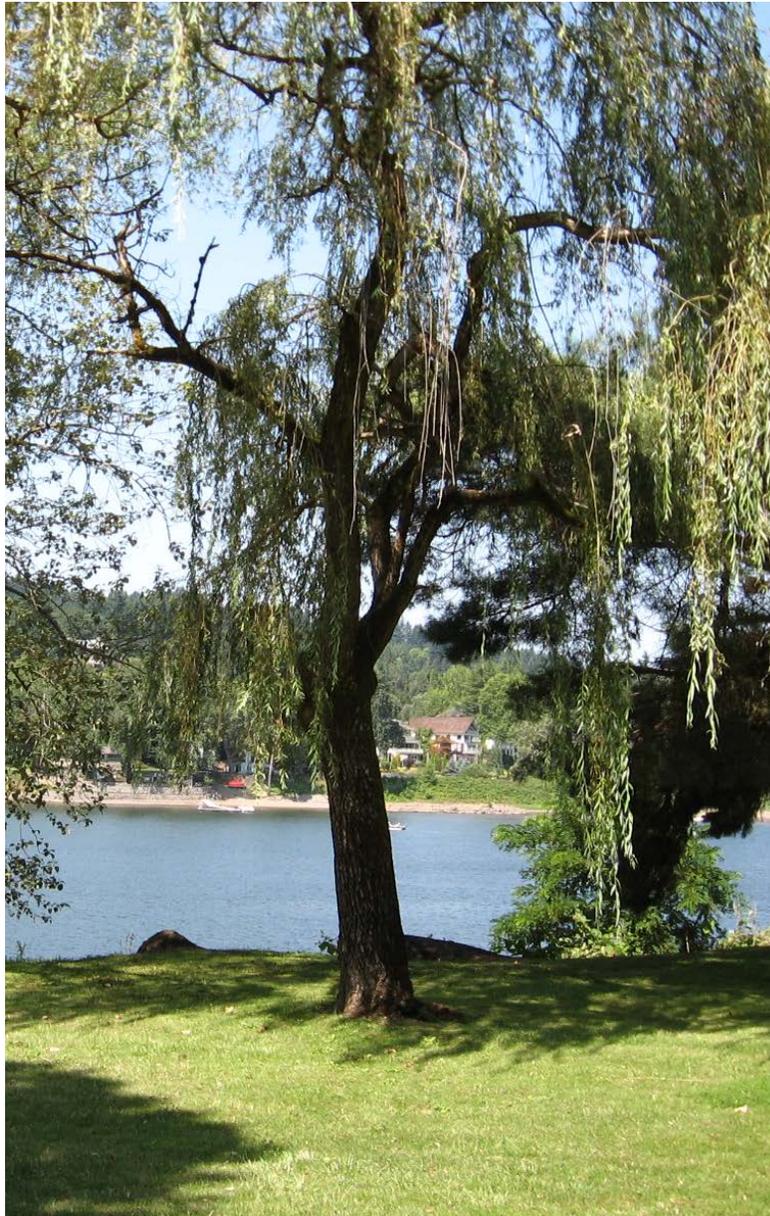
Tree #43 - Willow with prior limb failures, unbalanced crown and probable rot.

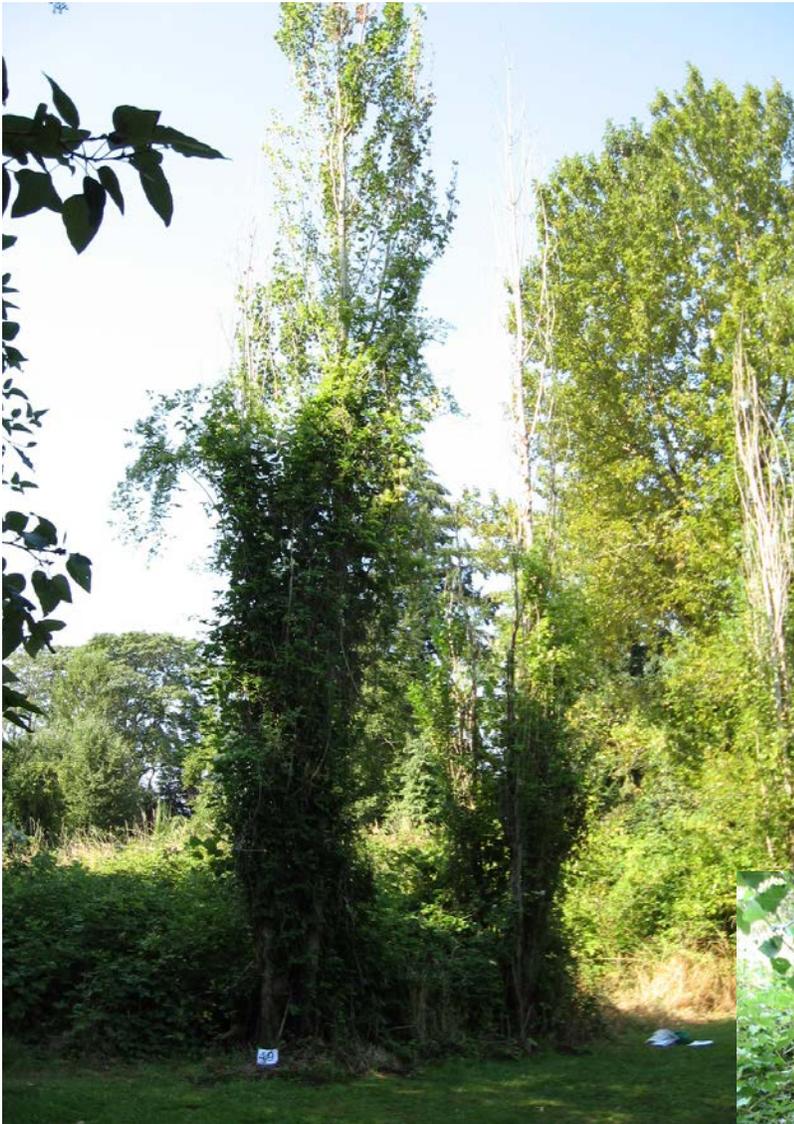
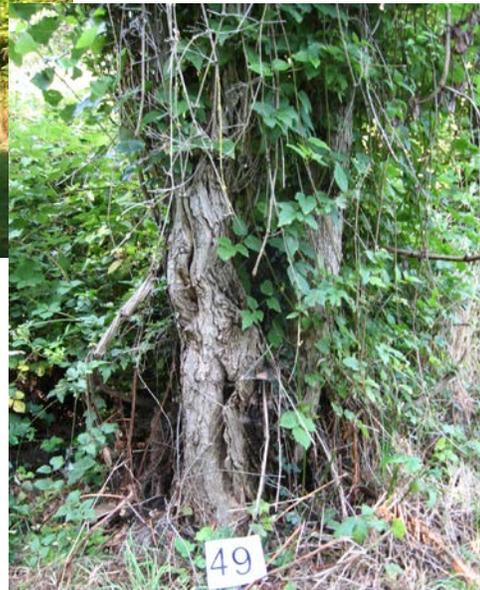
Tree #49 - Extensive crown dieback (top). Close-up of base showing central decay (bottom photo)

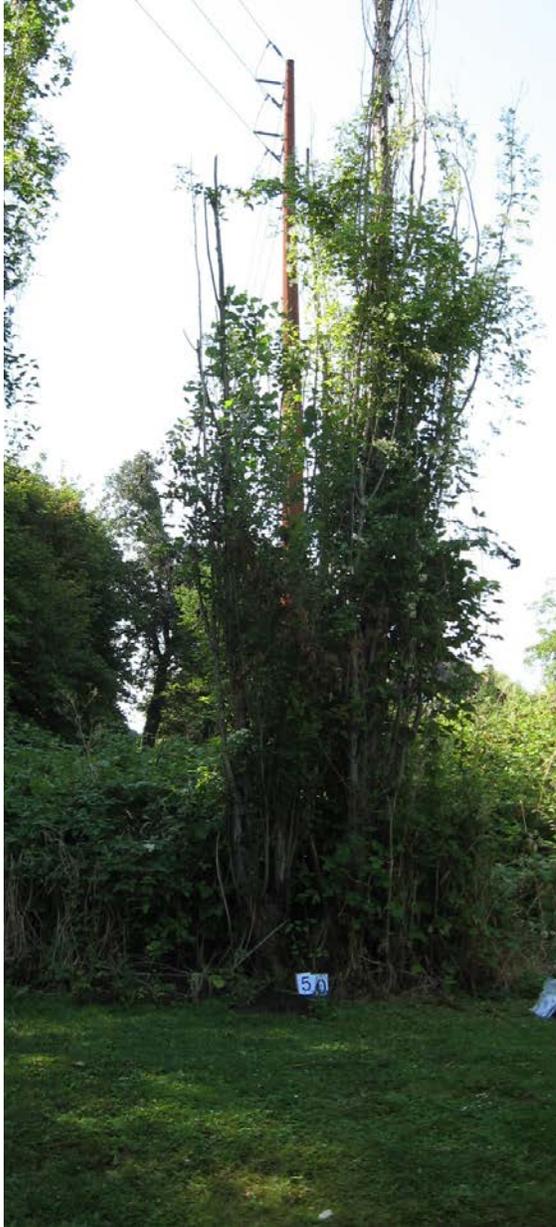
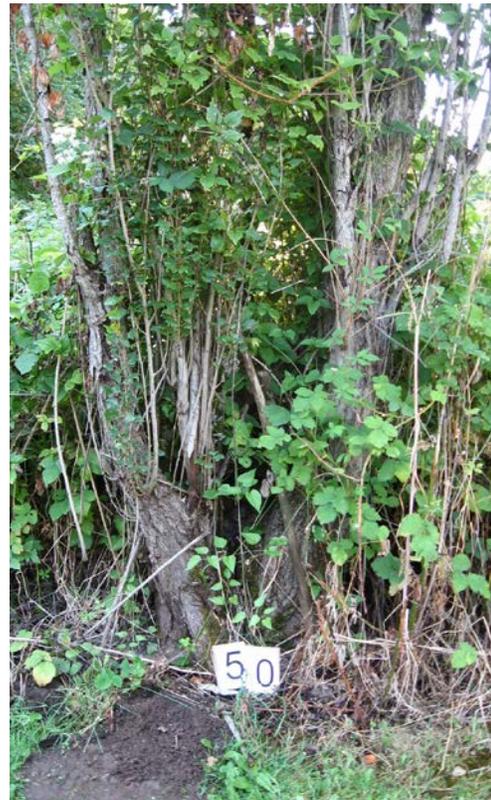
Tree #50 - Extensive crown dieback (top). Close-up of base showing central decay (bottom photo)

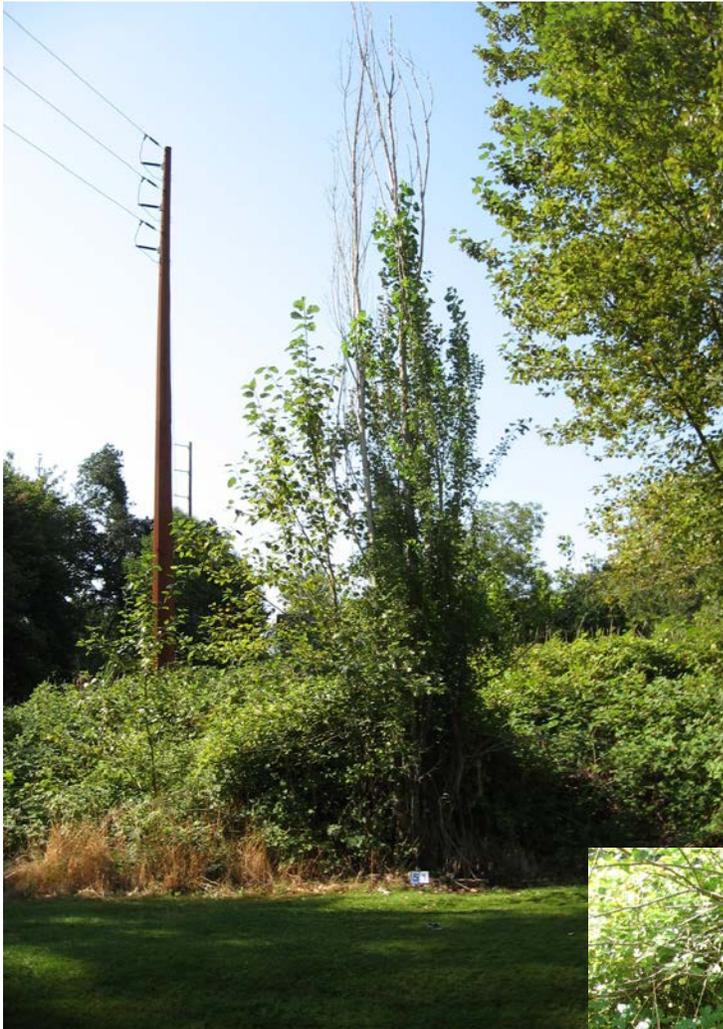
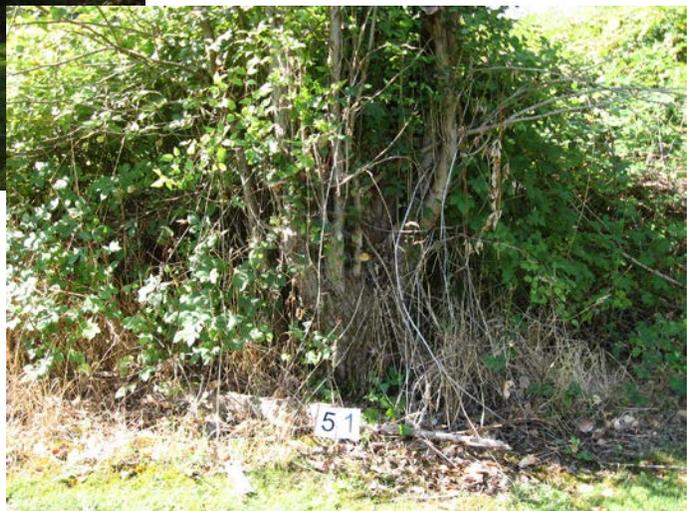
Tree #51 - Extensive crown dieback (top). Close-up of base showing central decay (bottom photo)
