**AGENDA
GOOD NEIGHBOR COMMITTEE**

SCHEDULE OF TREES TO BE REMOVED

KELLOGG WATER TREATMENT CONTROL PLANT - MILWAUKIE, OR 8/4/2014
TREES PROPOSED FOR REMOVAL

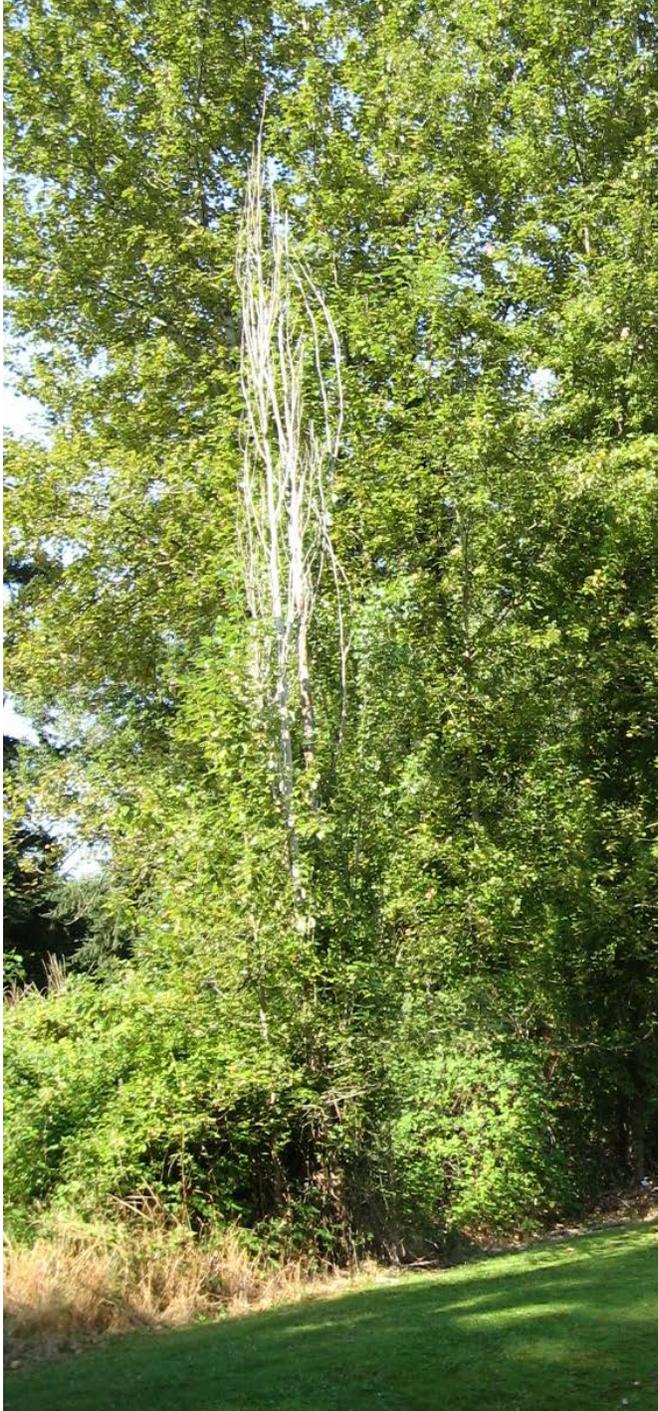
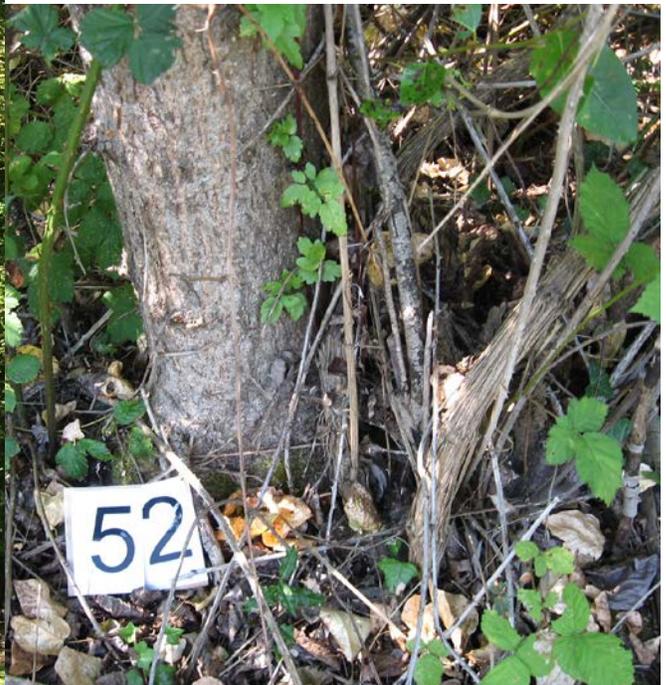
Tree #52 - Extensive crown dieback (top). Close-up of base showing central decay (bottom photo) and extensive invasive vines.

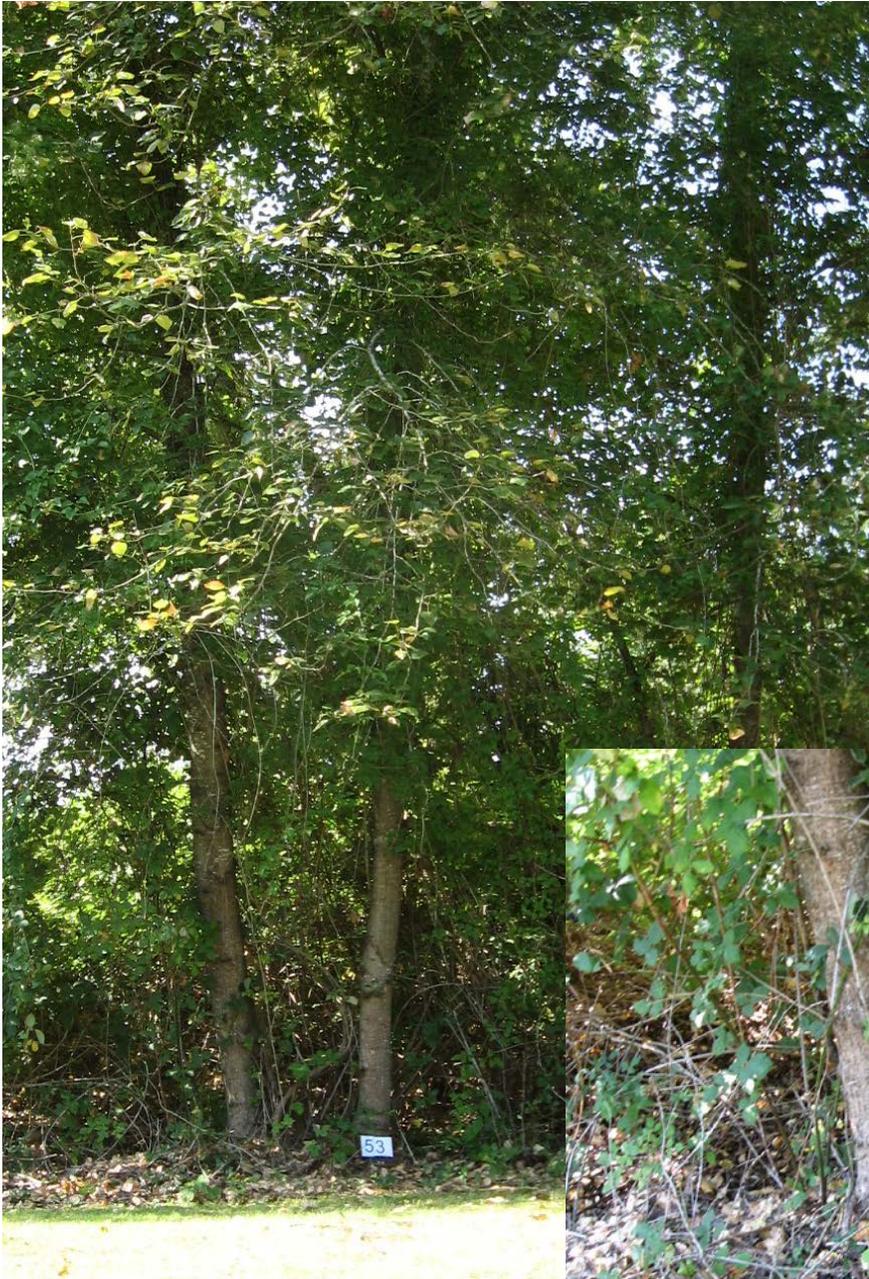
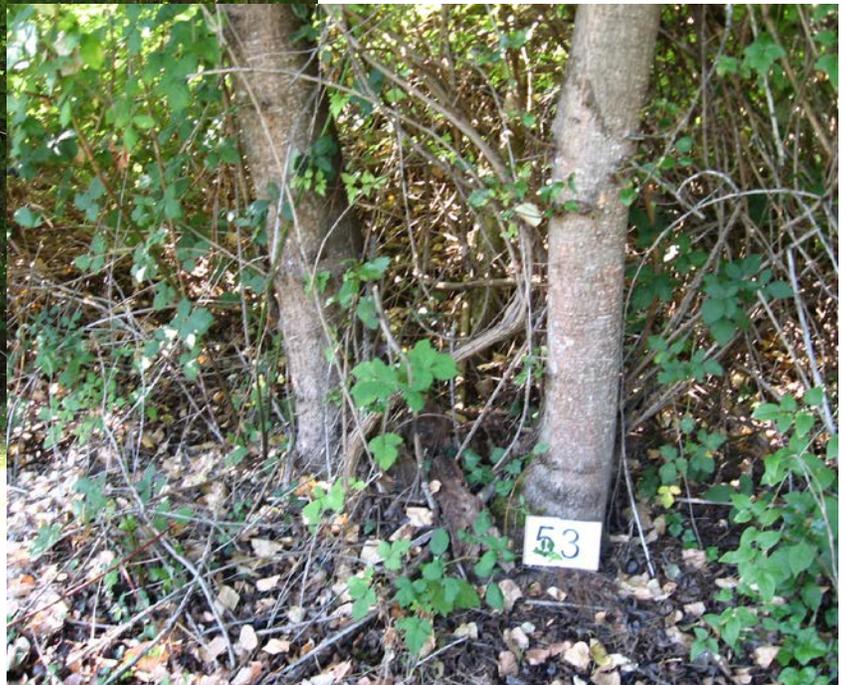
Tree #53 - Tree with two stems has one-sided canopy
(suppressed) due to adjacent tree offsite.

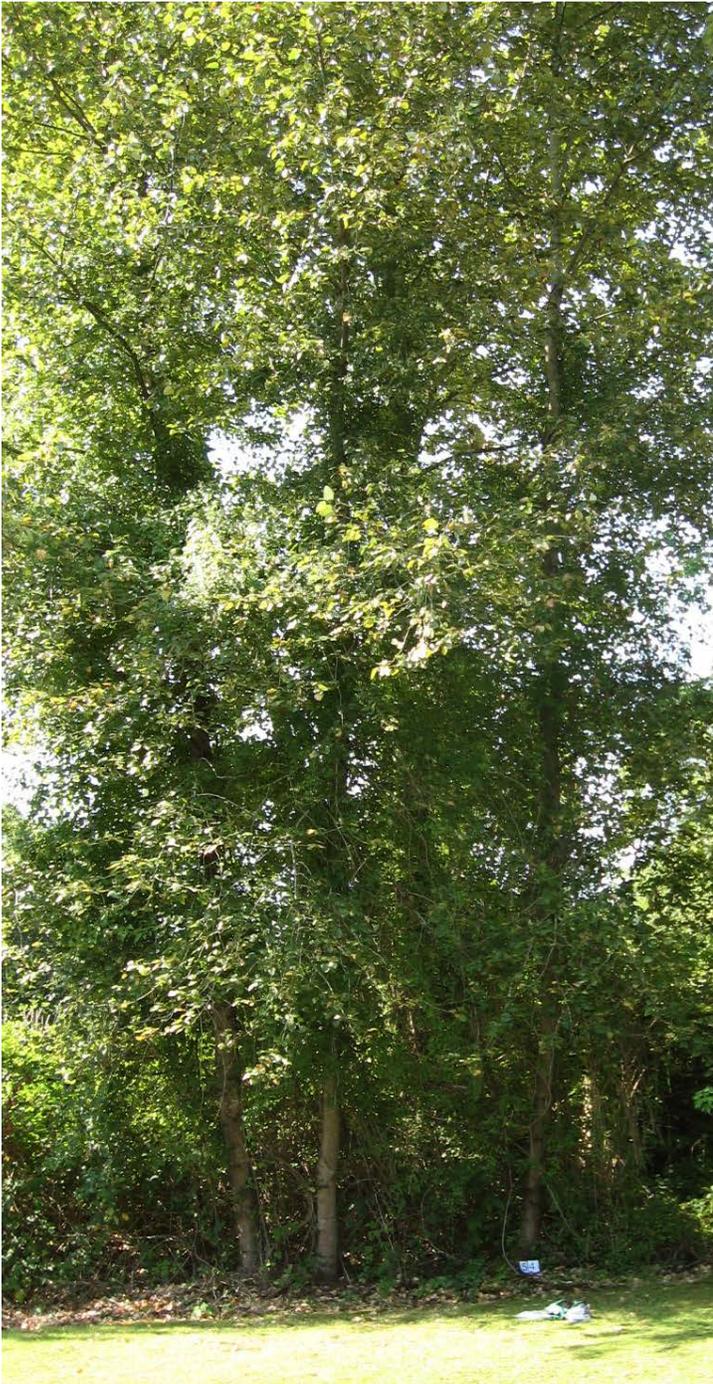
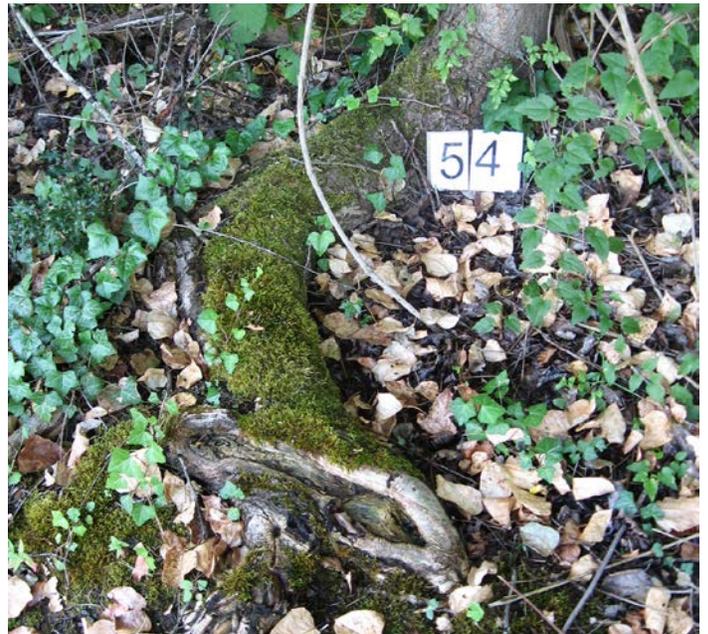
Tree #54 - This cottonwood has significant root damage, and is suppressed by adjacent cottonwood offsite. Since cottonwoods are brittle and limbs fail easily, recommend removal now while tree is relatively small.

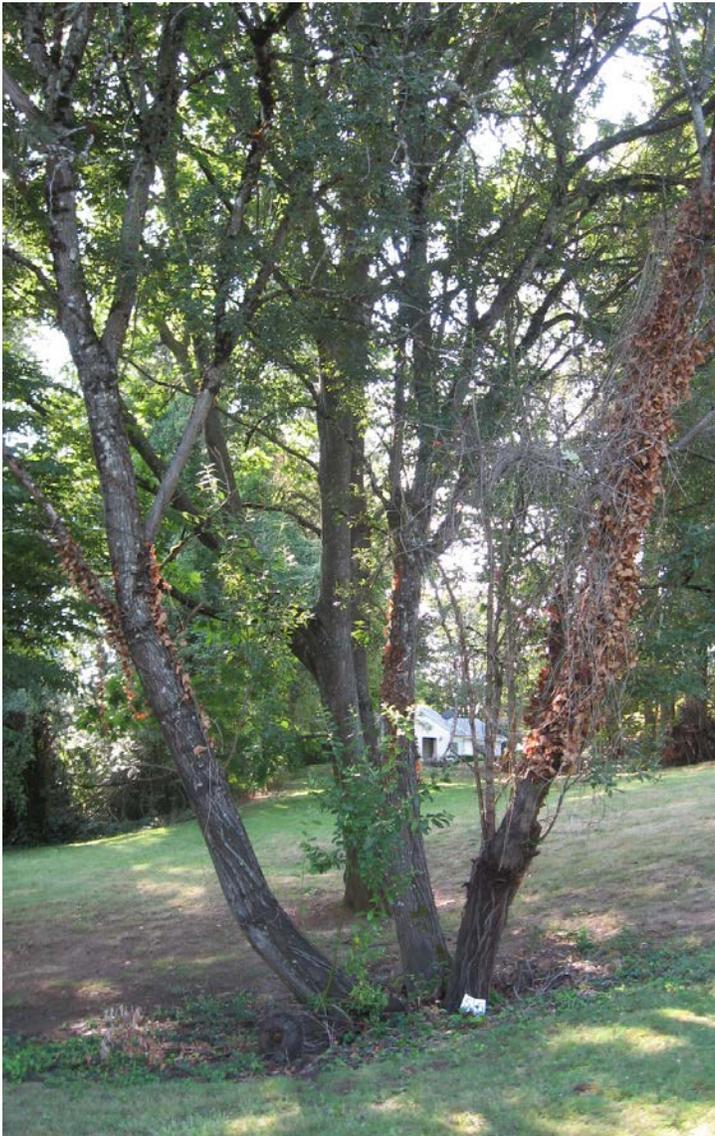
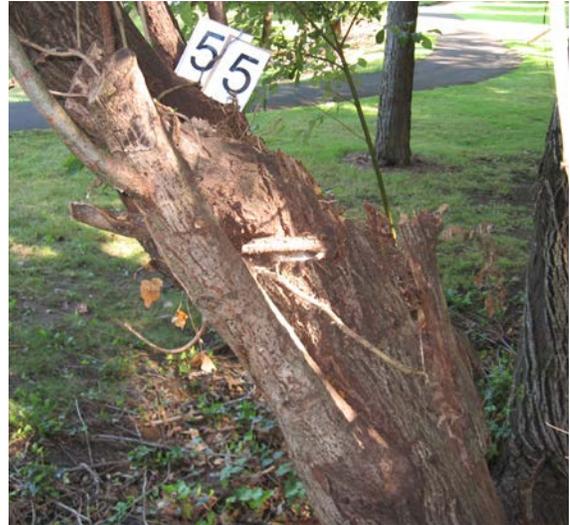
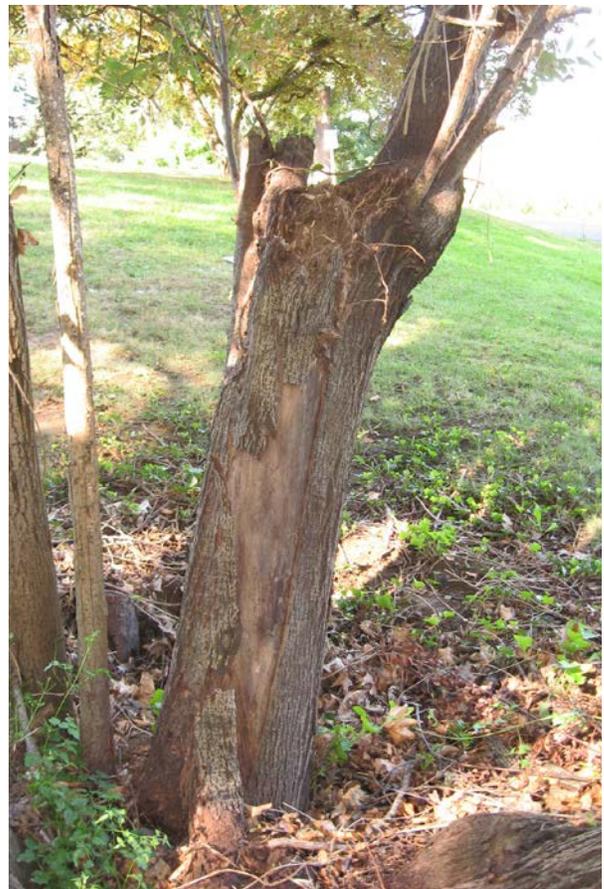
Tree #55 - Three main stems surround missing (decayed) prior stem. Two of the three stems have significant damage and/or decay.

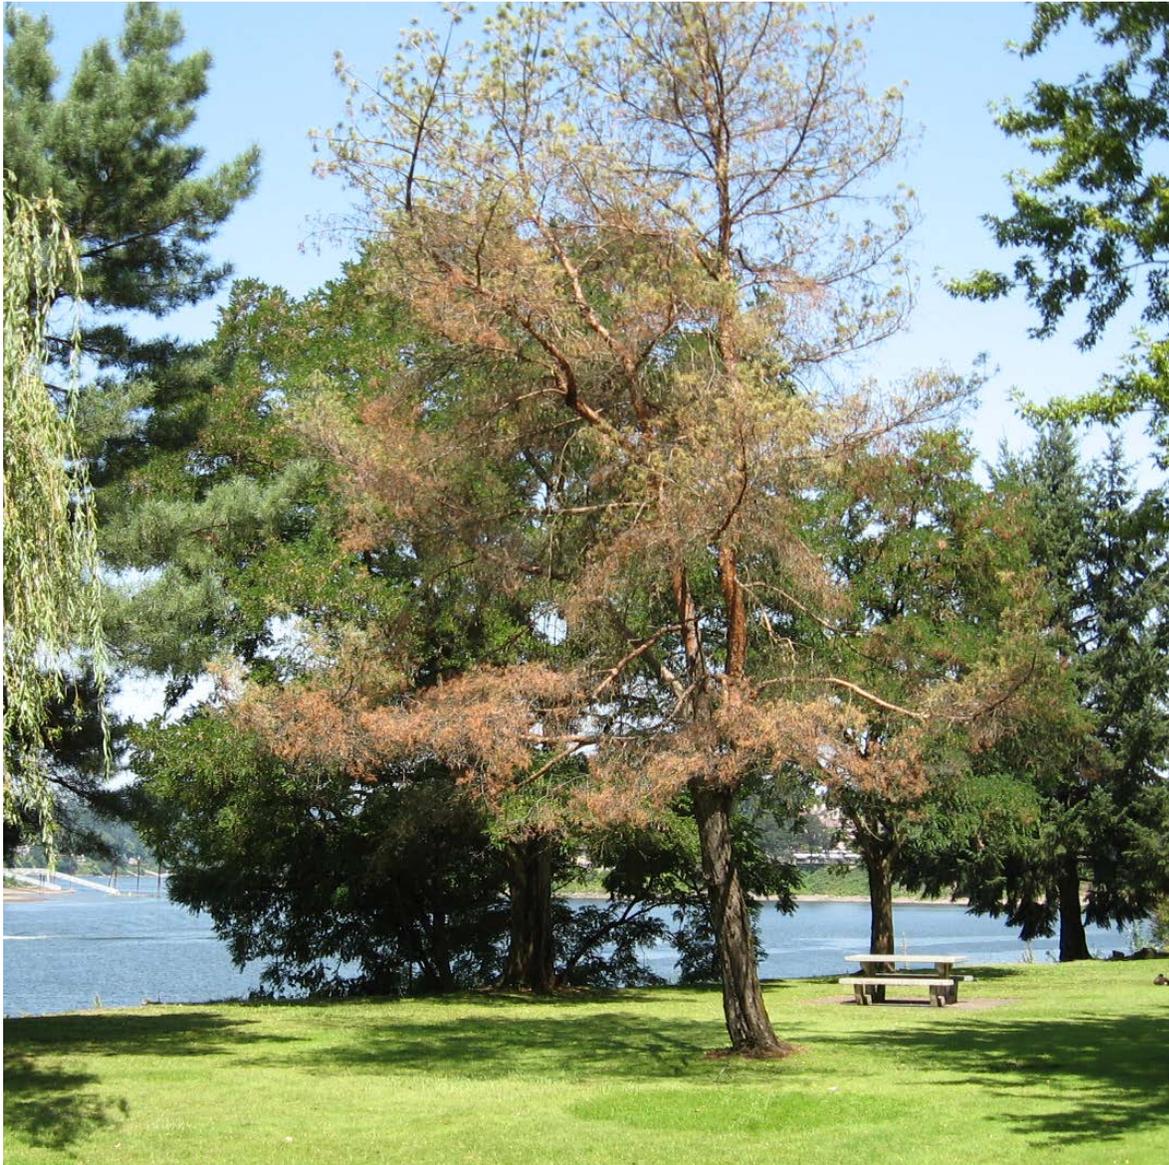
Tree #56 - This tree is dying from a fungal disease, most possibly caused by excessively wet soil. Only upper portion of crown has live foliage.

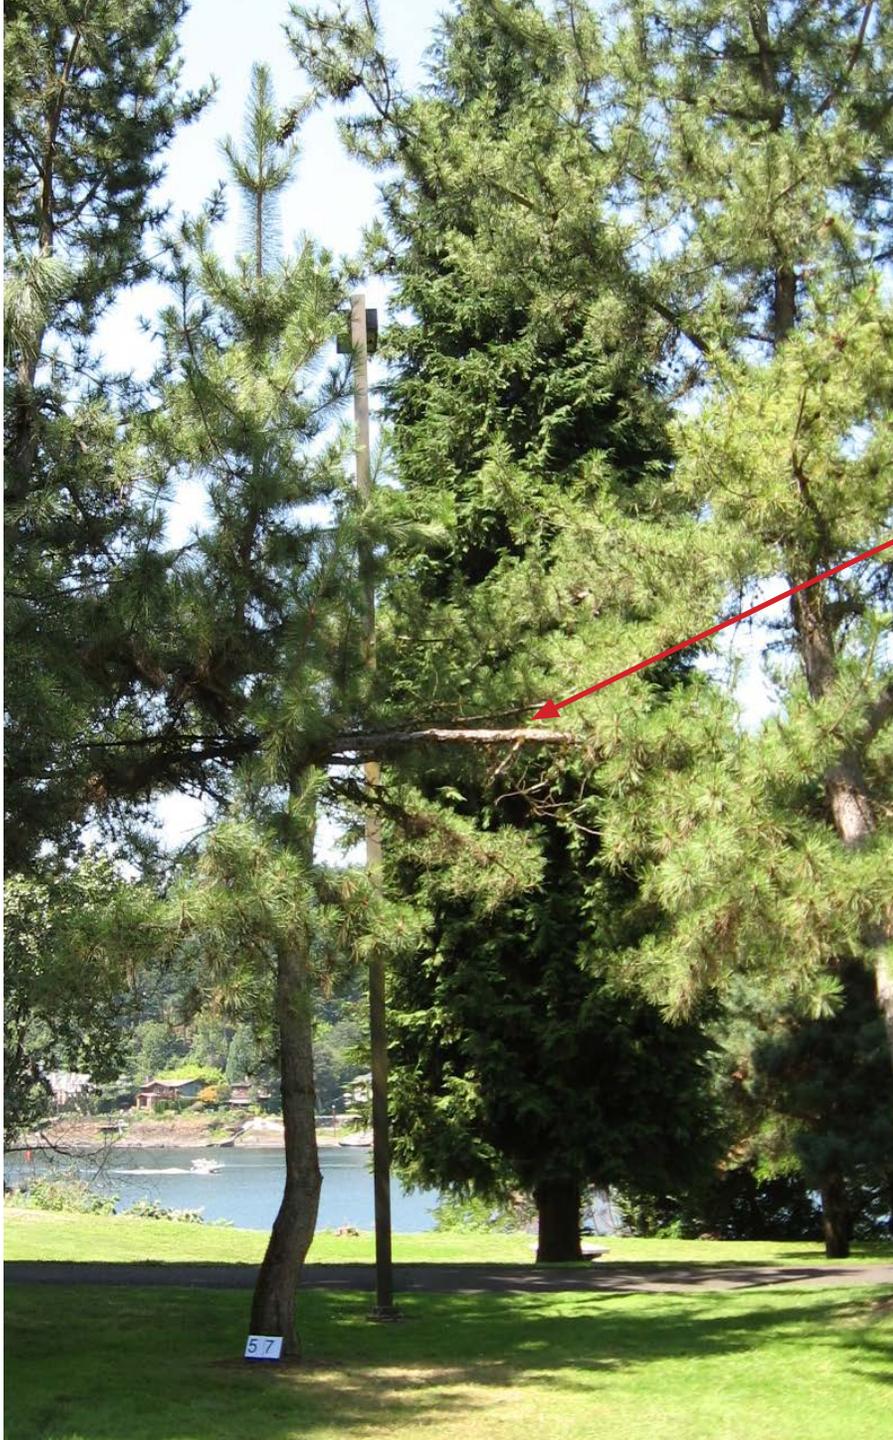
Tree #57 - Top has broken out of this pine and new leader is producing very unbalanced tree. Arrow below points to branch supporting new leader.

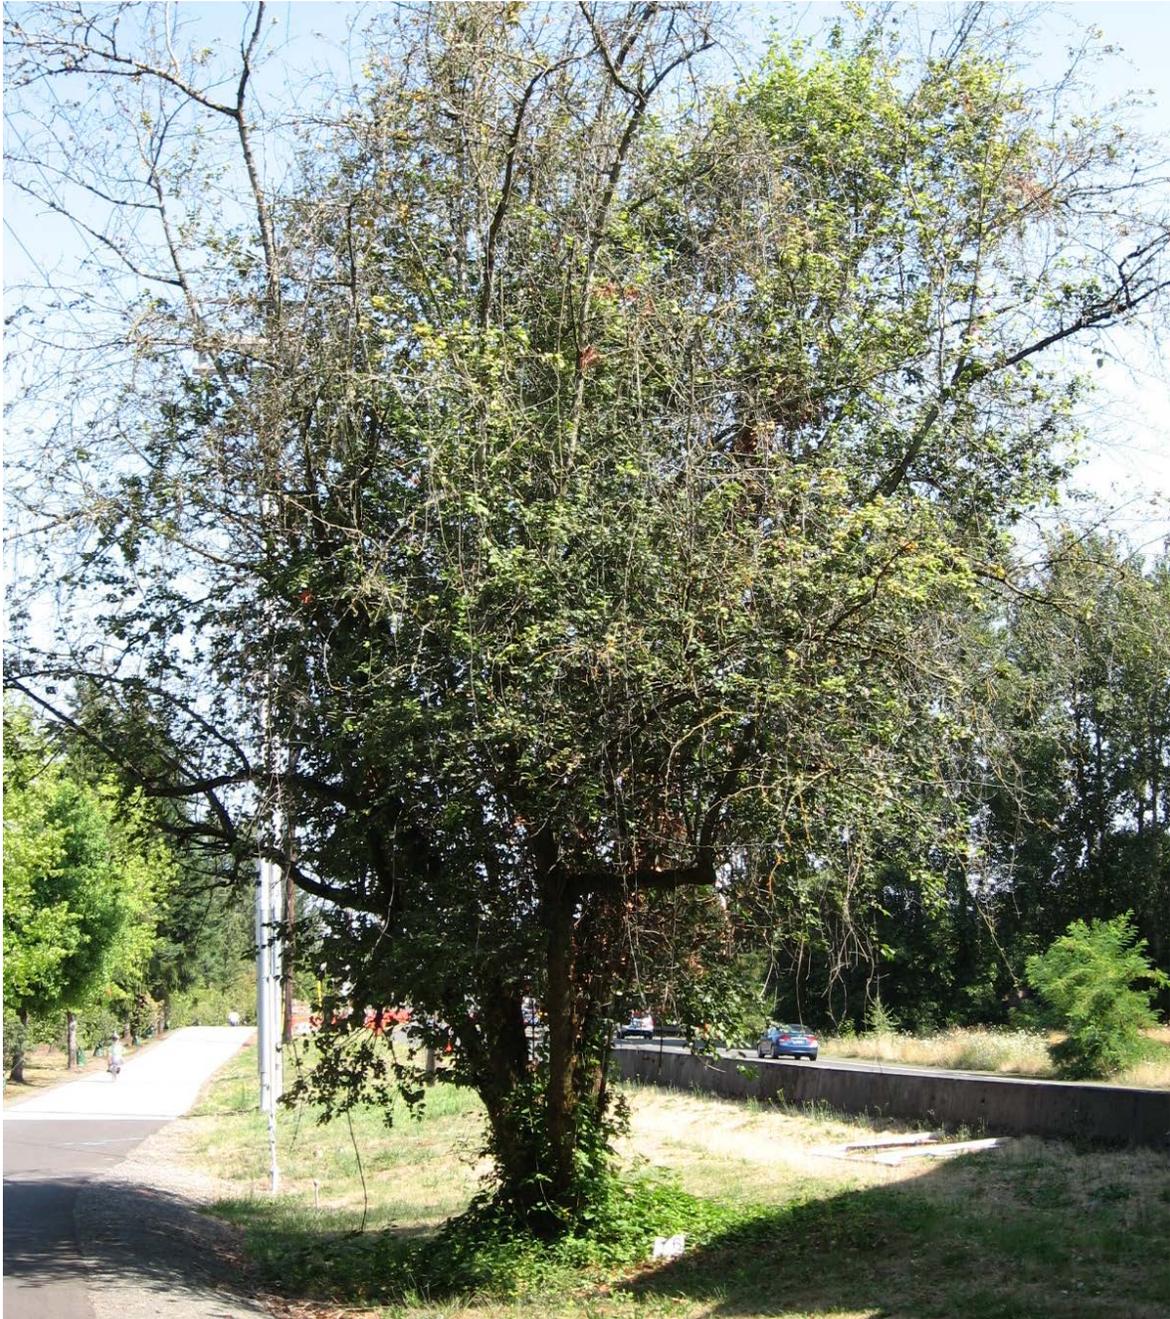
Tree #58- Sparse canopy; tree in decline.
