**Re: Riverfront Park Bridge Foundation Design**  
11211 SE McLoughlin Blvd.  
Milwaukie, Oregon  
154-038-004

Hart Crowser is pleased to present our geotechnical engineering recommendations for the Riverfront Park Bridge replacement in Milwaukie, Oregon. Hart Crowser was contracted by the City of Milwaukie (City) to evaluate mitigation alternatives for a bank failure at the bridge that occurred during recent storms. Based on the information gathered and the compromised condition of the existing bridge, we understand that the City has determined that the most cost effective solution is to replace the existing bridge. The bridge will be constructed using design-build construction techniques. The City has retained Hart Crowser to aid in preparation of preliminary foundation support recommendations for the new bridge. Our recommendations have been prepared in general accordance with our contract with the City (#C2106-011) dated March 7, 2016.

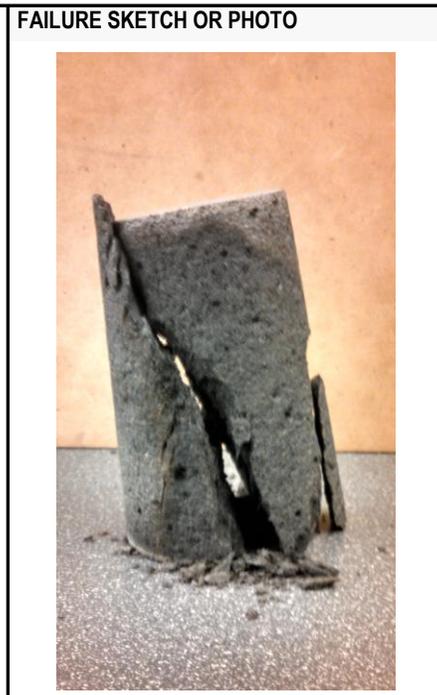
TEST DATA	SAMPLE DATA																								
<table style="width: 100%; border-collapse: collapse;"> <tr><td>unconfined compressive strength at peak (psi) =</td><td style="text-align: right;">13994.6</td></tr> <tr><td>compressive strength at failure (psi) =</td><td style="text-align: right;">13994.6</td></tr> <tr><td>time until failure (min) =</td><td style="text-align: right;">3.12</td></tr> <tr><td>average strain rate until failure (in/min) =</td><td style="text-align: right;">0.015</td></tr> <tr><td>vertical deformation at failure (in) =</td><td style="text-align: right;">0.048</td></tr> <tr><td>percent strain at failure =</td><td style="text-align: right;">0.943</td></tr> </table>	unconfined compressive strength at peak (psi) =	13994.6	compressive strength at failure (psi) =	13994.6	time until failure (min) =	3.12	average strain rate until failure (in/min) =	0.015	vertical deformation at failure (in) =	0.048	percent strain at failure =	0.943	<table style="width: 100%; border-collapse: collapse;"> <tr><td>sample mass (g) =</td><td style="text-align: right;">1019.4</td></tr> <tr><td>sample height (in) =</td><td style="text-align: right;">5.09</td></tr> <tr><td>sample diameter (in) =</td><td style="text-align: right;">2.40</td></tr> <tr><td>height-to-diameter ratio =</td><td style="text-align: right;">2.12</td></tr> <tr><td>initial dry density (pcf) =</td><td style="text-align: right;">162.7</td></tr> <tr><td>moisture content =</td><td style="text-align: right;">3.6%</td></tr> </table>	sample mass (g) =	1019.4	sample height (in) =	5.09	sample diameter (in) =	2.40	height-to-diameter ratio =	2.12	initial dry density (pcf) =	162.7	moisture content =	3.6%

**NOTES**  
 Specimen sampled by client representative and delivered to the Columbia West laboratory on March 22, 2016 for subsequent testing. Ends of the specimen were capped with sulfur mortar per ASTM C617 on March 22, 2016. Specimen was sealed in plastic wrap and stored in the temperature controlled laboratory until the time of test.

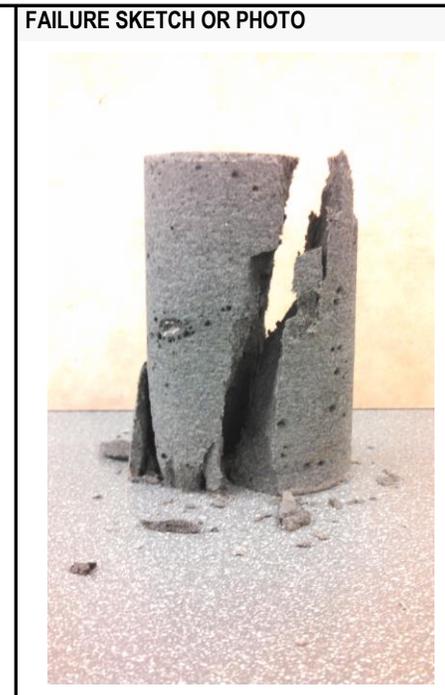
TEST DATA	SAMPLE DATA																								
<table style="width: 100%; border-collapse: collapse;"> <tr><td>unconfined compressive strength at peak (psi) =</td><td style="text-align: center;">13353.5</td></tr> <tr><td>compressive strength at failure (psi) =</td><td style="text-align: center;">13353.5</td></tr> <tr><td>time until failure (min) =</td><td style="text-align: center;">5.65</td></tr> <tr><td>average strain rate until failure (in/min) =</td><td style="text-align: center;">0.009</td></tr> <tr><td>vertical deformation at failure (in) =</td><td style="text-align: center;">0.049</td></tr> <tr><td>percent strain at failure =</td><td style="text-align: center;">0.959</td></tr> </table>	unconfined compressive strength at peak (psi) =	13353.5	compressive strength at failure (psi) =	13353.5	time until failure (min) =	5.65	average strain rate until failure (in/min) =	0.009	vertical deformation at failure (in) =	0.049	percent strain at failure =	0.959	<table style="width: 100%; border-collapse: collapse;"> <tr><td>sample mass (g) =</td><td style="text-align: center;">1032.3</td></tr> <tr><td>sample height (in) =</td><td style="text-align: center;">5.11</td></tr> <tr><td>sample diameter (in) =</td><td style="text-align: center;">2.40</td></tr> <tr><td>height-to-diameter ratio =</td><td style="text-align: center;">2.13</td></tr> <tr><td>initial dry density (pcf) =</td><td style="text-align: center;">164.1</td></tr> <tr><td>moisture content =</td><td style="text-align: center;">3.6%</td></tr> </table>	sample mass (g) =	1032.3	sample height (in) =	5.11	sample diameter (in) =	2.40	height-to-diameter ratio =	2.13	initial dry density (pcf) =	164.1	moisture content =	3.6%

NOTES  
 Specimen sampled by client representative and delivered to the Columbia West laboratory on March 22, 2016 for subsequent testing. Ends of the specimen were capped with sulfur mortar per ASTM C617 on March 22, 2016. Specimen was sealed in plastic wrap and stored in the temperature controlled laboratory until the time of test.
