North Clackamas Park

North Side Master Plan

October 2009

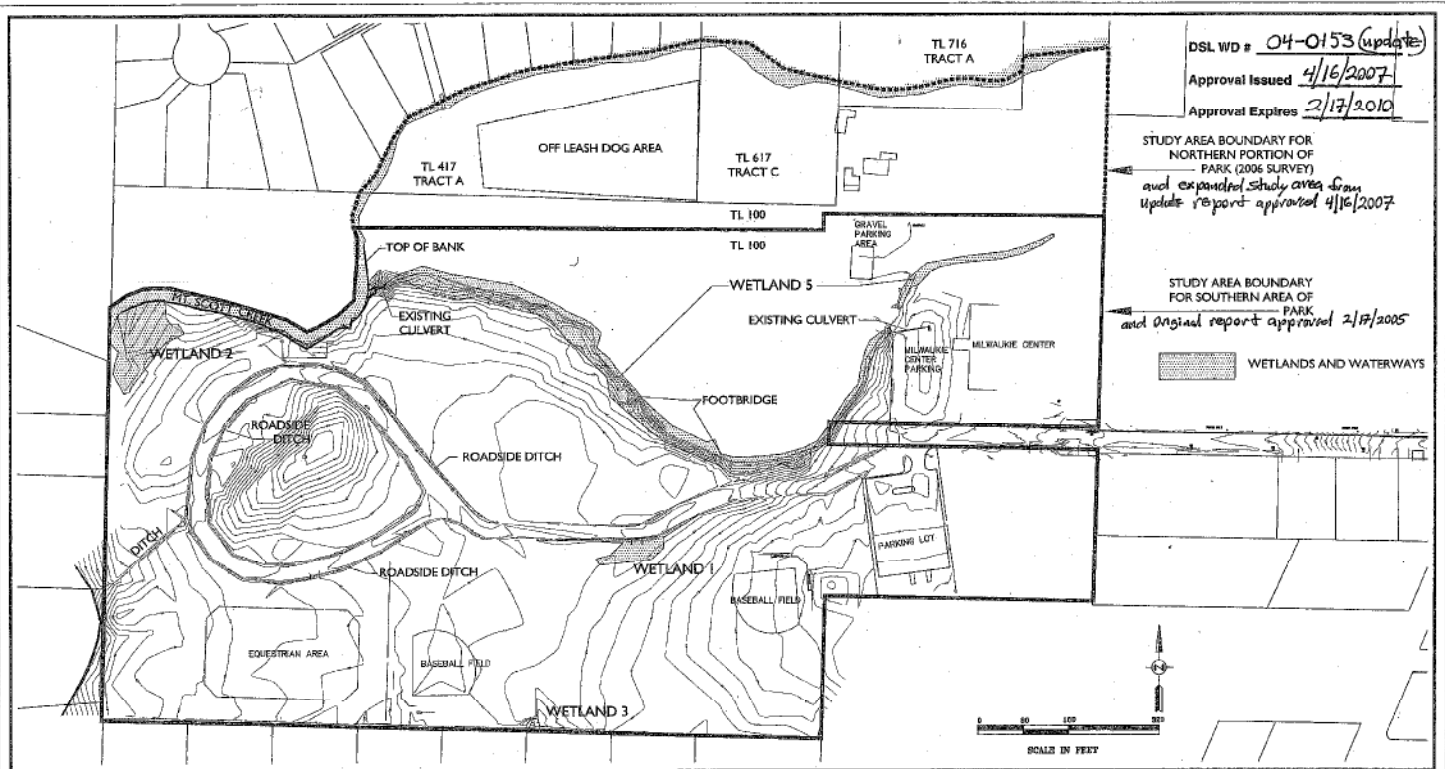
FIGURE
 6

DSL WD # 04-0153 (update)
 Approval Issued 4/16/2007
 Approval Expires 2/17/2010

STUDY AREA BOUNDARY FOR
 NORTHERN PORTION OF
 PARK (2006 SURVEY)
 and expanded study area from
 update report approved 4/16/2007

Figure 6 provides an overview of the two study area boundaries for the North Clackamas Park project. DSL approved the wetland/waterways in the southern half of the park in a February 17, 2005, concurrence letter. Figure 7 depicts the surveyed site conditions in the northern portion of the park.

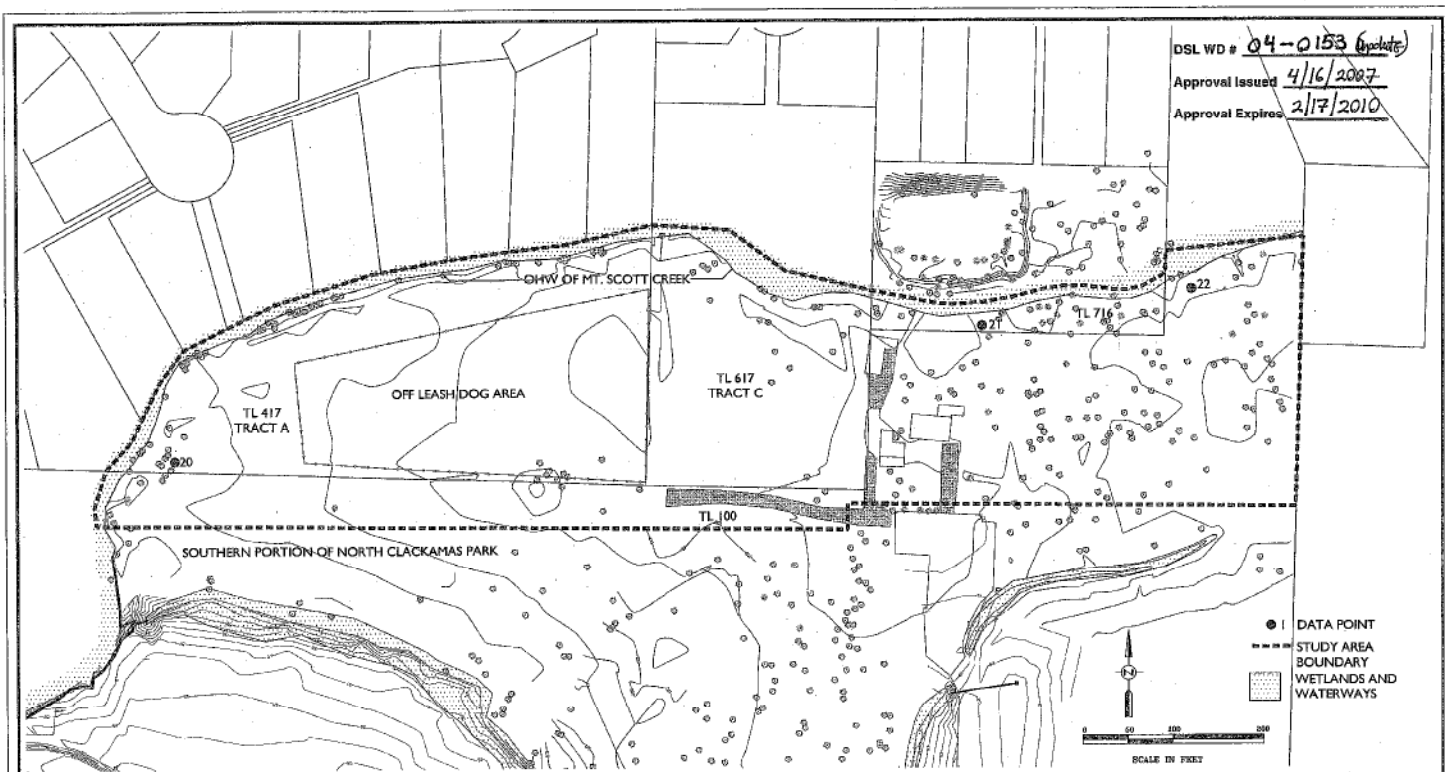
Survey of waterway boundaries for the northern portion of North Clackamas Park in Clackamas, Oregon. Map accuracy is +/- 1 foot.

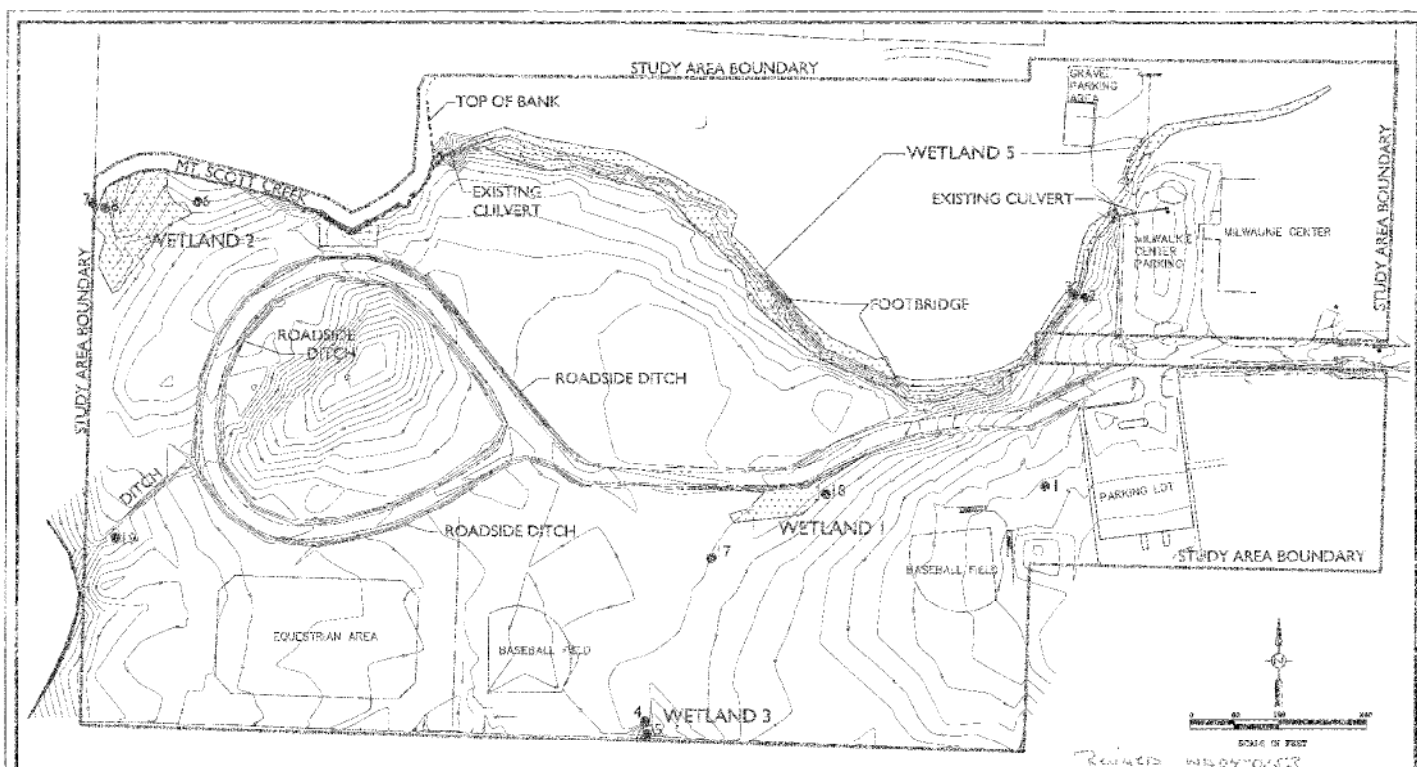
Revised location of wetlands and waterways at North Clackamas Park in Clackamas, Oregon. Survey provided by Clackamas County. Map accuracy for wetland and waterway boundaries is ± 0.01 foot. Data plot location estimated by pacing from the wetland boundary in the field. Map accuracy for data plots is ± 5 feet.

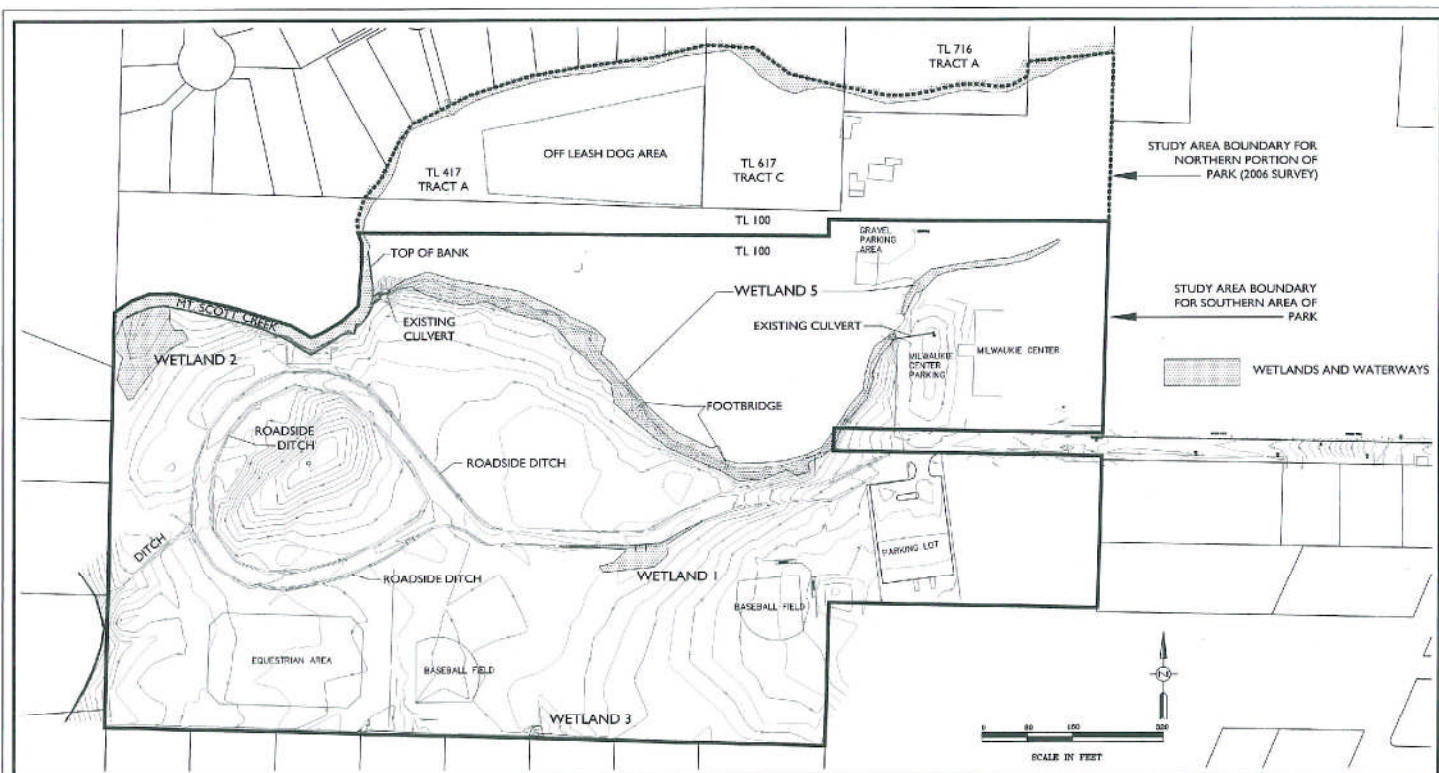
FIGURE
6

Overview of the study area boundaries and the wetland and waterway boundaries at North Clackamas Park in Clackamas, Oregon. Survey of southern portion provided by Clackamas County. Survey for the northern portion provided by Compass Engineering. Map accuracy is ± 1 foot.

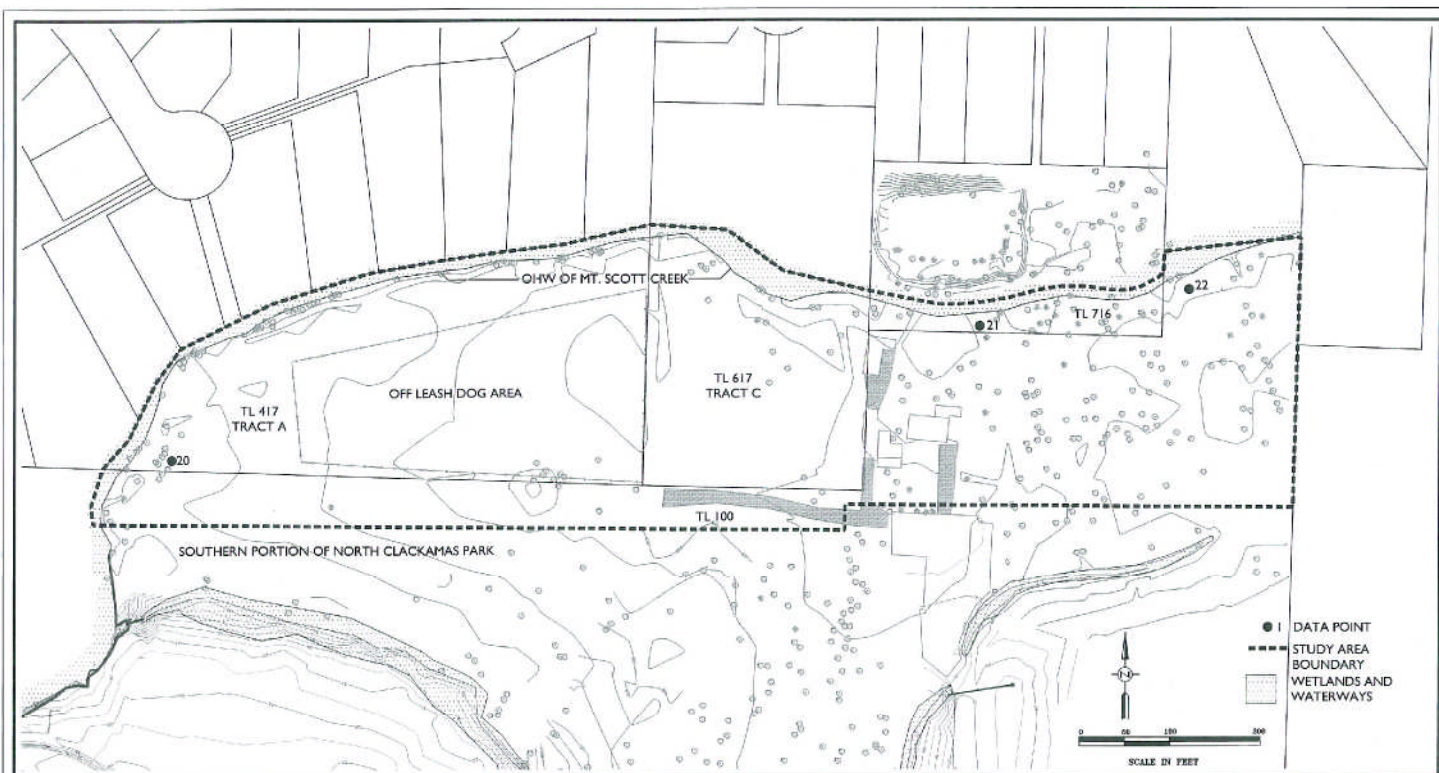
Survey of waterway boundaries for the northern portion of North Clackamas Park in Clackamas, Oregon. Map accuracy is ± 1 foot.
