date March 18, 2019
to Vera Kolias, AICP
from Sarah Hartung, Senior Biologist
subject Natural Resource Review for Elk Rock Estates

This memorandum summarizes ESA's technical review of land use application materials relating to site natural resources regulated by Milwaukie's Municipal Code, including Habitat Conservation Areas (HCAs) and Water Quality Resources (WQRs). Responses to specific technical review tasks are identified in *italics*.

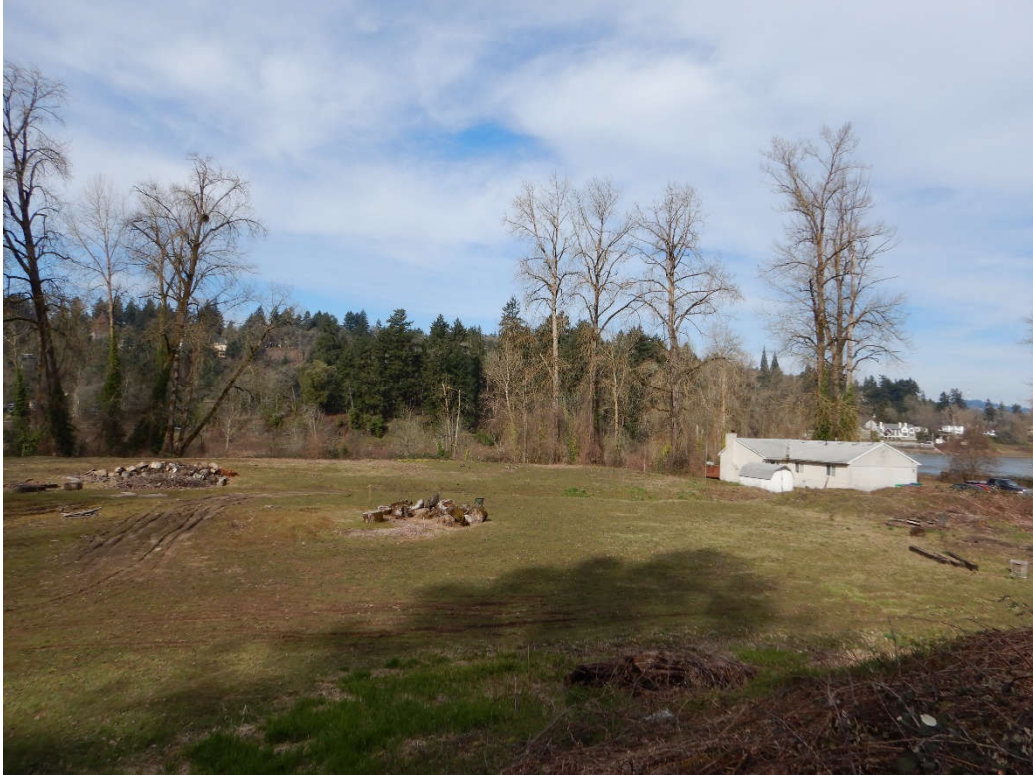
Response: ESA personnel (Sarah Hartung) visited the project site on March 16, 2019 to confirm the description of existing site conditions in the application. Existing conditions are generally as described in the application. The site consists of an open field with two single-family residences along SE 19th Avenue. Several tire ruts and a few piles of firewood and debris were noted in the open field. The field consisted of newly emerged grasses and forbs with a few patches of nuisance weeds such as lesser celandine. Himalayan blackberry has formed a dense thicket on the steep slope (greater than 25%) adjacent to the slough. Mature black cottonwood trees are growing along the southern and western boundaries of the site, although it's not clear if these trees are rooted within the subject property boundaries. Canada geese were observed foraging in the field.

Photo 1: Looking west at the subject property which includes an open field with grasses and forbs as well as debris piles. A handful of black cottonwood trees are growing along the western boundary – although it’s not clear if these should be included on the site plans. March 16, 2019.

Response: The inventory of existing vegetation looks reasonably accurate, although it's not clear if more black cottonwood trees should be shown on the map within the subject properties. Only 2 trees are mapped at the northwest end on the landscaping plan Sheet L1. The application concludes that the study area is "degraded" based on the low cover of shrubs and trees and the high percentage of weeds in the groundcover. This characterization is assumed to meet the Class C "Poor" category per Table 19. 402.11.C. The application does not provide a detailed discussion of ecological functions of riparian habitat.

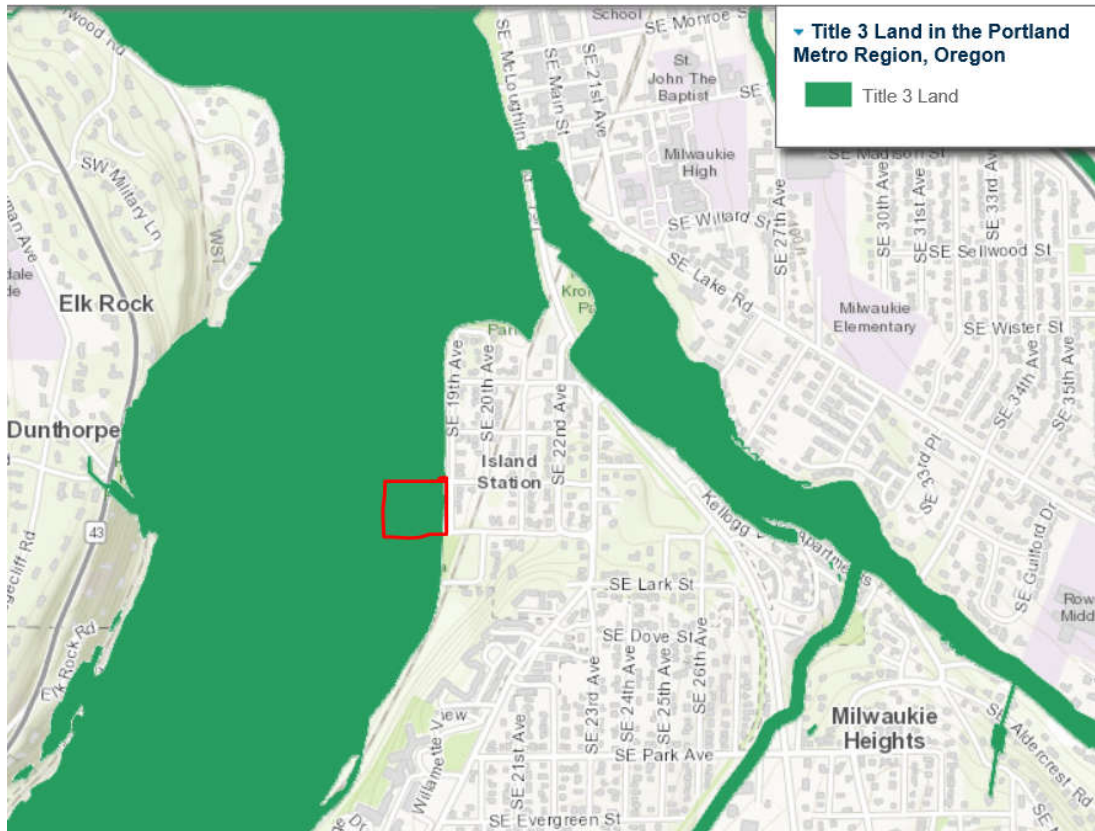
The application states that Wetlands A and B are secondary protected features, but then correctly identifies a 50-foot buffer that overlaps with the study area. The off-site wetlands (A and B) are primary protected features with 50-foot buffers because they occur within Title 3 Land as mapped by Metro – see snippet below. The project site is approximated in red – west of SE 19th Ave and within Metro’s Title 3 Lands: <https://databasin.org/maps/new#datasets=88691cc47cbd4992838864c29dbb147f>

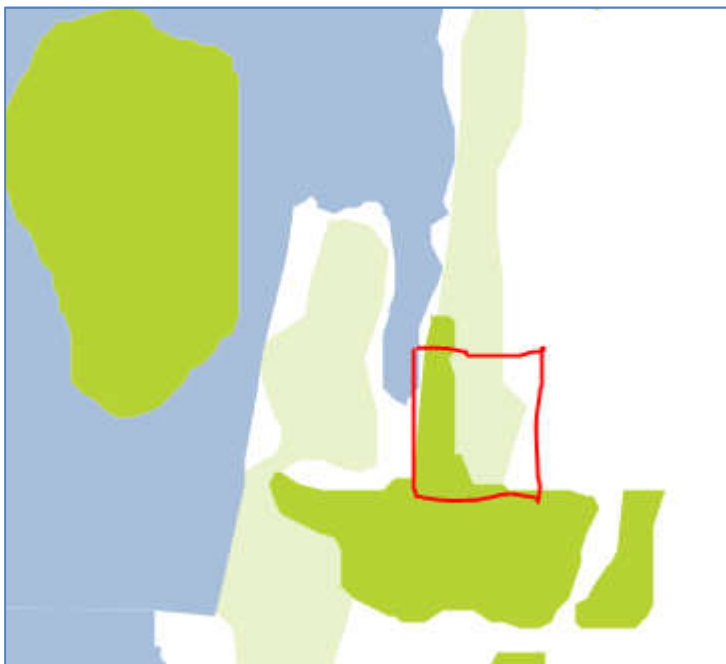
The application is missing the following mapped data as part of the HCA verification: All flood areas within 100 feet of the property; and vegetative cover status as identified on Metro's Vegetative Cover Map (see <https://gis.oregonmetro.gov/metromap/> - or ESA can send the pdf version). The site qualifies as Class I Riparian Area. Class I Riparian Areas remain as mapped regardless of development value [Table 19.402.15.A.2.b(2)(c)].

Metro's vegetative cover map identifies shrub/scrub (light green shading) as well as forested cover (medium green shading) on the site which is approximated by the red polygon below. Even if the vegetative cover were to be downgraded to Class II, the HCA mapping would still hold up regardless of the development value.

- The HCA verification is missing the analysis of flood areas and vegetative cover status per Metro mapping. The HCA mapping as drawn appears warranted, therefore the applicant should reassess impacts and mitigation to HCA/WQRs.
- Include the walkway, benches and dock construction in the impact analysis.
- Provide an alternatives analysis that meets code requirements.
- For updated mitigation plans, please clearly identify the type, quantity and condition of native plants proposed in regulated WQRs and HCAs per city code. The development layout on Sheet L1 should match the site plan.
- Provide a more detailed assessment of water quality, flood storage, and habitat functions for the site, including the slough where a dock is proposed as part of the project, in order to assess impacts to ecological functions and whether mitigation addresses the loss or modification of these functions.

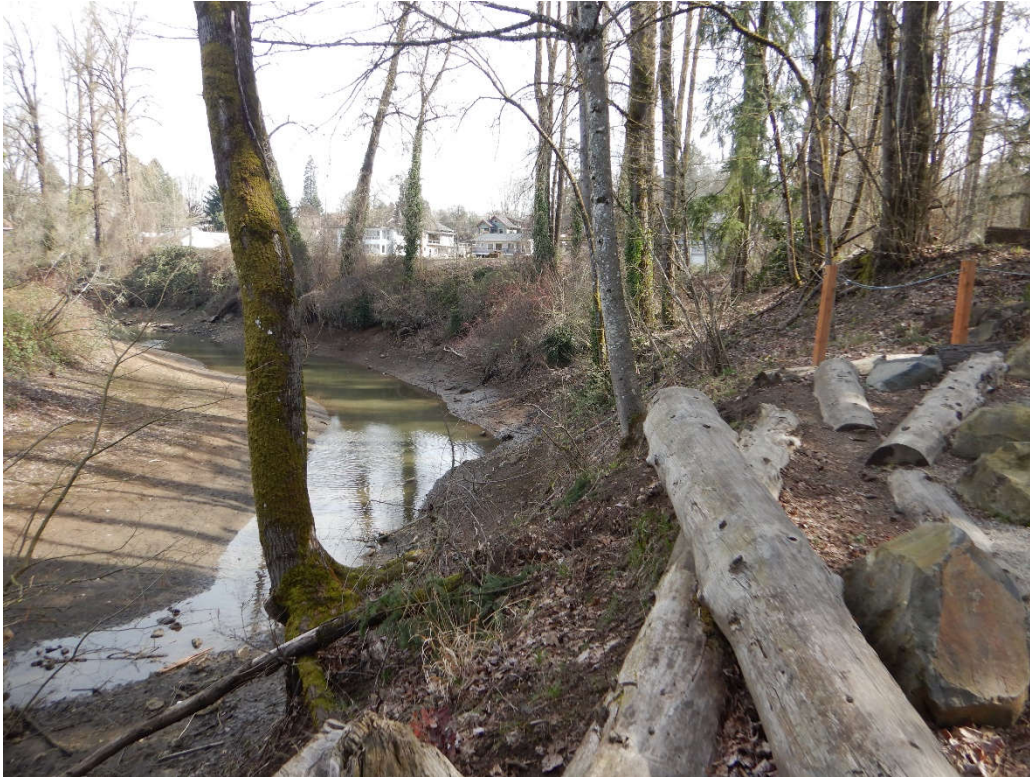
The applicant provides a feasibility discussion of removing the Himalayan blackberry from the steep slope along the slough and concludes that the "do nothing" approach is the best option. Depending on how the HCA mapping resolves, this area may be needed for mitigation or the area across the slough that is in the same ownership. The steep slopes just south of the study area in the public park have been successfully cleared of Himalayan blackberry and replanted with native shrubs. This may be an example of how it is possible to remove nuisance plants from a steep slope while maintaining bank stability.

Photo 2: In Spring Park looking at restored, steep banks that are similar in slope to the subject property (visible in the upper left). March 16, 2019.
