HCA MITIGATION PROPOSAL AND ALTERNATIVES ANALYSIS
FOR ELK ROCK ESTATES
City of Milwaukie ID #: 18-004PA

MITIGATION PROPOSAL AND ALTERNATIVE ANALYSIS

For Elk Rock Estates

City of Milwaukie ID #: 18-004PA

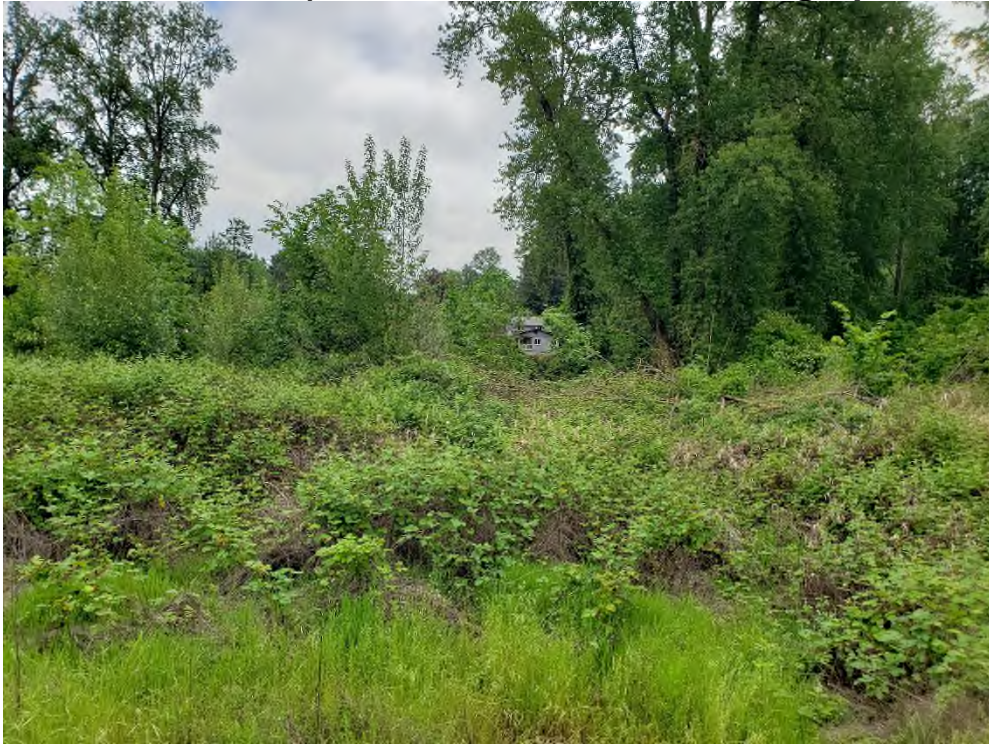
Photo 1: Looking east into Mitigation Area 1, from the south. Part of the blackberry patch is evident in the photo along with some native Black Cottonwood and Ash

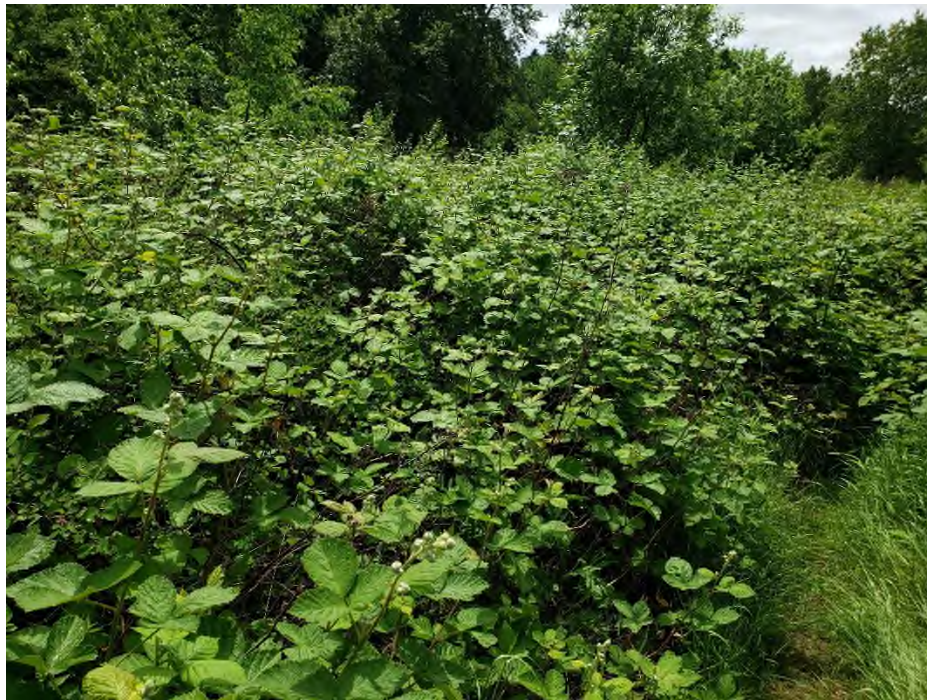
Photo 2: Looking directly into the dense blackberries in Mitigation Area 1.

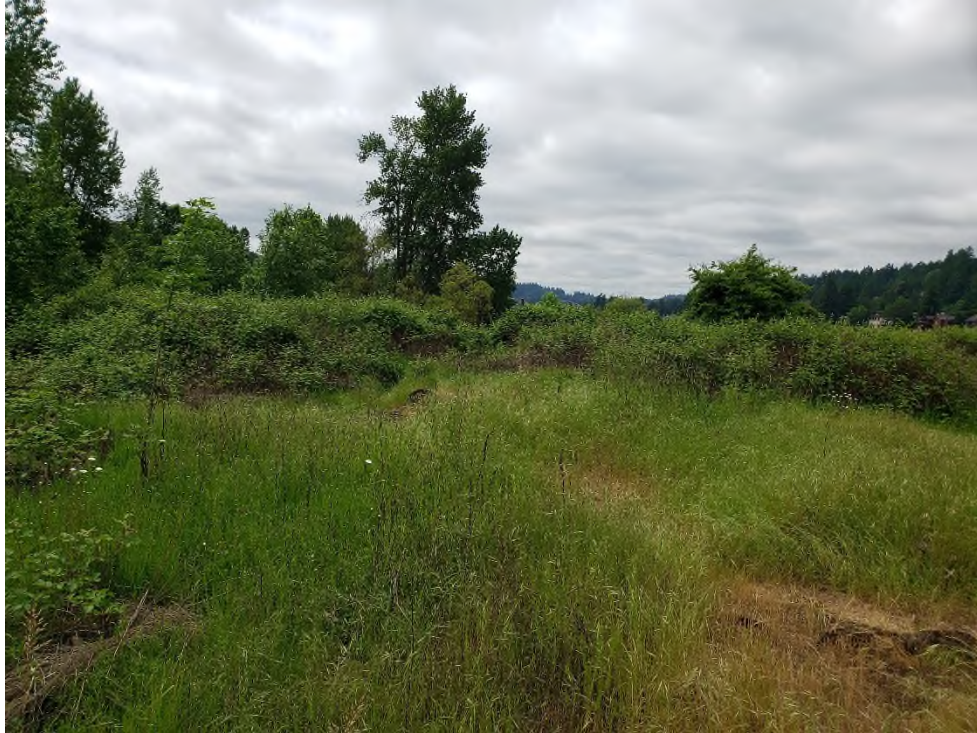
Photo 3: Looking south into Mitigation Area 1 (on the left) and Mitigation Area 2 (on right) with the wild grass in the middle.

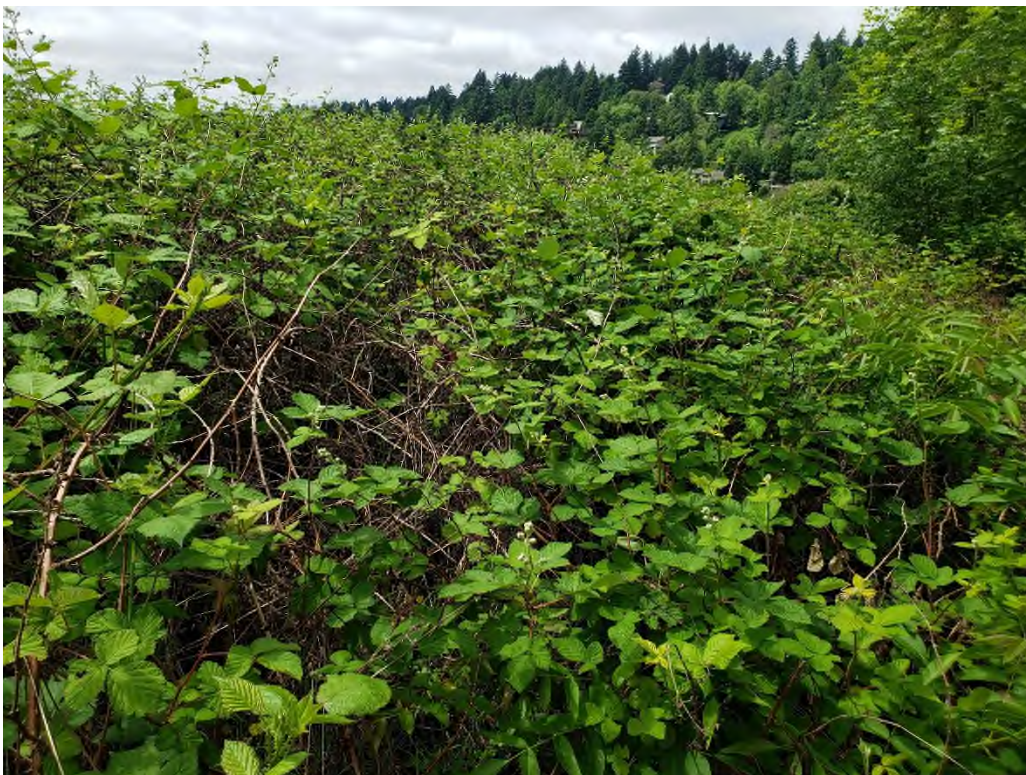
Photo 4: Dense blackberry patch in Mitigation Area 2, Tree of Heaven in upper right corner.

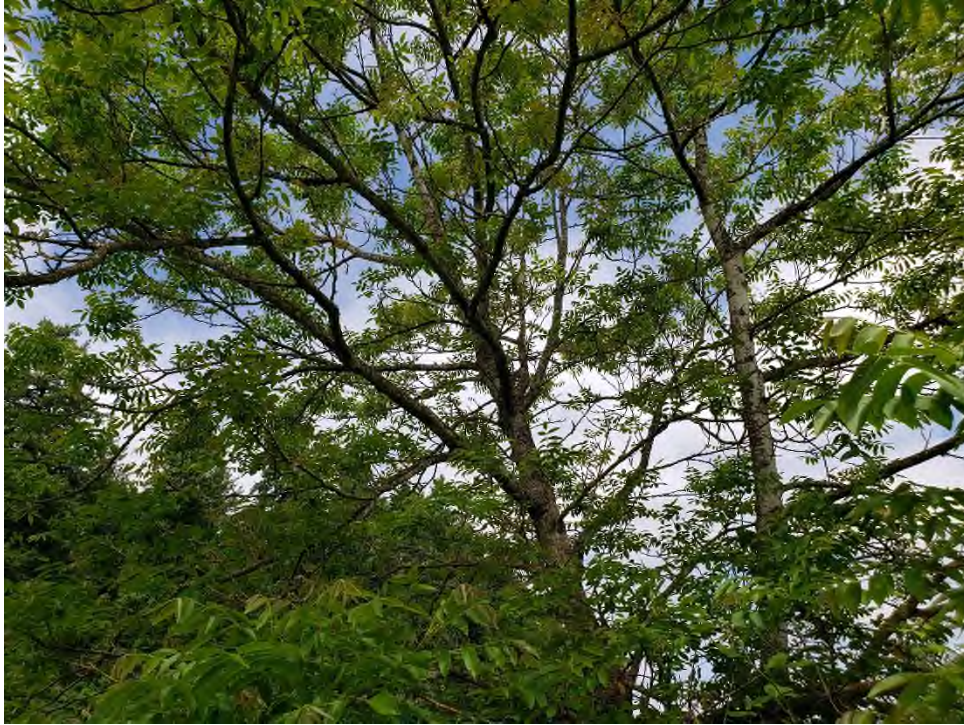
Photo 5: Tree of Heaven in Mitigation Area 1.

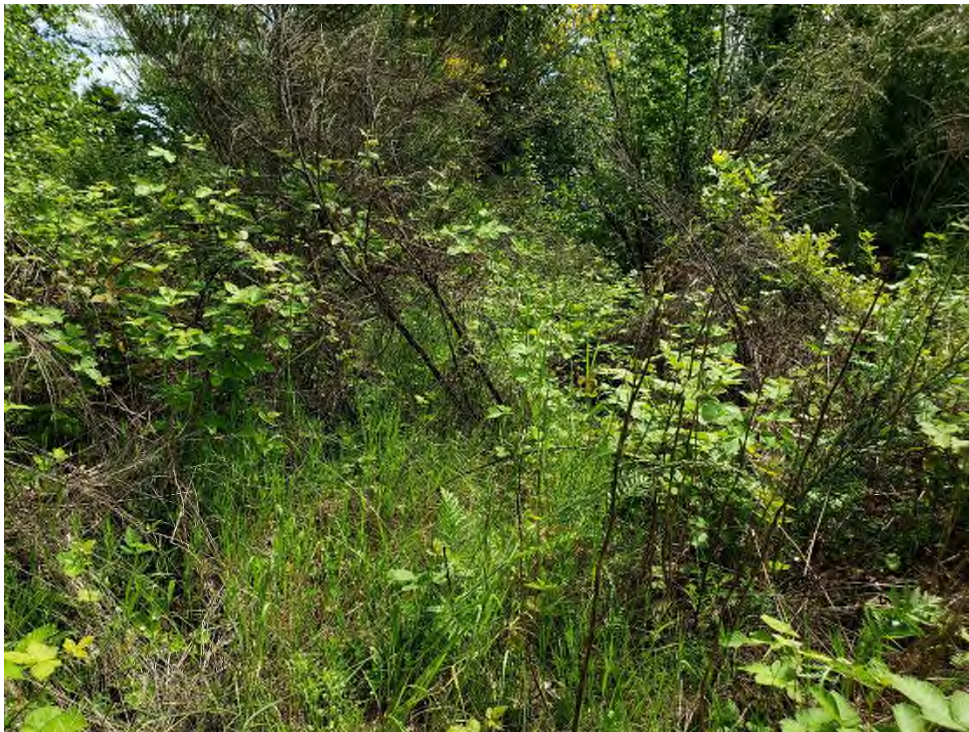
Photo 6: A picture of P8, which is in the northeast corner of the property, the most native vegetation that was observed besides the native grasses.

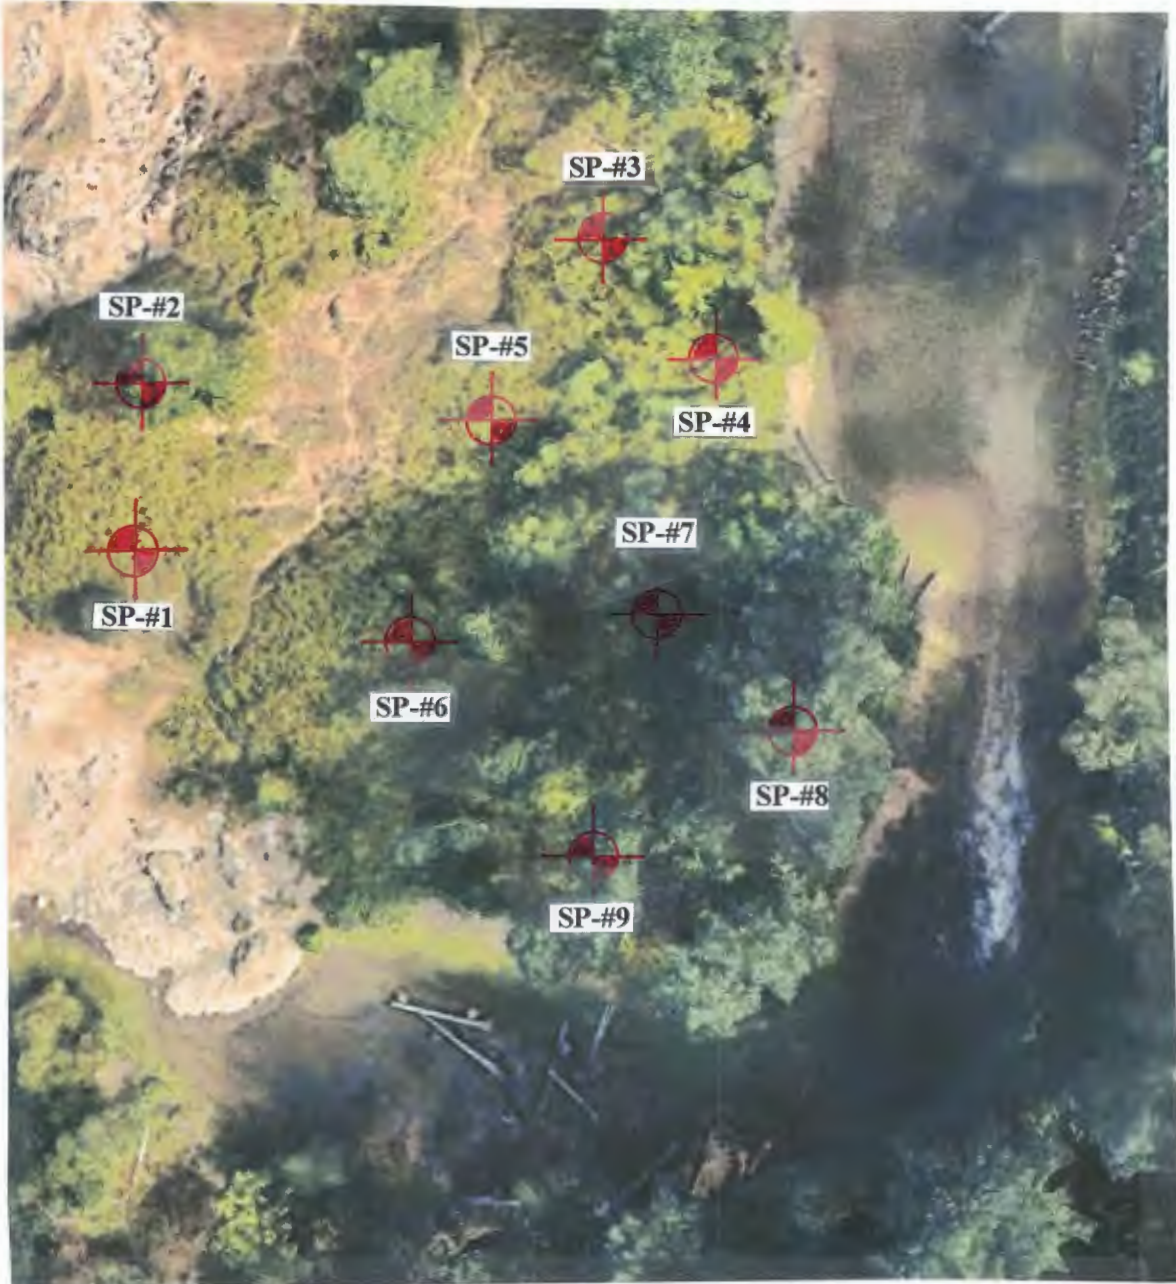
LEGEND

SP-#9 Indicates approximate location of soil probe
