Application for Land Use Action

Primary File #: **NR-2022-002**

WETLAND DELINEATION, HCA

City of Milwaukie Type II HCA Determination Report
Parcel Number 00098030 Tax Lot 12E31DA05500

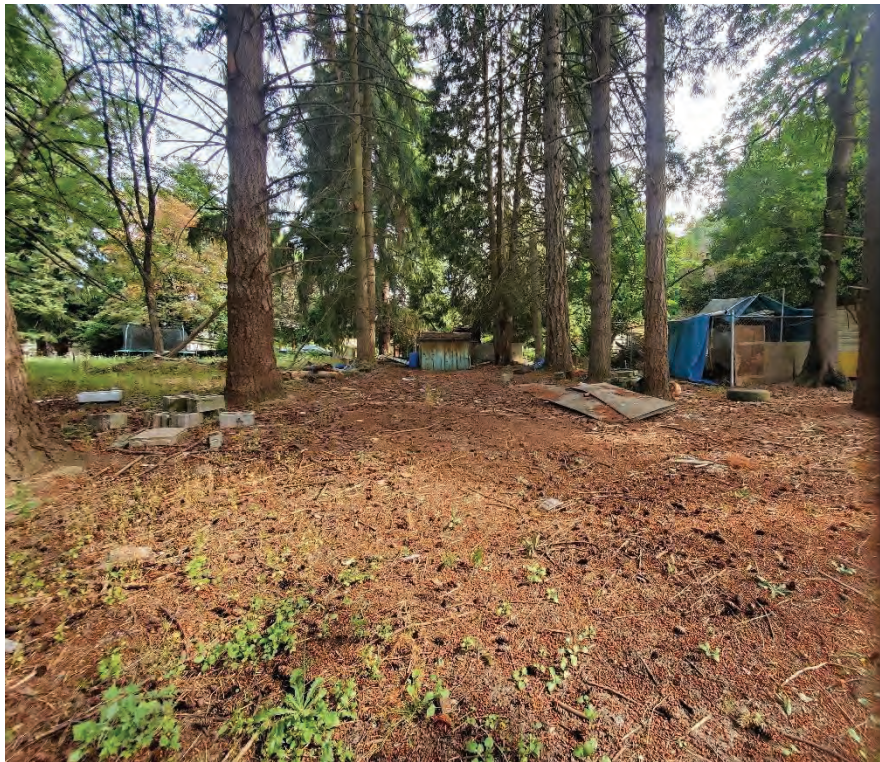
Cover Photo Looking across the property, evidence of past use as a back yard and vehicle storage. A circular trampoline in the clearing that is visible in recent aerial photographs. Owners have largely cleared brush from the property leaving the vegetation consisting of a number of mature trees and whatever herbaceous vegetation

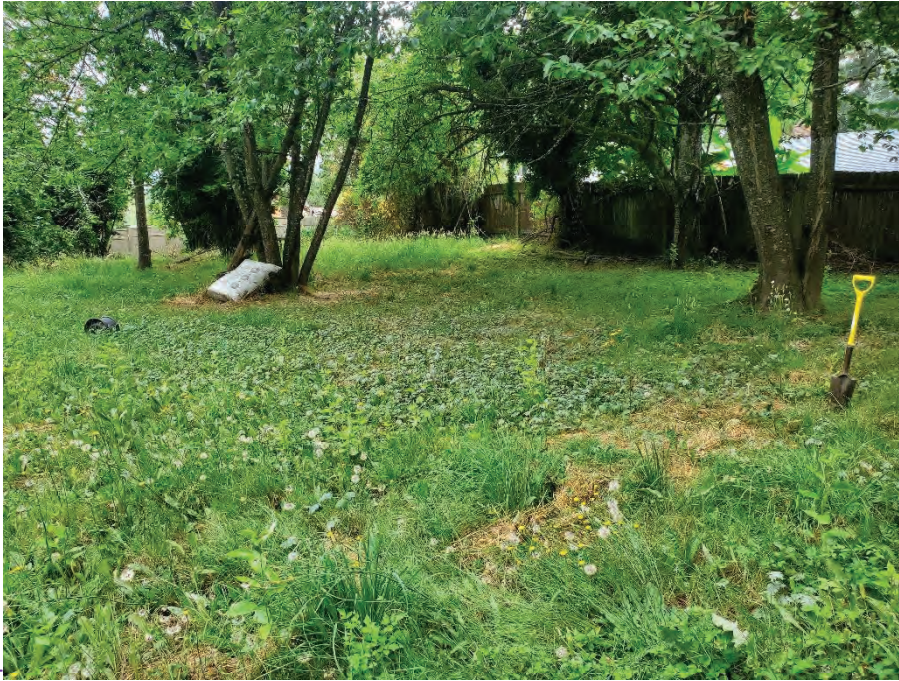
Photo 1. This is a photo of the *Ranunculus repens* patch and *Corylus cornuta*, this area did not meet the wetland criteria for vegetation, soils and hydrology . ETC Photo: 8/19/22

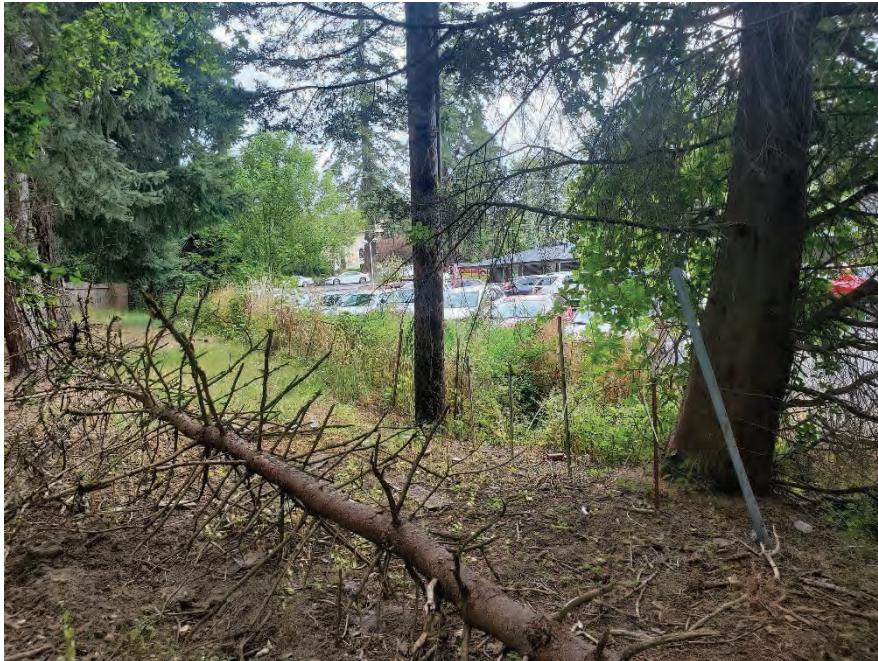
Photo 2. This photo is looking southeast at the stormwater drainage ditch offsite and adjoining property parking lot. ETC Photo: 8/19/2022

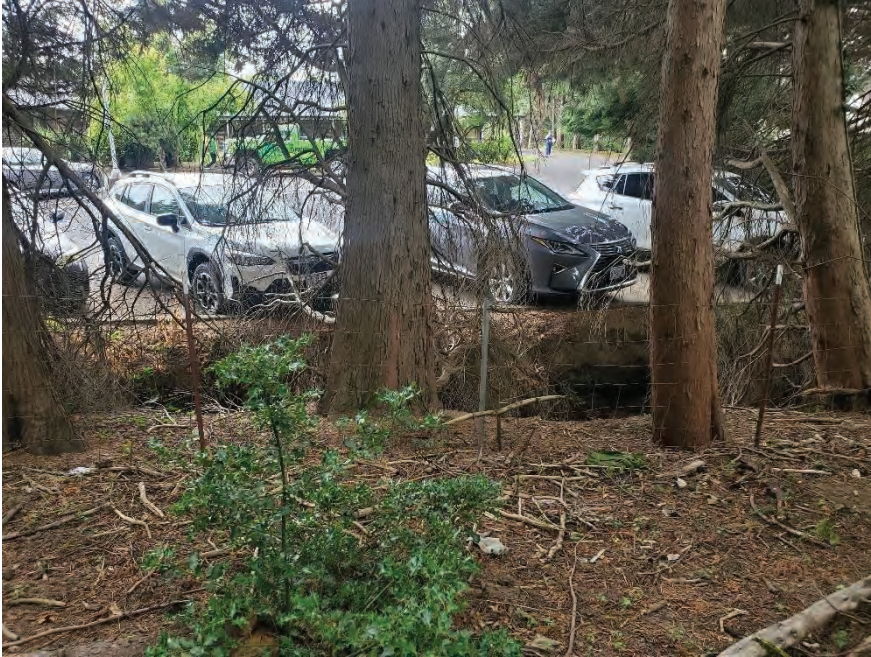
Photo 3. This photo is looking southeast at the stormwater drainage ditch offsite and the North parking lot of the Prestige Rehab Center. ETC Photo: 8/19/2022

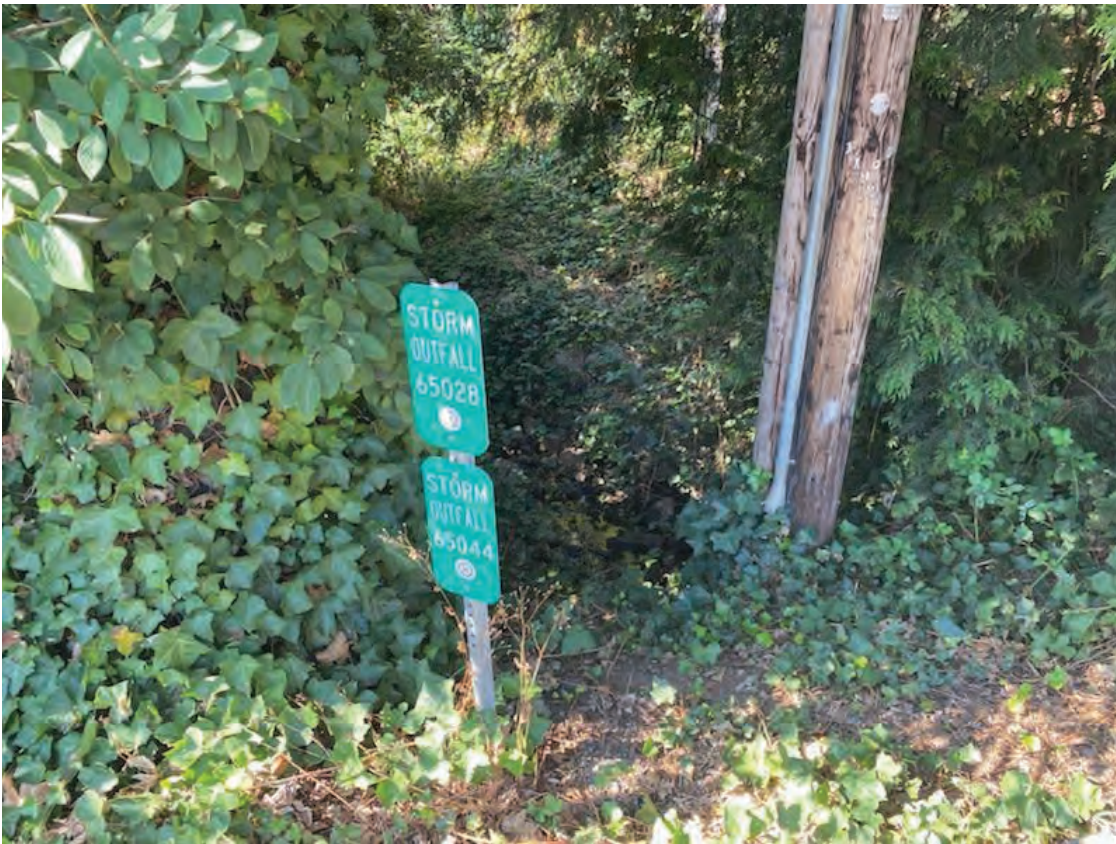
Photo 4 . Two stormwater outfalls bring offsite stormwater to the ditch on the North end of the Prestige Rehabilitation facility parking lot.

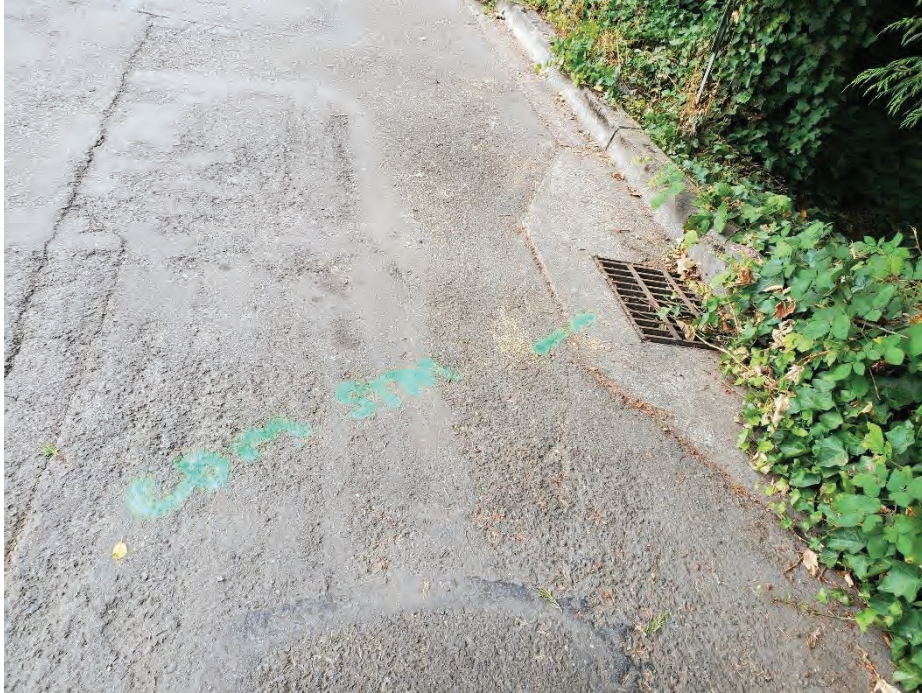
Photo 5 . Stormwater drain sends water to the stormwater ditch. The is one of two sources, the other is piped from the Lynwood Elementary School and possibly other more distant developments.

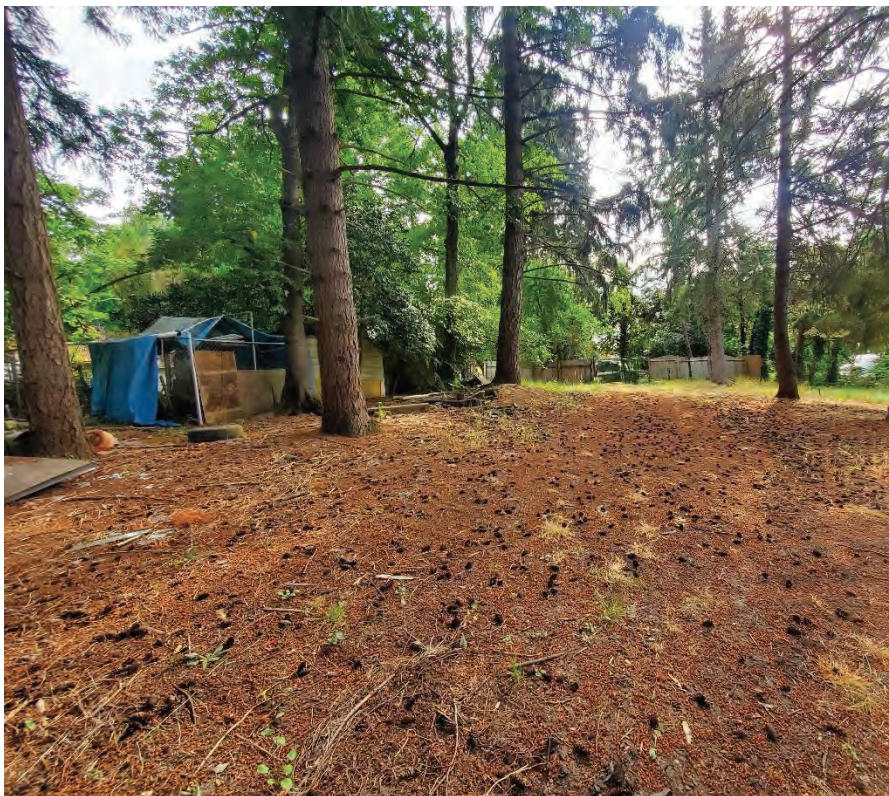
Photo 5 . A photo looking east at on the property. ETC Photo 8/19/2022

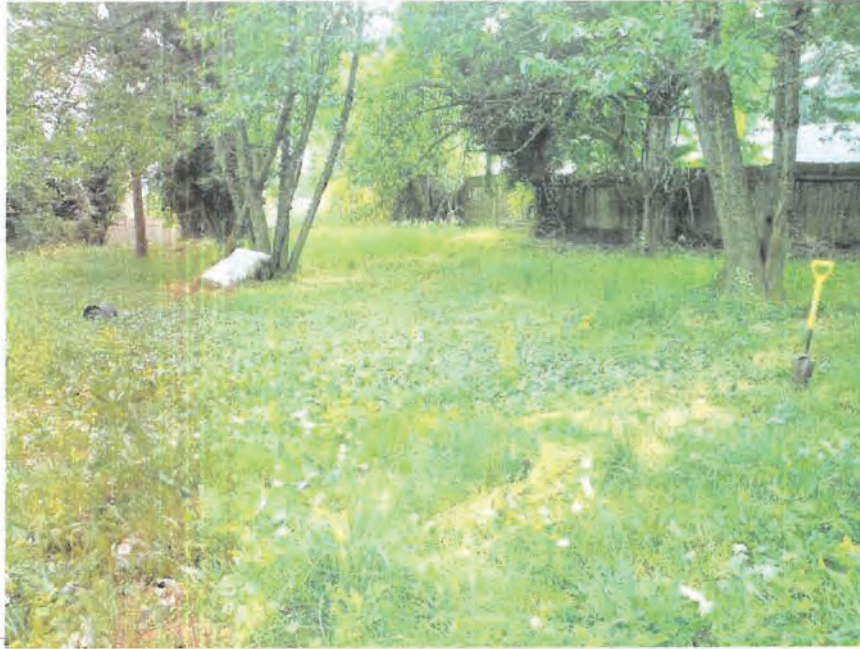
Photo 1. This is a photo of the *Ranunculus repens* patch and *Corylus cornuta* . ETC Photo: 8/19/22

Plants. The study area consisted primarily of grasses and weeds, *Taraxacum officinale*, *Cirsium arvense*, and a patch of *Ranunculus repens*. The *Ranunculus* patch was found along with *Corylus cornuta* and *Ilex sp.*

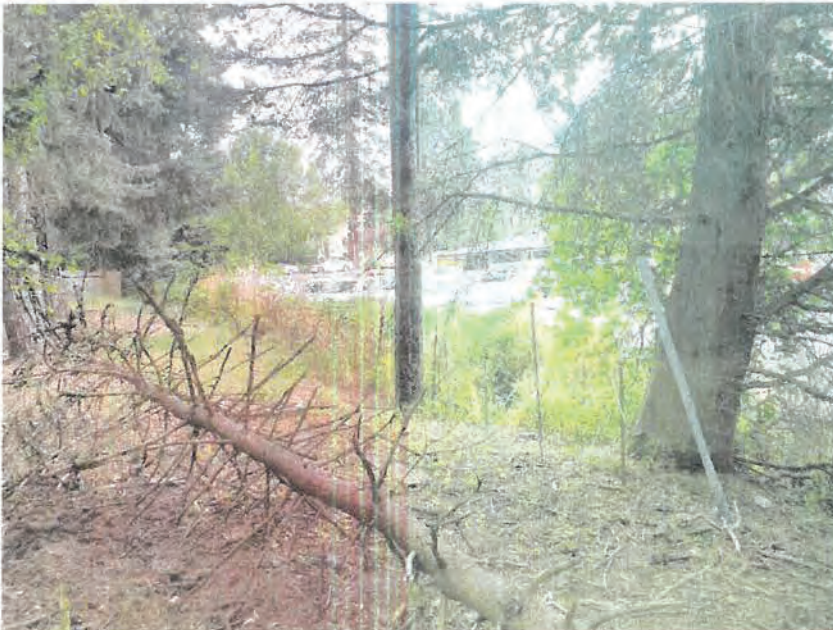
Photo 2. This photo is looking southeast at the stormwater drainage ditch offsite, ETC Photo: 8/19/2022

There were no wetlands or waters found on the subject property. There is a stormwater drainage ditch offsite to the south, approximately 10'.

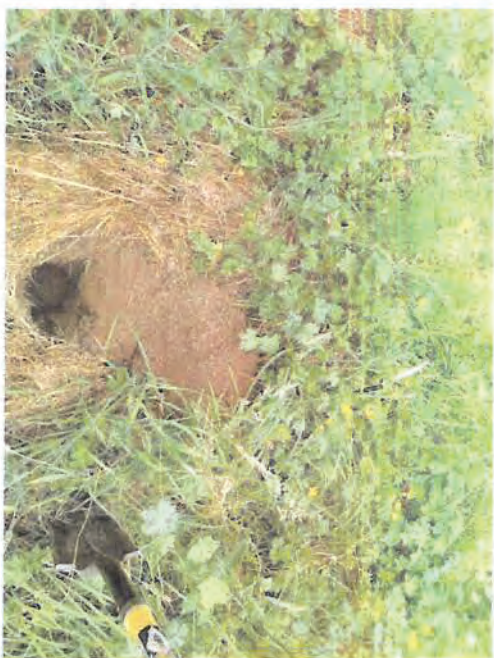
Photo 3. This is a photo of the color of the soil in the *Ranunculus* patch. ETC Photo: 8/19/2022
