Natural Resource Review
for the Proposed Kellogg Creek
Subdivision in Milwaukie, Oregon
(Township 2 South, Range 2 East, Section 6AD,
Clackamas County, TL 600 and Portions of 700, 900, 901)

Prepared by
Caroline Rim
Craig Tumer
John van Staveren
Pacific Habitat Services, Inc.
9450 SW Commerce Circle, Suite 180
Wilsonville, Oregon 97070
(503) 570-0800
(503) 570-0855 FAX
PHS Project Number: 5975

April 6, 2017

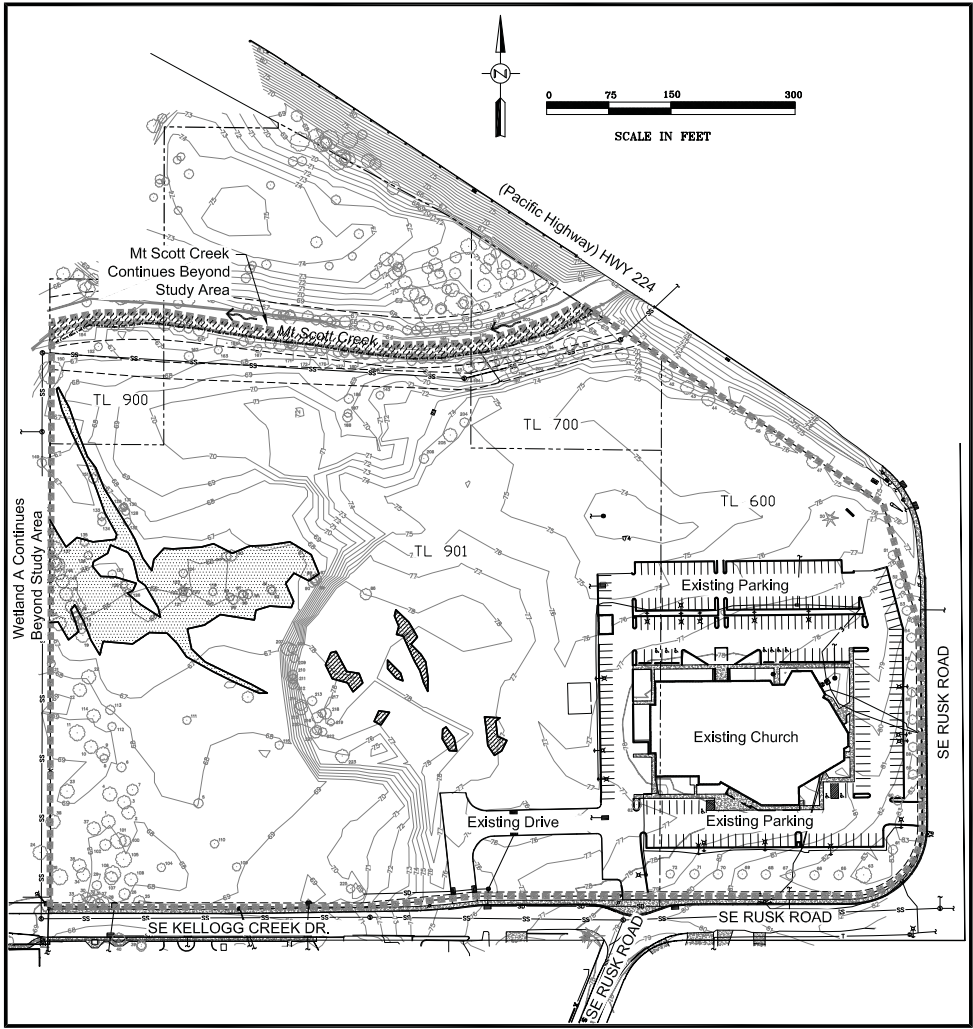
FIGURE
3

Existing Conditions
 Kellogg Creek Subdivision - Milwaukie, Oregon

On November 21, 2016, PHS identified and delineated one potential wetland area (Wetland A) and Mt. Scott Creek (south bank only), as well as six potentially artificially created wetland areas (Wetlands B through G). Descriptions of the on-site wetlands and non-wetland waters are provided below, and are further detailed in the Wetland Delineation Report (Attachment B). Figure 3 shows the existing site conditions.

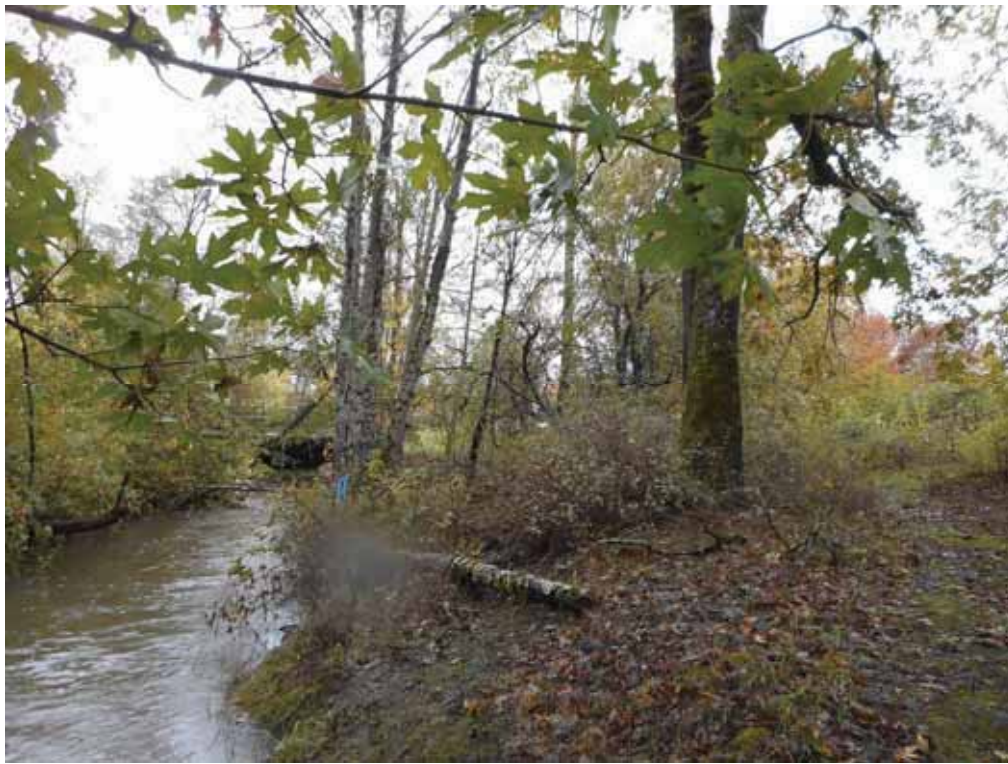
Photo A

Looking east along south bank of Mt. Scott Creek

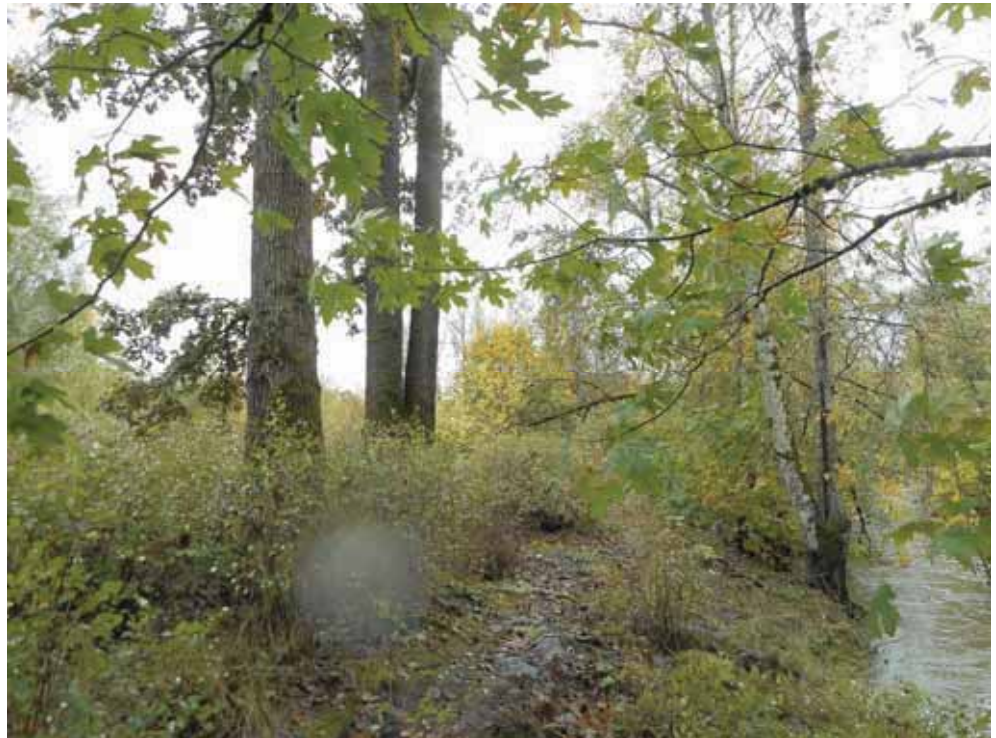
Photo B

Looking west along south bank of Mt. Scott Creek

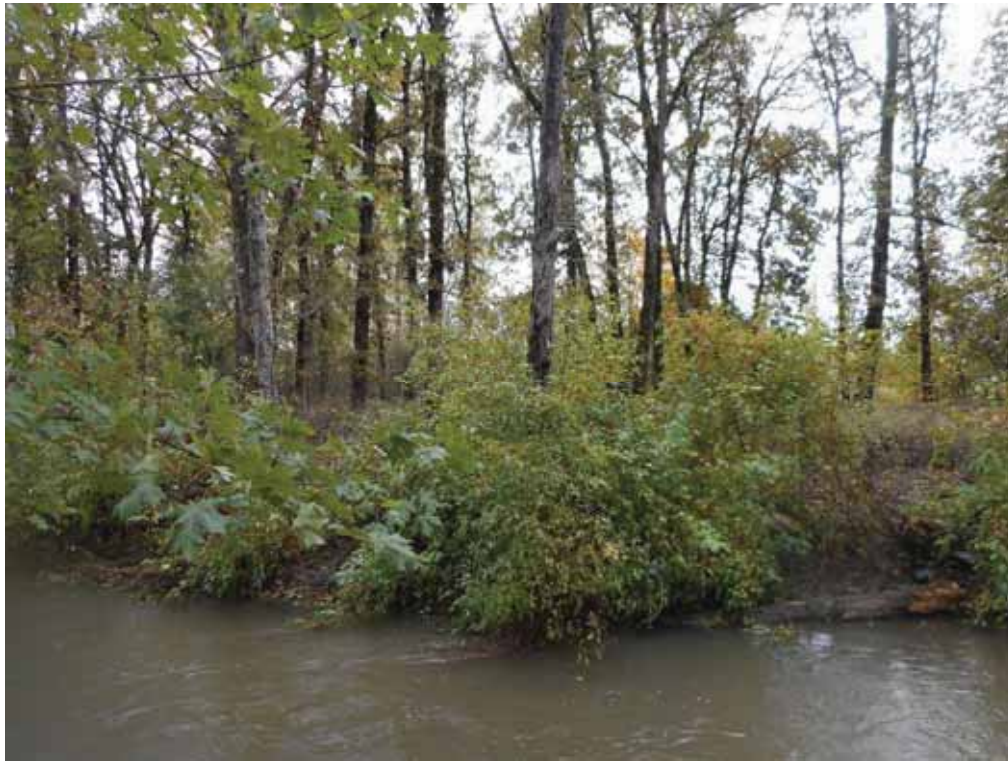
Photo C

Looking north across
Mt. Scott Creek

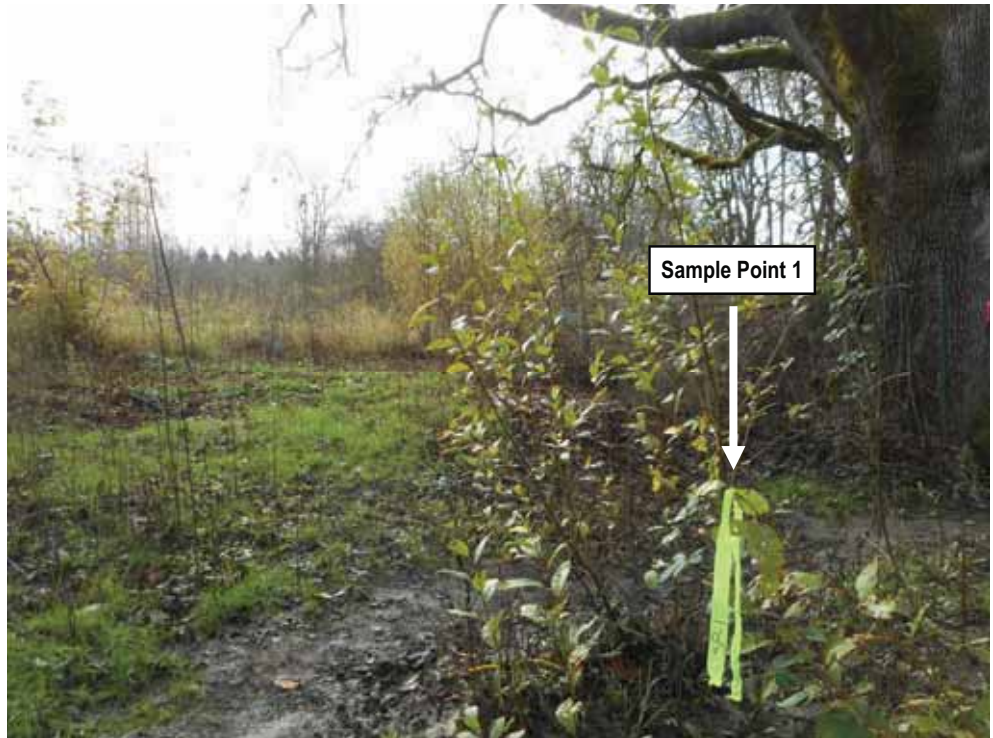
Photo D

Looking southeast toward
Wetland A

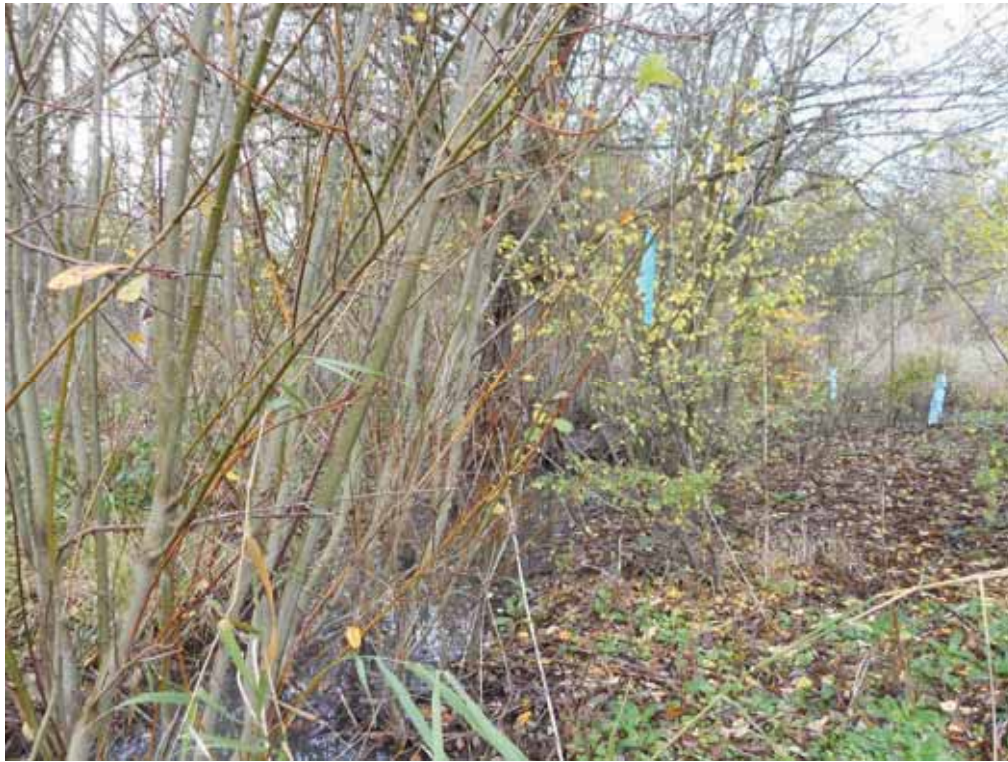
Photo E

Looking northwest
toward north end of
Wetland A

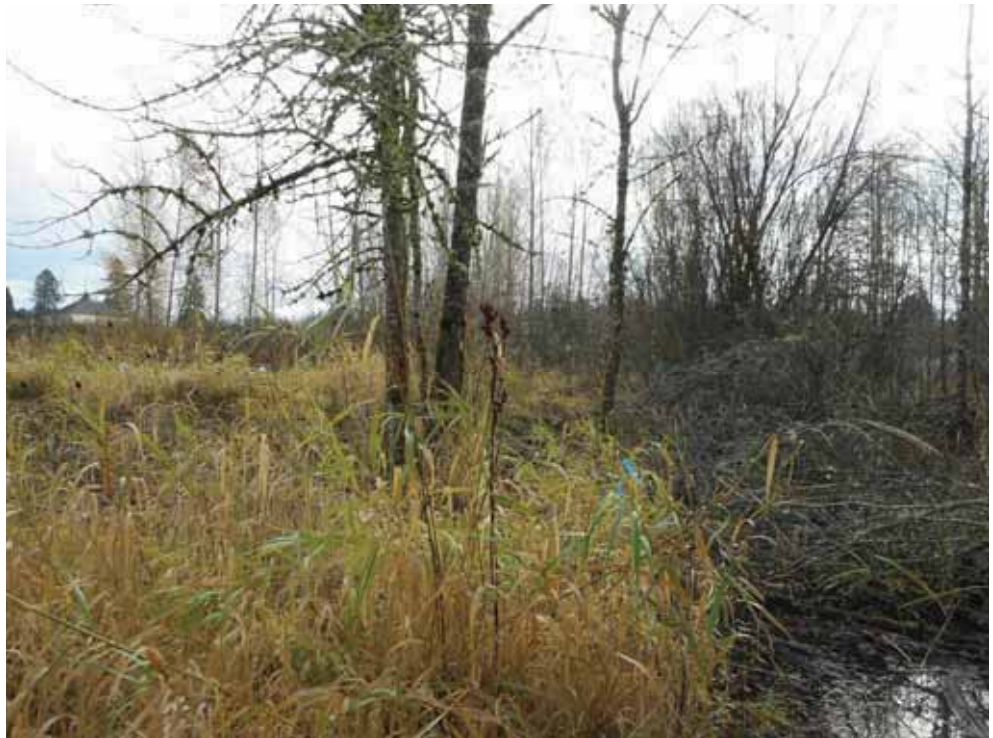
Photo F

Looking southeast toward center
of Wetland A

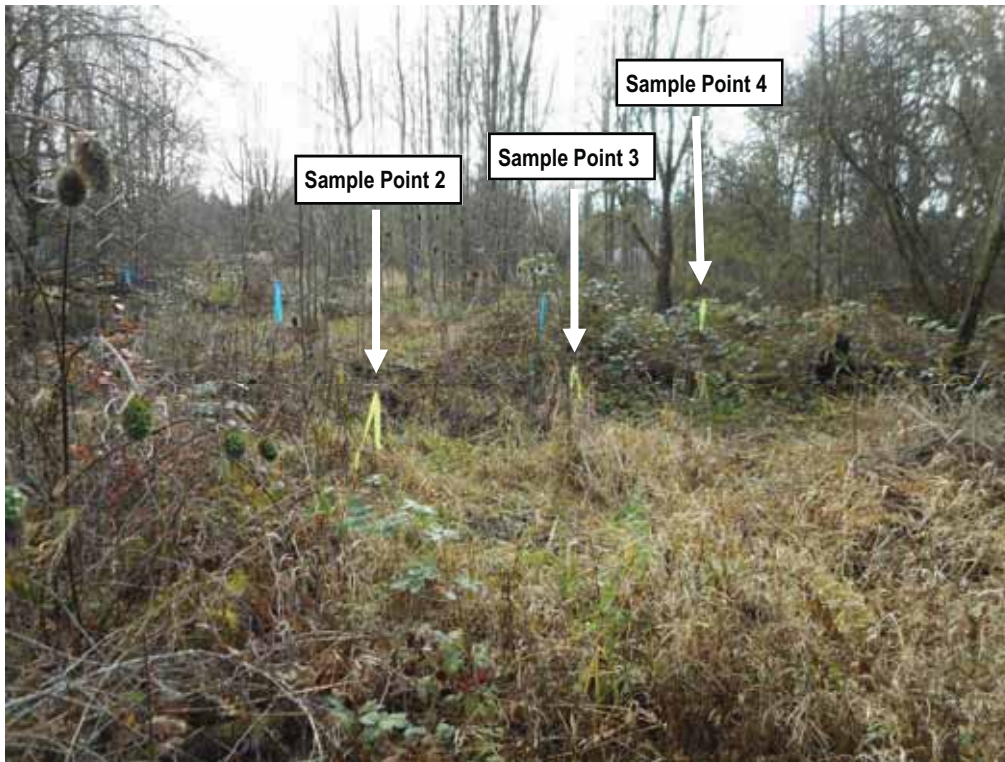
Photo G

Looking southeast toward upland island (Sample Point 4) and center of Wetland A

As described above and shown by Sample Points 3 and 4, the plant community northeast of Wetland A has little to no tree canopy coverage. The combined tree, shrub and groundcover layers provide coverage that exceeds 80 percent; however, tree canopy coverage is less than 25 percent. Therefore, the existing condition of the WQR east of Wetland A meets the definition of a Class C (“Poor”) WQR, as defined in Table 19.402.11.C of the municipal code.

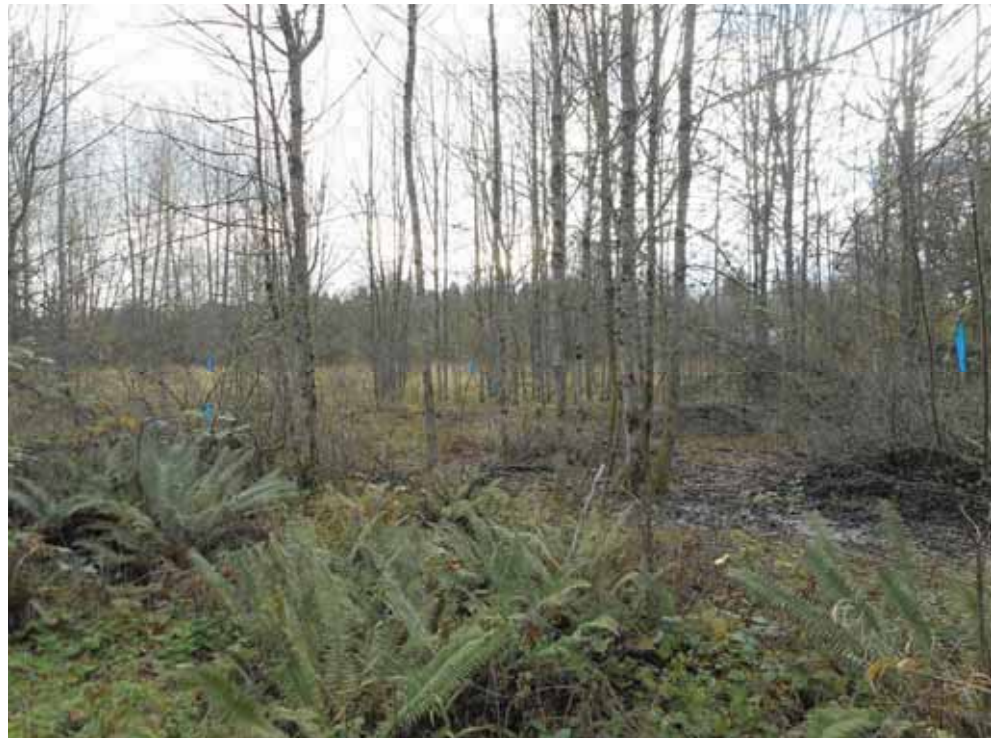
Photo H

Looking southeast toward southern portion of Wetland A from south end of upland island

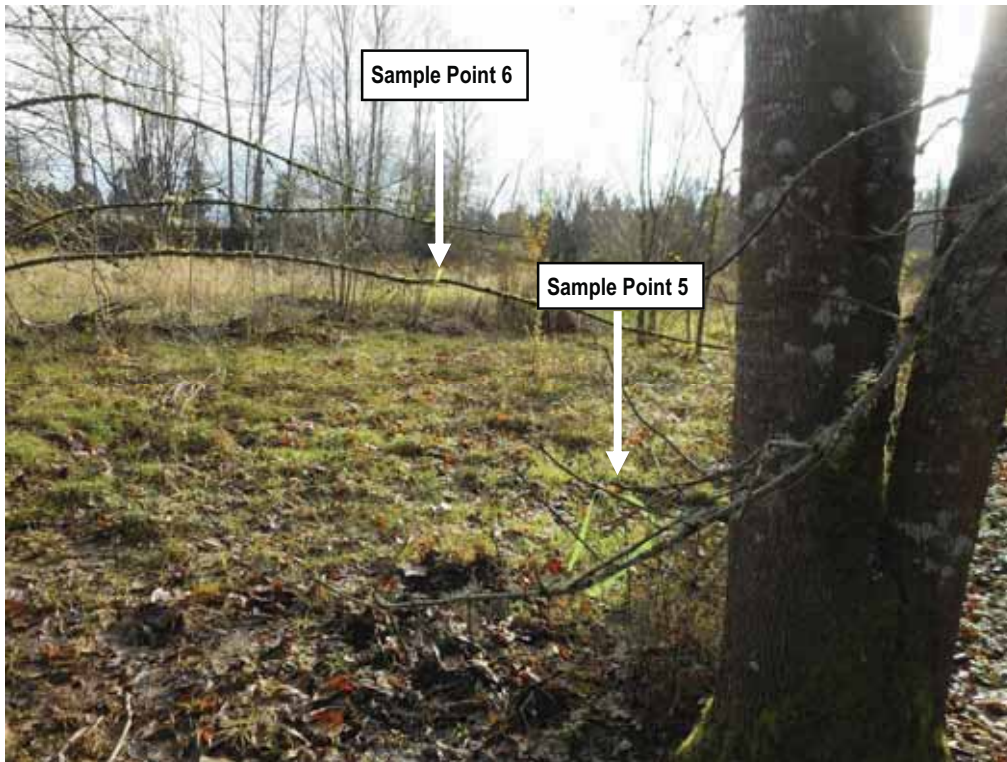
Photo I

Looking southeast toward southern boundary of Wetland A

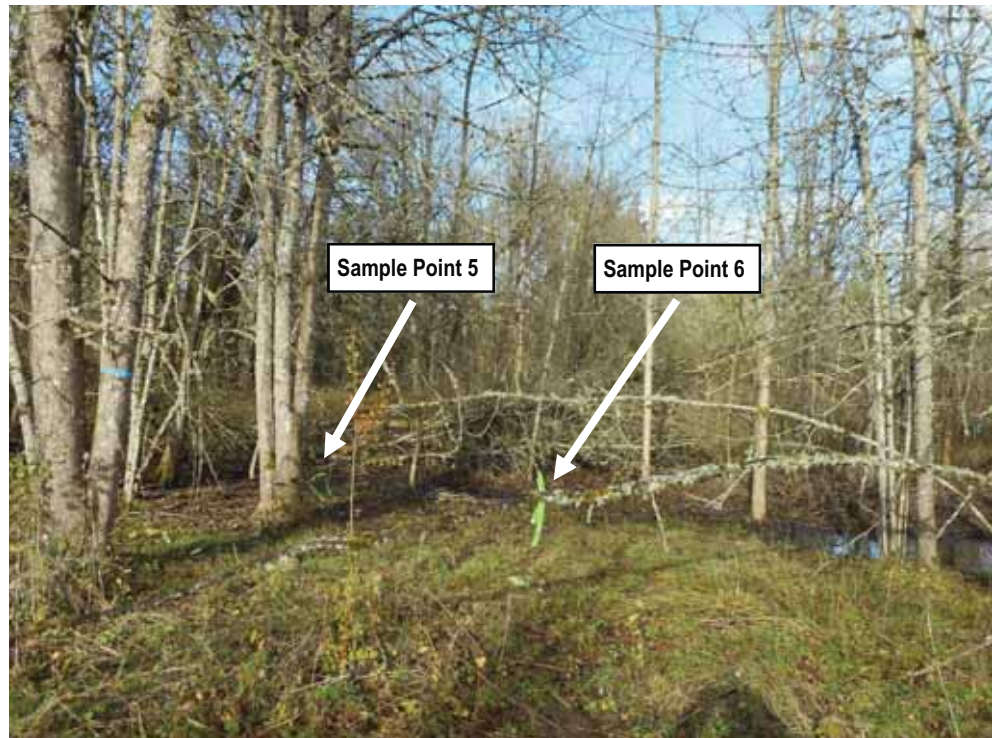
Photo J

Looking toward the northwest portion of Wetland A from its southern boundary.

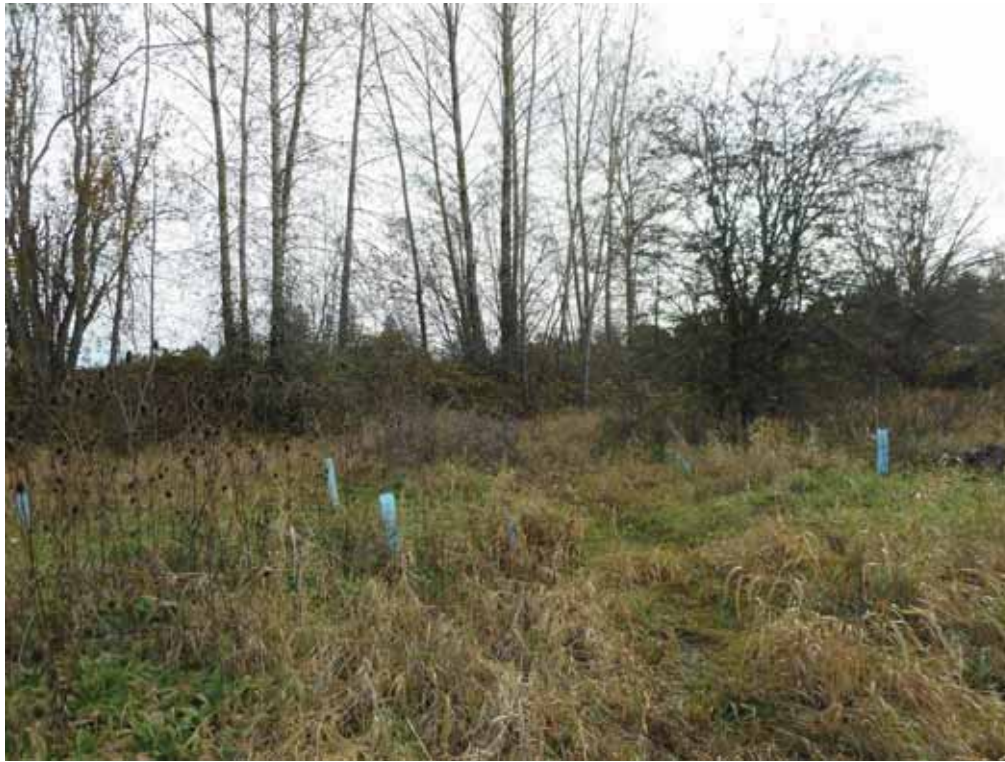
Photo K

Looking southeast at south end of Wetland A

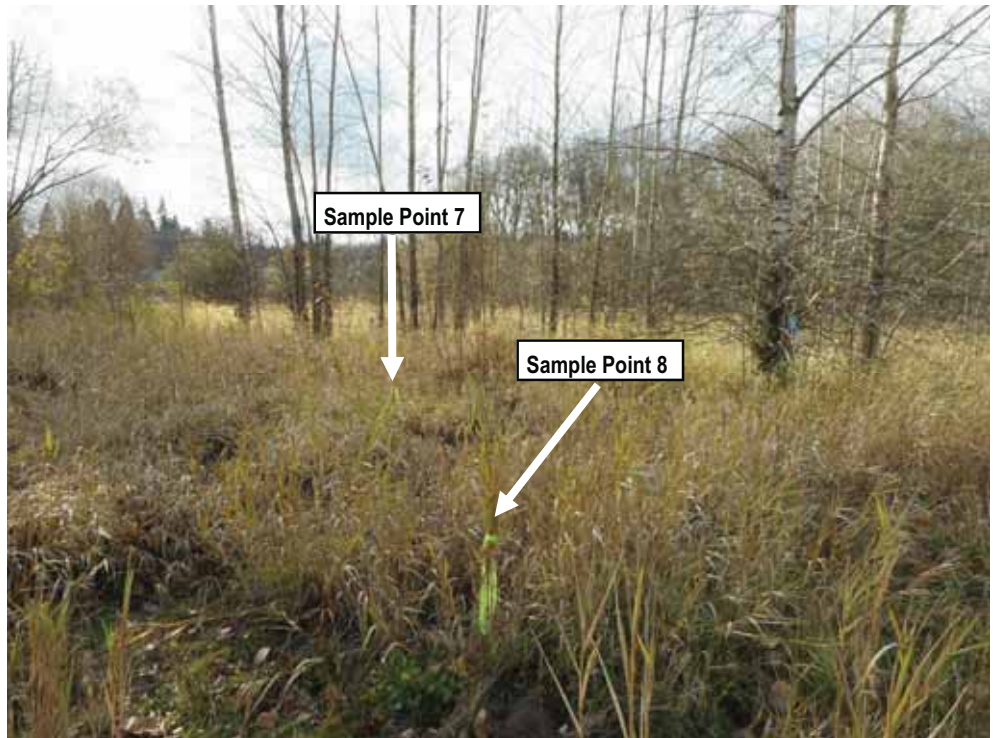
Photo L

Looking south at eastern portion of Wetland A

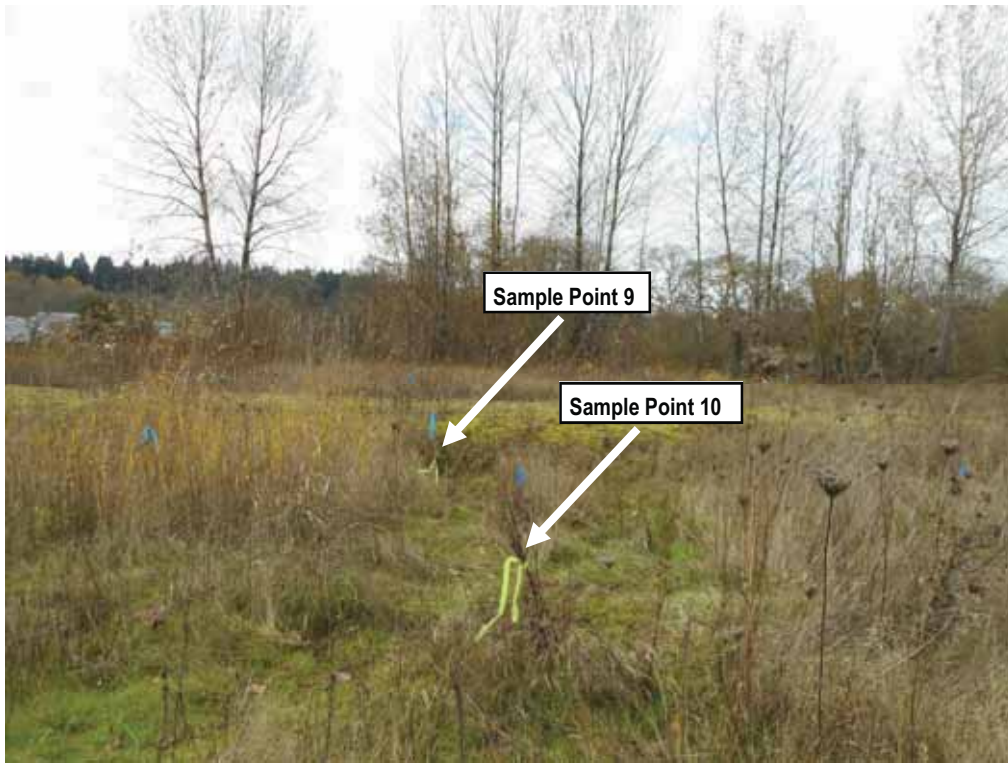
Photo M

Looking southwest
across Wetland E

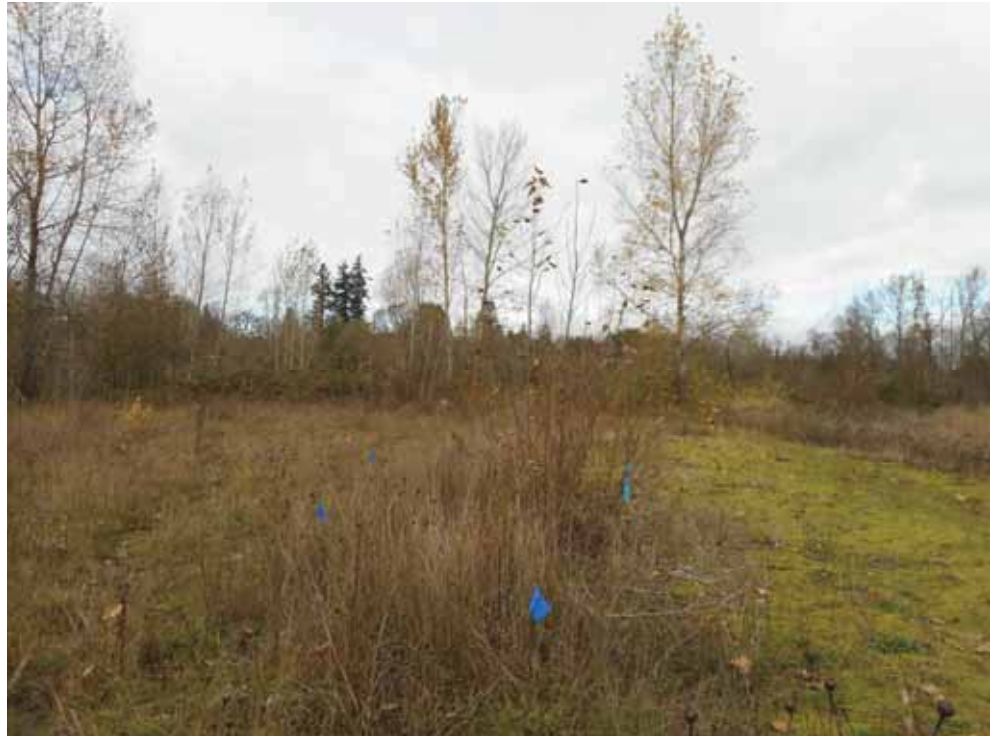
Photo N

Looking north at Wetland C

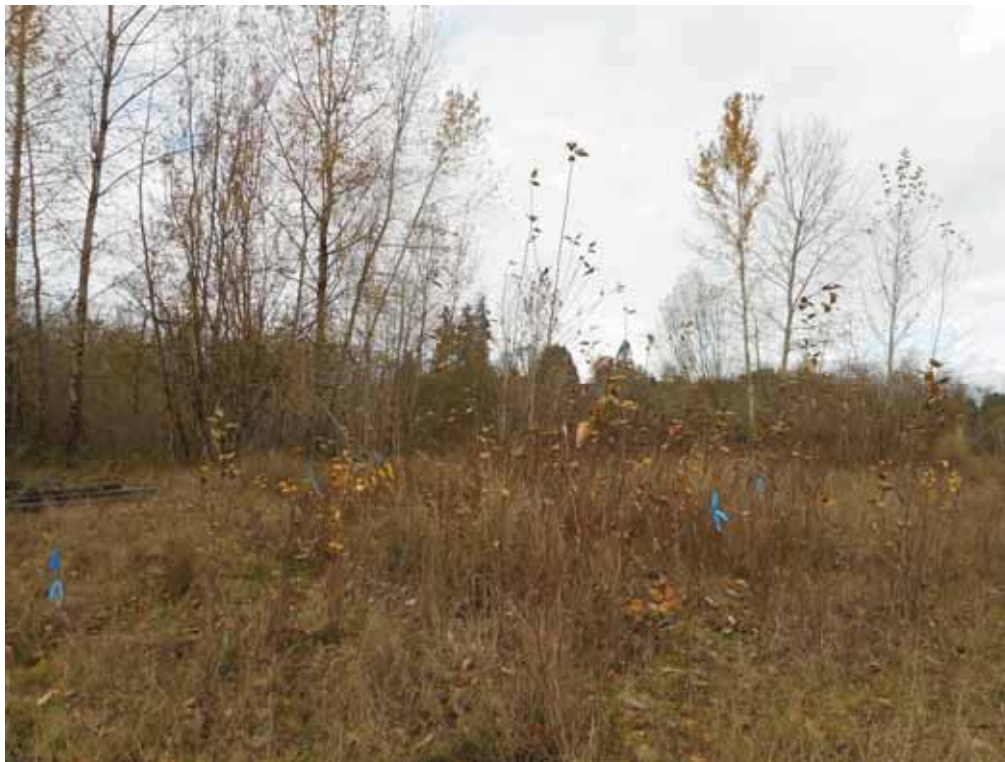
Photo O

Looking northwest at
Wetland B

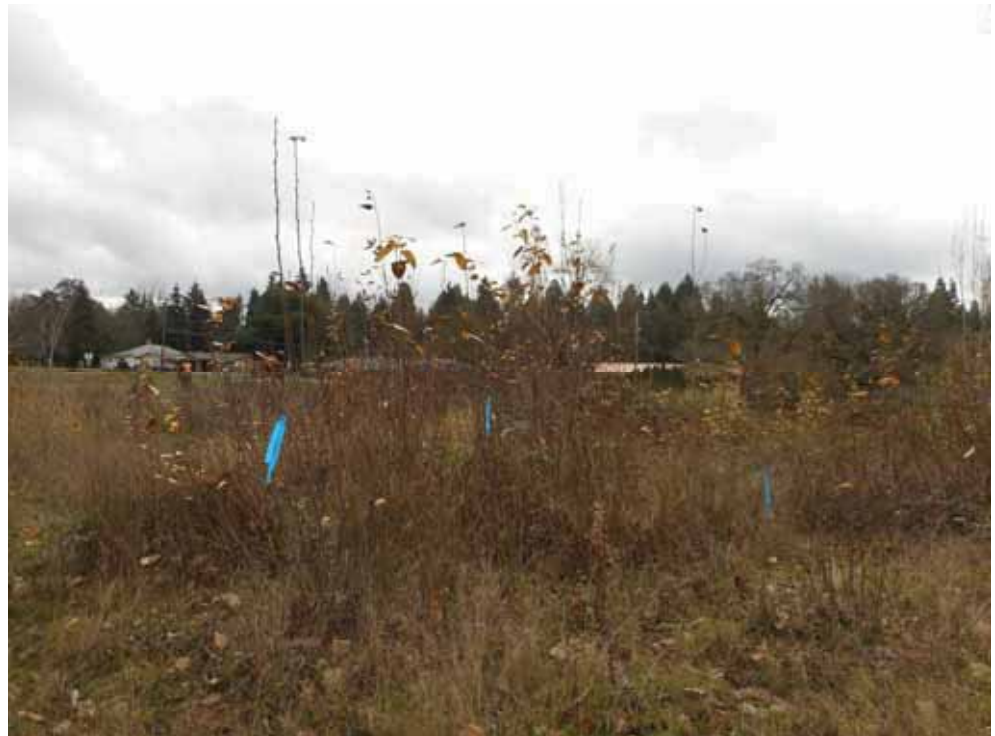
Photo P

Looking southeast at Wetland D

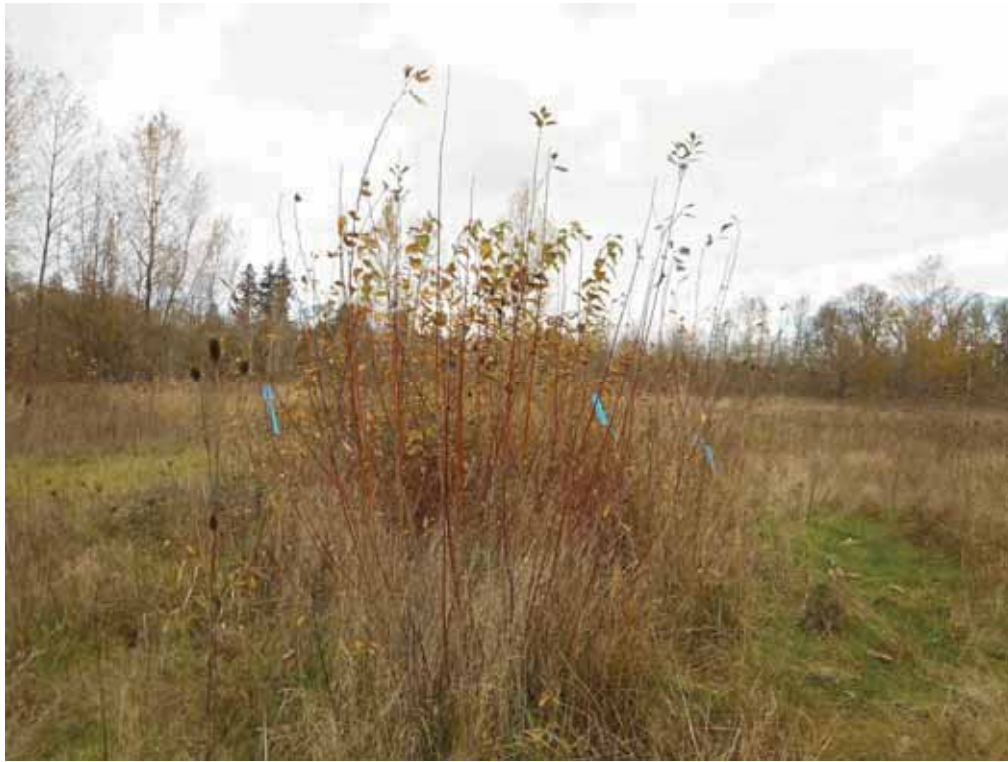
Photo Q

Looking northwest at
Wetland F

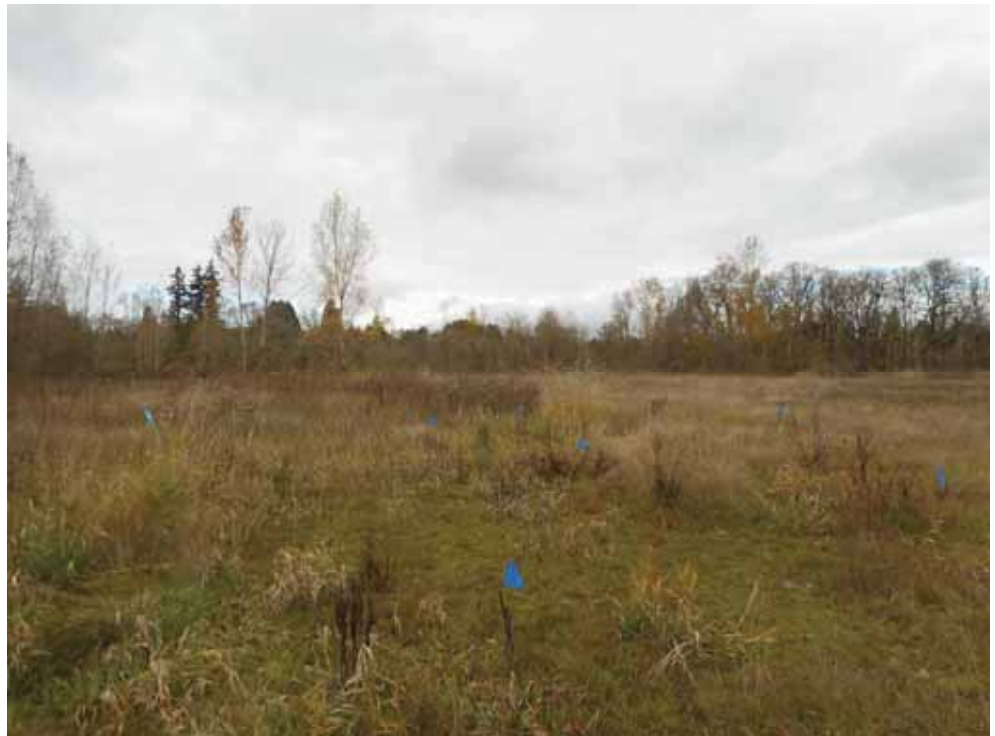
Photo R

Looking north at Wetland G
