Subject: Hydromodification Assessement

Hydromodification Assessment

Prepared for
City of Milwaukie
August 2015

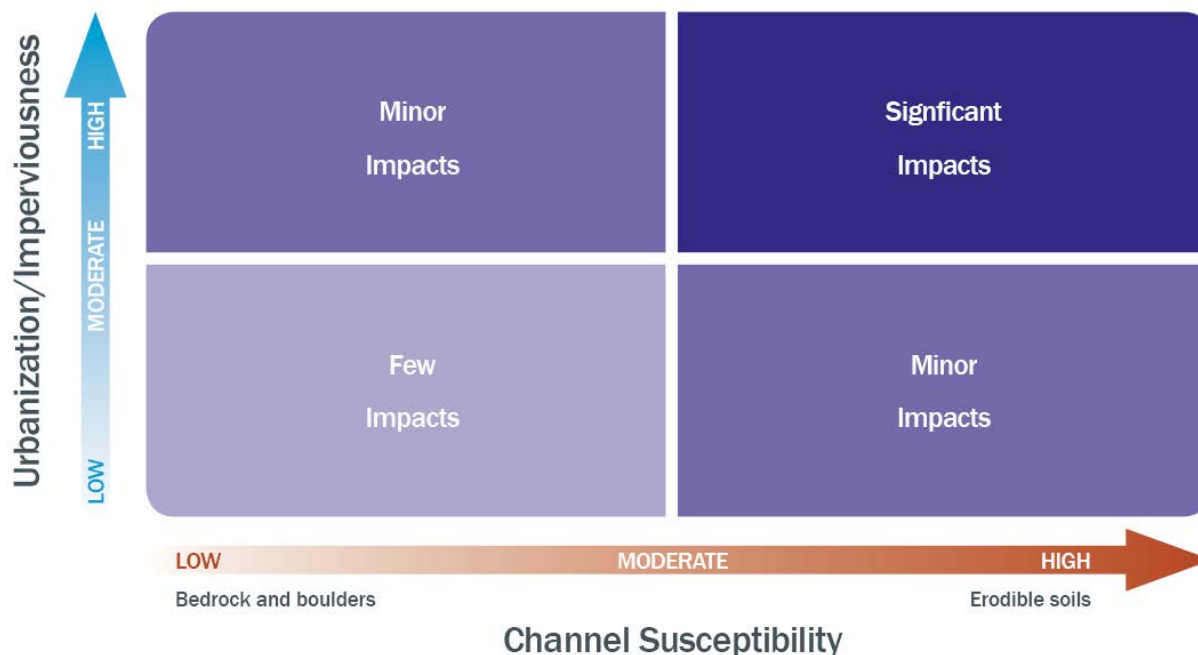
The overall goal of this hydromodification assessment is to conduct a qualitative evaluation of stream channel conditions and to determine locations where past development patterns and controls (or lack of controls) have resulted in significant stream channel impacts. The assessment also looks at channel conditions to identify areas that are naturally resistant to erosion and incision and areas where minor increases in flows have the potential to cause significant impacts. Figure 3-1 illustrates the relationship between natural stream channel condition and urbanization patterns in causing or resisting hydromodification impacts.

Figure 3-1. Relationship of urbanization and stream channel conditions on hydromodification potential

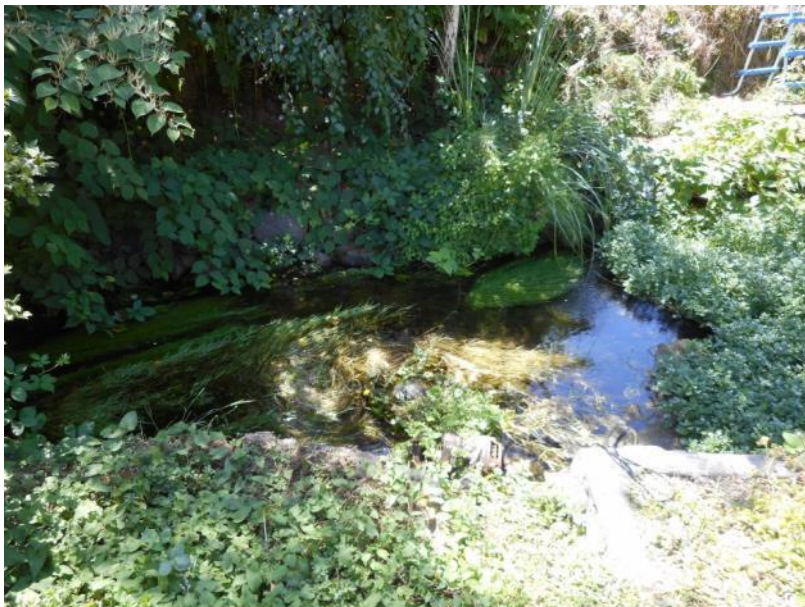
Site location: 001
Photo number: 004
Description: Looking downstream along private property. Armored banks and manmade impoundment to detain water onsite.

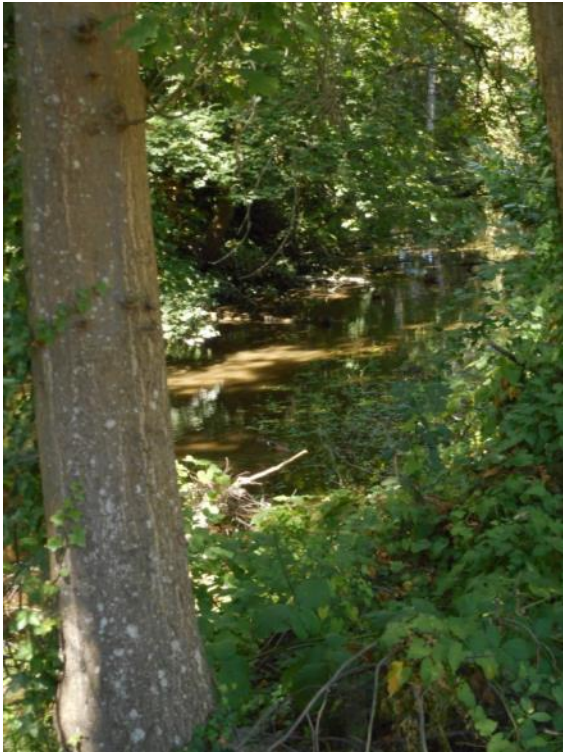
<p>Site location: 002</p> <p>Photo number: 012</p> <p>Description: Looking downstream from 2725 SE Washington Street. Observed high sediment load and evidence of minor sediment accumulation.</p>

Aggradation/ sediment loads <i>(evidence of increasing sediment loads without capacity to transport)</i>	<ul style="list-style-type: none"> Minor evidence of sedimentation in flat reach downstream of SE Washington Street (site 002), which looks to be sediment from localized incision upstream of SE Washington Street at the old mill site. 	<ul style="list-style-type: none"> None observed or reported.
Other observed problems or unique features	<ul style="list-style-type: none"> Man-made features on private properties include concrete pools, weir structures, and bed controls. Creek is integrated into urban landscaping, including man-made waterfalls and ponds. 	<ul style="list-style-type: none"> Channel is primarily constructed open-channel conveyance system to serve industrial business park along Highway 224. Channel has been constructed as a landscaping feature through industrial park, including pond areas, footbridges, and other landscape features.

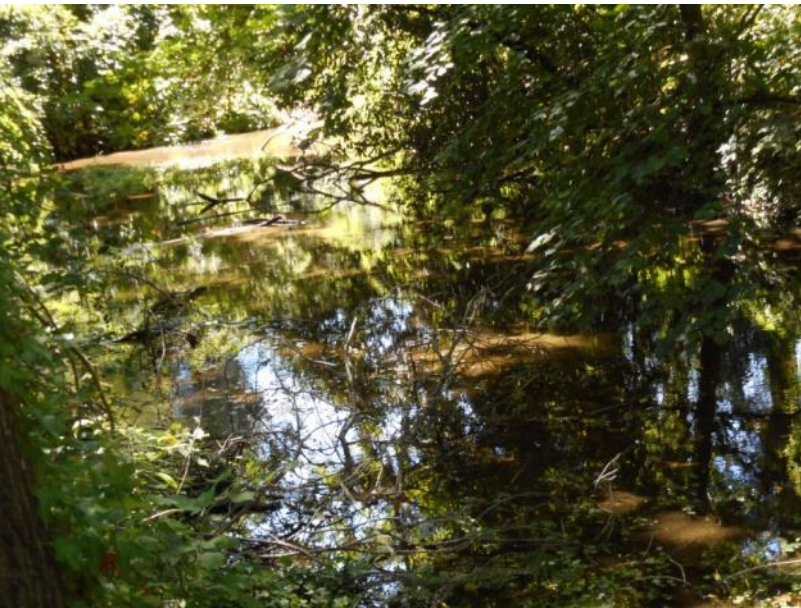
<p>Site location: 002</p> <p>Photo number: 014</p> <p>Description: Looking upstream toward SE Washington Ave. Widened channel with little flow. Established riparian vegetation.</p>

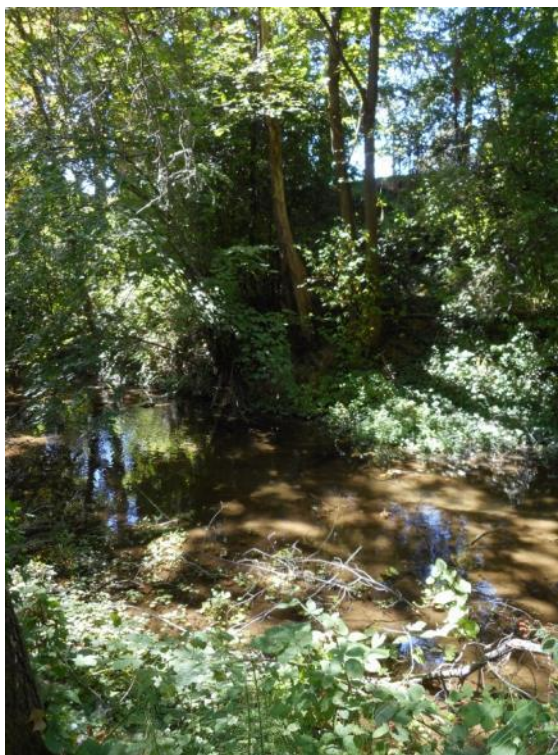
Site location: 002
Photo number: 015
Description: Steep western bank adjacent to St Johns Church and School. Leaning trees but limited evidence of bank sloughing.

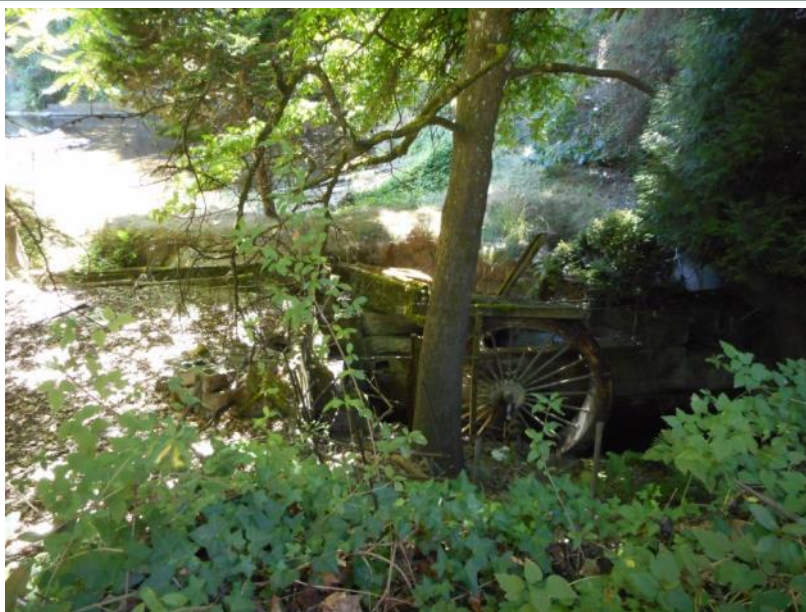
Site location: 002
Photo number: 016
Description: Mill site at corner of SE Washington Street and SE 27th Avenue, upstream of photos 012, 014 and 015. Concrete lined channel and fast moving flow discharges directly to natural channel system. Evidence of incision and bank erosion at pond outlet.

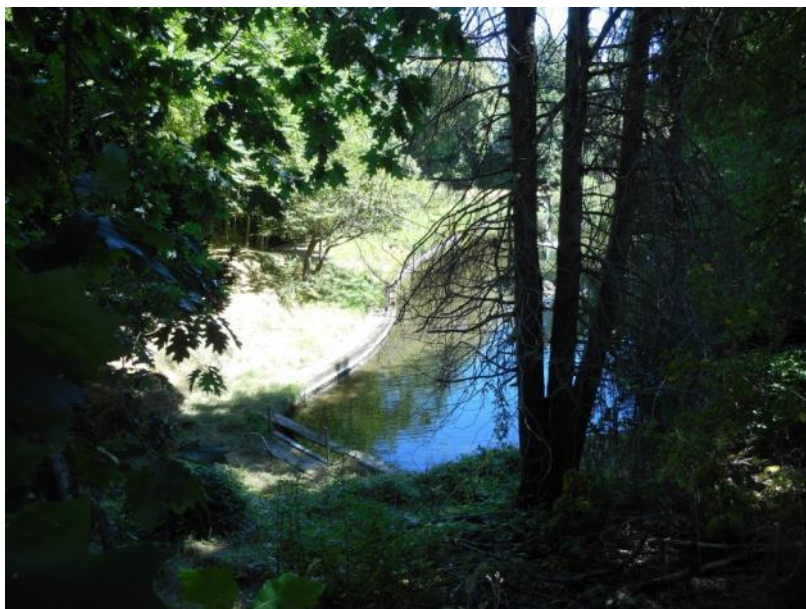
Site location: 002
Photo number: 017
Description: Concrete impoundment at Mill site.

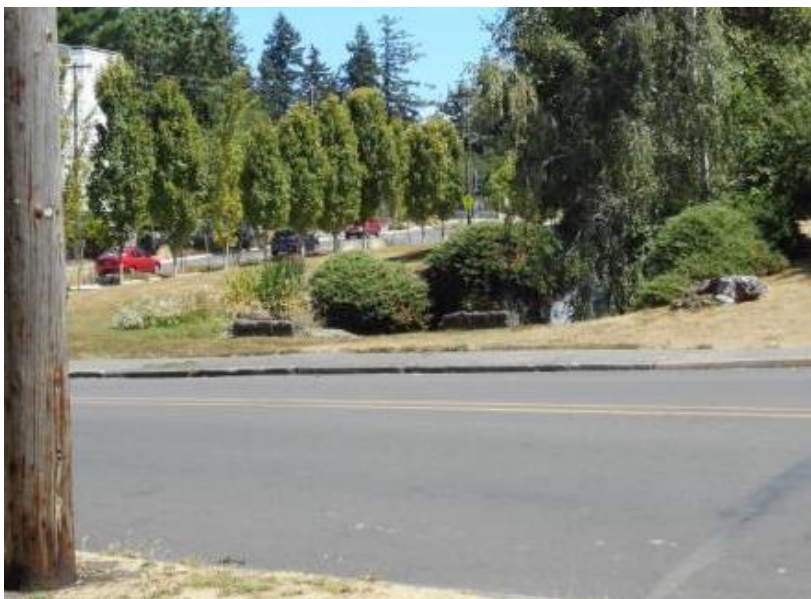
Site location: 004
Photo number: 023
Description: Looking upstream from 25th Avenue. Manmade waterfall on the St Johns campus.

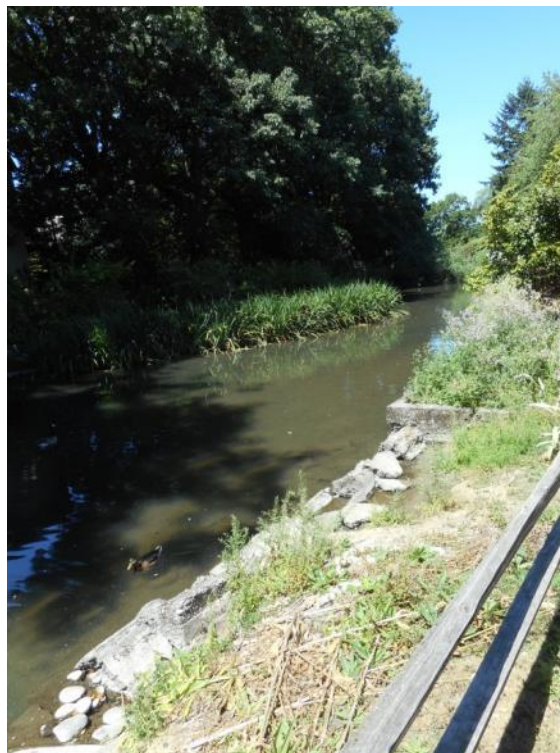
Site location: 004
Photo number: 025
Description: Looking downstream from 25th Avenue. Manmade impoundment.

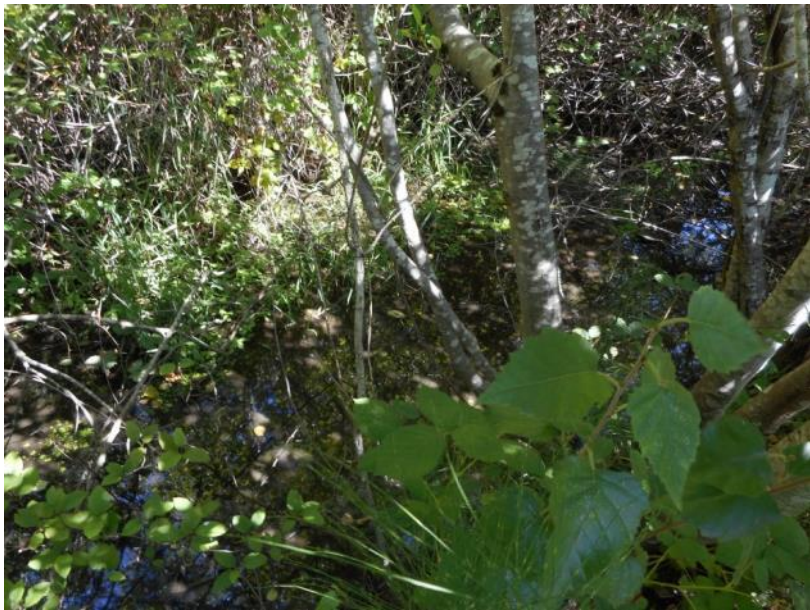
<p>Site location: 005 Photo number: 028 Description: Dense vegetative cover along channel adjacent to SE Mallard Way.</p>

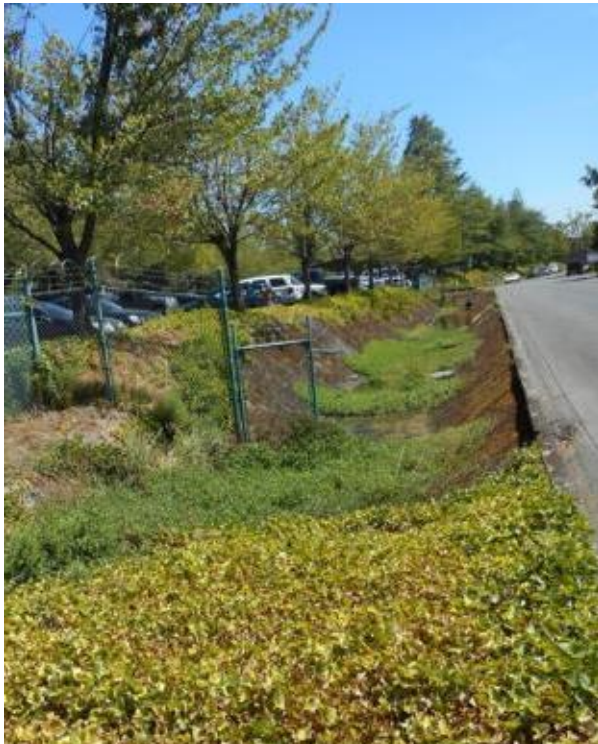
<p>Site location: 005 Photo number: 030 Description: Looking downstream. Discharge to concrete lined sediment of channel. Significant invasive (ivy).</p>

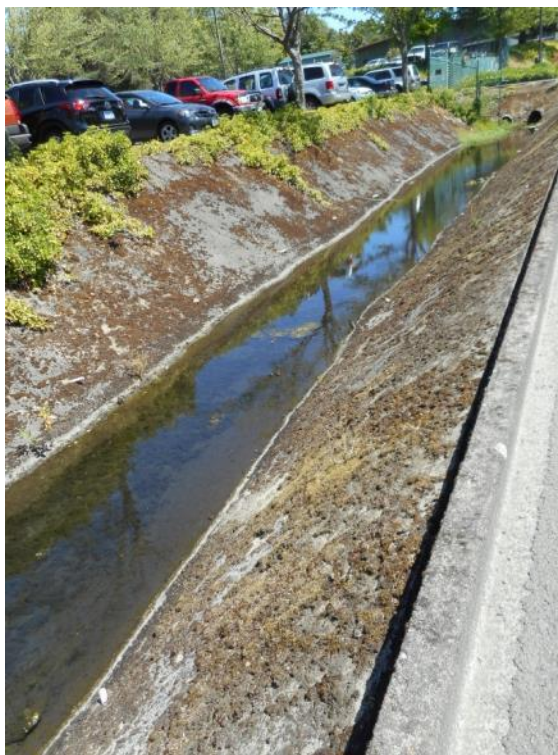
Site location: 005
Photo number: 032
Description: Concrete lined portion of channel.

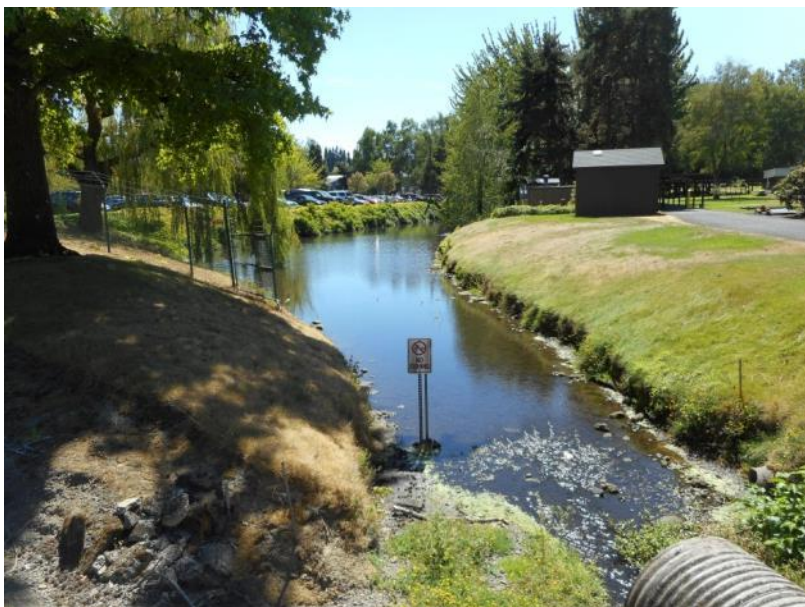
Site location: 005
Photo number: 034
Description: Downstream from photo 032. Manmade impoundment.

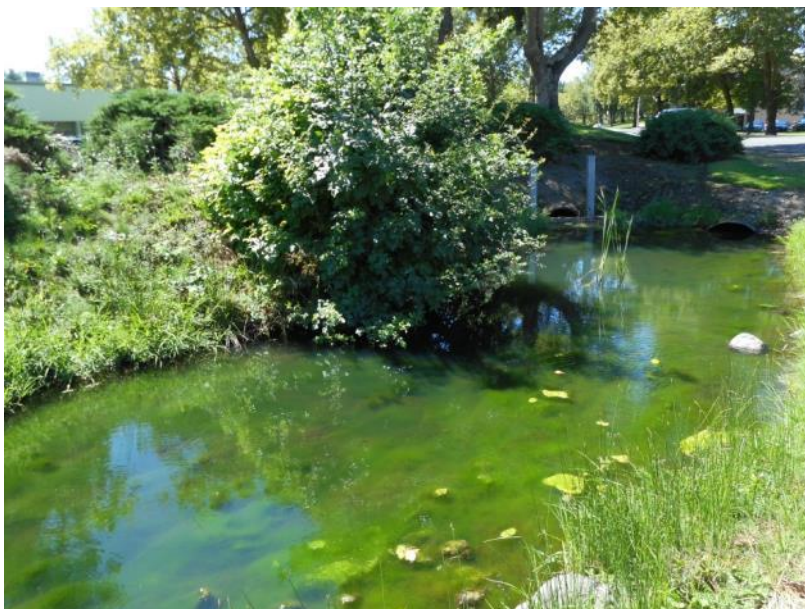
Site location: 007
Photo number: 042
Description: Observed algal growth

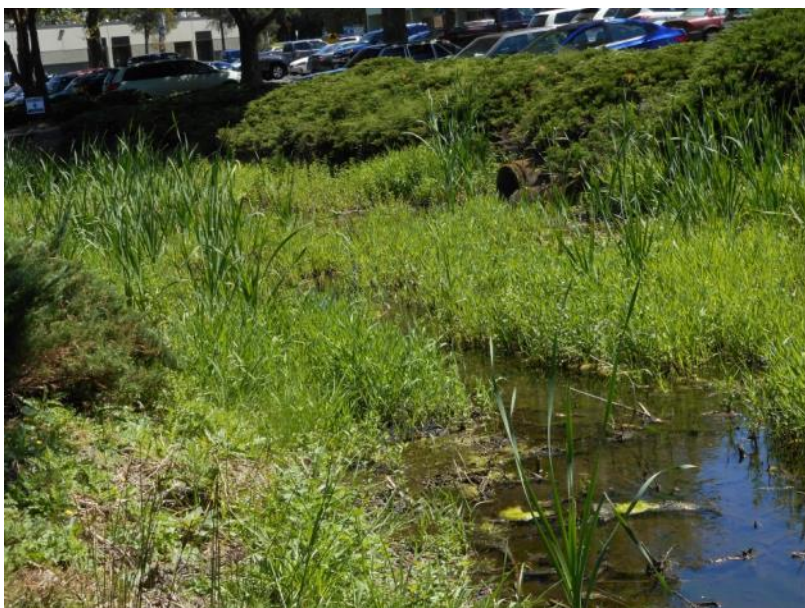
Site location: 007
Photo number: 044
Description: Roof drain and parking lot runoff directly discharges to channel.

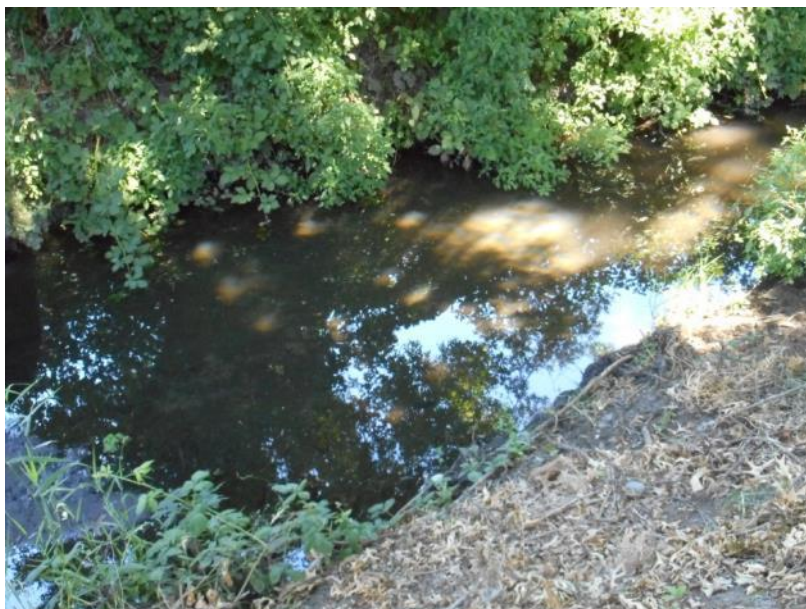
Site location: 008
Photo number: 056
Description: Silty bed sediment and limited flow conditions.
