NORTH CLACKAMAS
PARKS & RECREATION DISTRICT

North Clackamas Park

North Side Master Plan

August, 2012

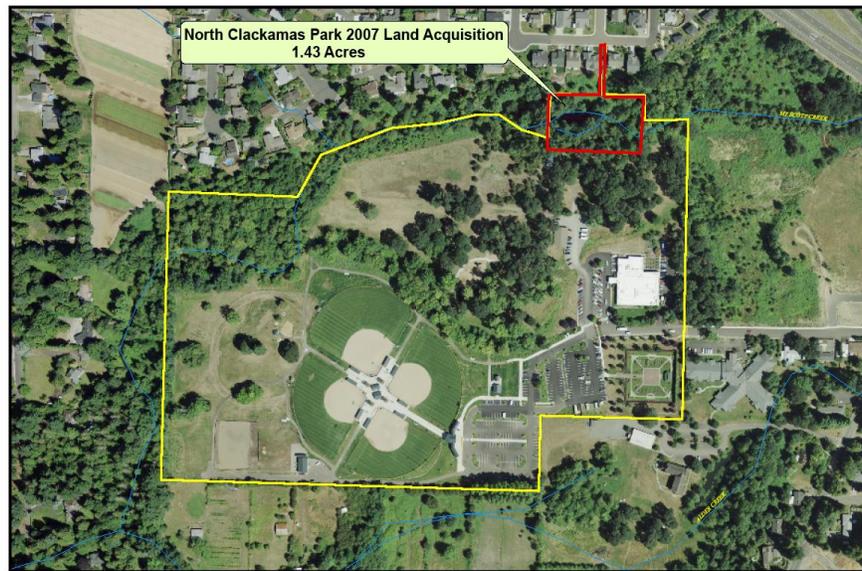
Figure 2: Map highlighting the property acquired in 2007 on the north side of the park.

An additional one and a half acres was donated to the District in 2006 north of the former caretaker's facility and north of Mt. Scott Creek. A small pond was dredged out of this area many years ago. This property is currently inaccessible from the park or the neighborhood due

to steep slopes on the north and the creek on the south. Enhancement of this riparian area is needed to improve wildlife habitat.
